PIP5982 Diagnostic Tip: No Heat Or Poor Heater Performance

Brand:	Model:	Model Years:	VIN:		Engine:	Transmissions:
			from	to		
Chevrolet	Colorado	2023 - 2024	All	All	2.7 L3B	All
GMC	Canyon	2023 - 2024	All	All	2.7 L3B	All

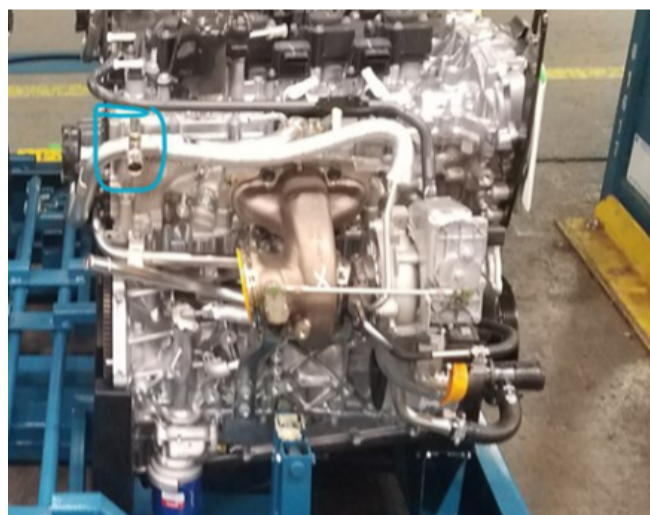
If the temperature of the heater core coolant feed pipe is not at or near operating temperature and appears cold this could be due to a potential blockage from an incomplete machining process where the heater core coolant feed pipe connects to the exhaust manifold coolant outlet pipe.

Picture below shows exhaust manifold outlet pipe spigot connection location where potential blockage could exist.

Allow the engine to cool down and when safe to do so disconnect the heater core coolant feed pipe at the exhaust manifold outlet pipe and inspect the outlet pipe spigot connection for potential blockage.

Note: If this issue is found it will be necessary to replace the exhaust manifold coolant outlet pipe using the latest parts available in EPC.

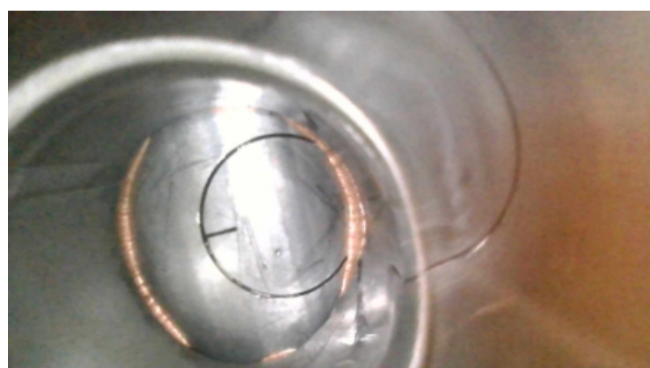
Involved Region or Country:	North America
Condition:	Poor heater performance or no heat in passenger compartment
Cause:	Heater core feed pipe port located on the Exhaust Manifold outlet pipe may be obstructed due incomplete machining process

Picture below shows inside of heater core coolant feed pipe spigot connection with blockage from incomplete machine process

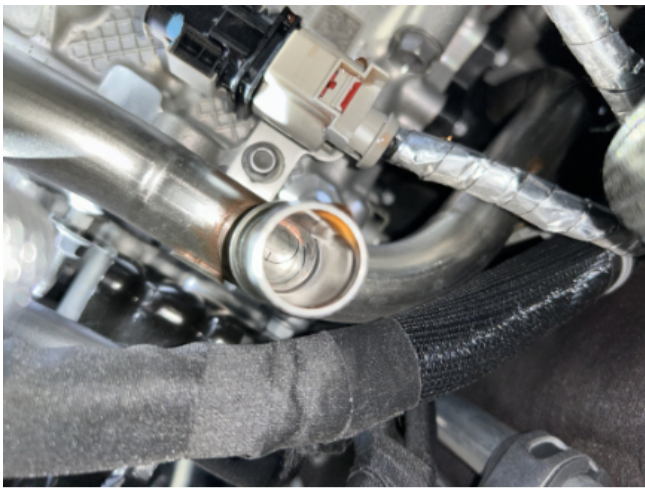
Picture below inside of spigot connection with blockage
