Preliminary Information

PIT6154A Diagnostic Tip For Steering Wheel Oscillation Wobble Shimmy Dither Vibration

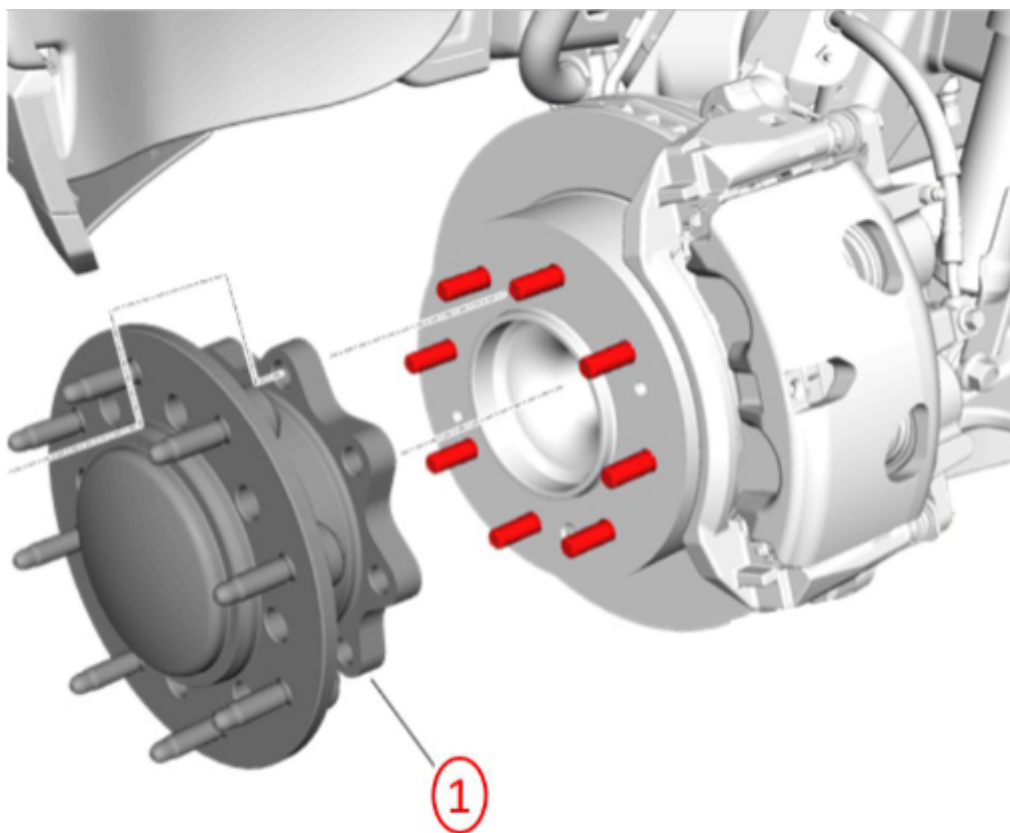
| Cause | The cause of this condition could be excessive runout within the front hub extensions (1), shown below. |

If after following normal SI diagnostics and a root cause has not been found, then inspect the front hub extensions for excessive runout. Remove the wheel and tire assemblies and then use a dial indicator to measure the face of the hub extension where the wheel mounts. Slowly rotate the hub extension while measuring the runout, it should not exceed .005" (.127 mm). If the hub extension has excessive runout, then remove it and use the dial indicator to measure the runout on the face of the brake rotor where the hub extension mounts, again it should not exceed .005" (.127 mm). If the rotor face is within spec, but the hub extension is out of spec then the hub extension will need to be replaced. In some cases, the hub extension may not need to be replaced if the brake rotor face has some runout, but within spec. It may be possible to index the low spot on the rotor face with the high spot on the hub extension, then remeasure the hub extension runout to see if it is now within spec. On trucks with RPO NV8, please read the important statement above before going on a test drive.

**NOTE:** After installing a new front hub extension, recheck the runout to verify it does not exceed .005" (.127 mm).
