PIP5932D Information on Malfunction Indicator Lamp (MIL) Illuminated with Any Combination of DTCs P0521, P06DD or P06DE Setting

Models

Brand:	Model:	Model Years:	VIN:		Engine:	Transmissions:
			from	to		
Buick	Encore GX	2024	All	All	1.2L LIH	All
Buick	Envista	2024	All	All	1.2L LIH	All
Chevrolet	Trailblazer	2024	All	All	1.2L LIH	All
Chevrolet	Trax	2024	All	All	1.2L LIH	All

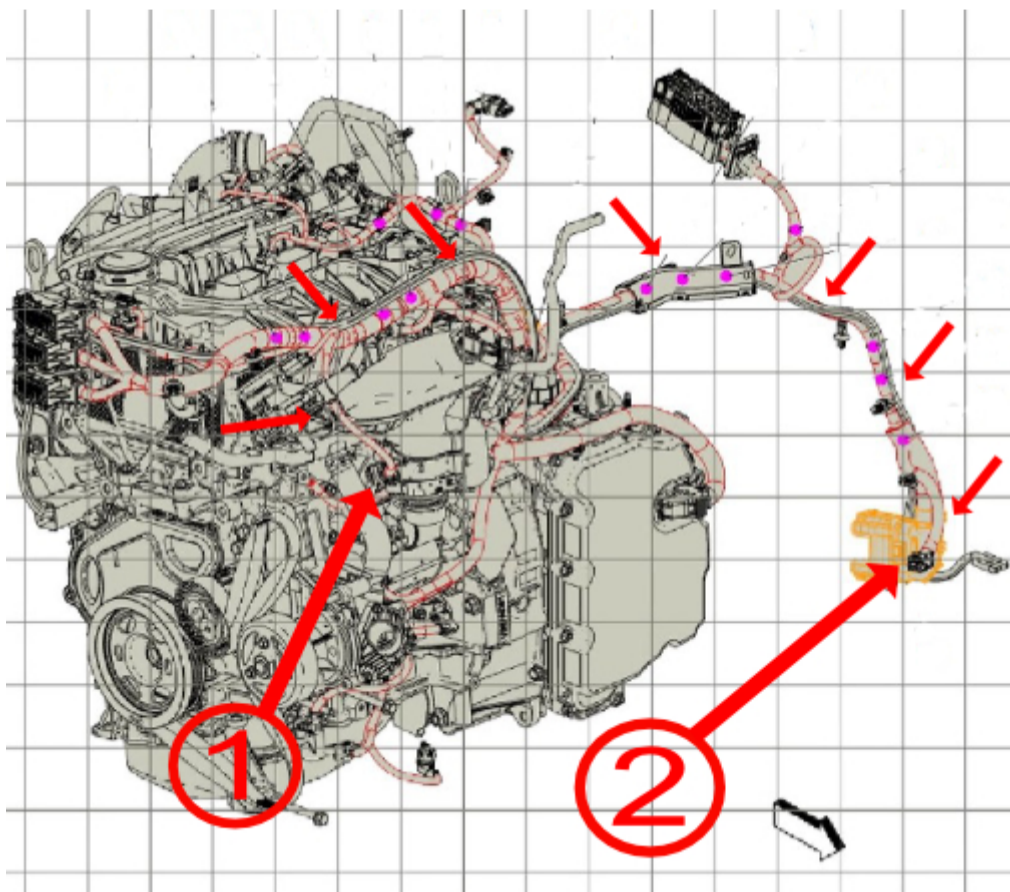
If the resistance is within range, tap and manipulate the engine wiring harness between the oil pressure sensor (1) and X125 (2) shown below, while monitoring for a change in the resistance reading.

If the concern is not isolated to the engine wiring harness, reinstall all components and if P0521, P06DD, P06DE
