Service Bulletin

Bulletin No.: 18-NA-115

Subject: Cold Start Misfire and/or Rough Idle – DTC P0300 May Be Set

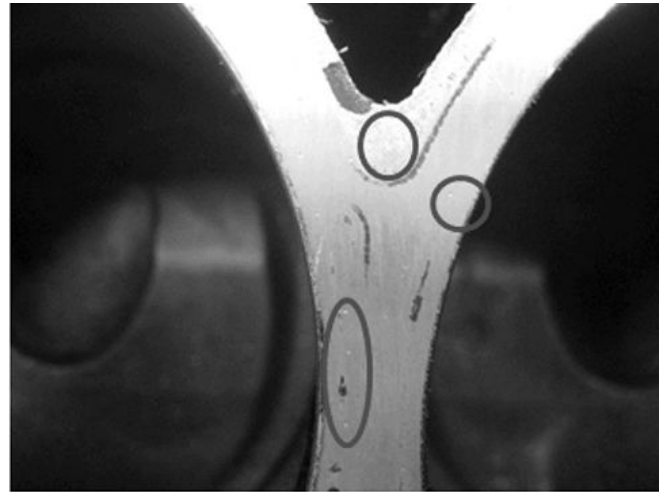
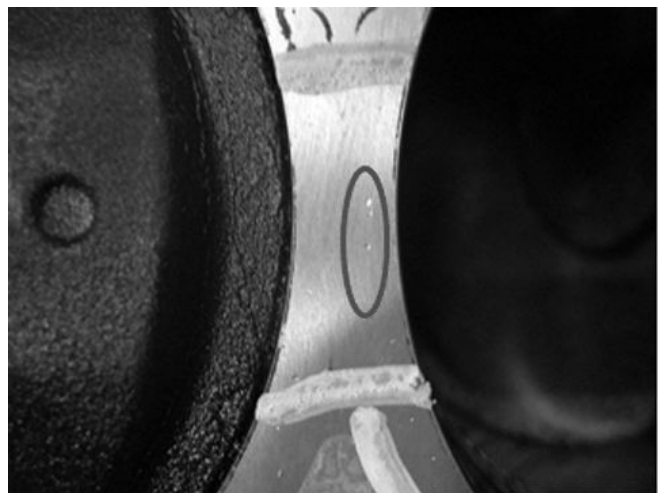
- ⇒ If the borescope inspection is inconclusive, it may be necessary to remove the cylinder head for further visual inspection.
6. With the cylinder head removed, perform a visual inspection. Reference the following pictures provided. The first two pictures represent normal examples of deck pitting and are not the cause of the misfire and/or rough idle condition.

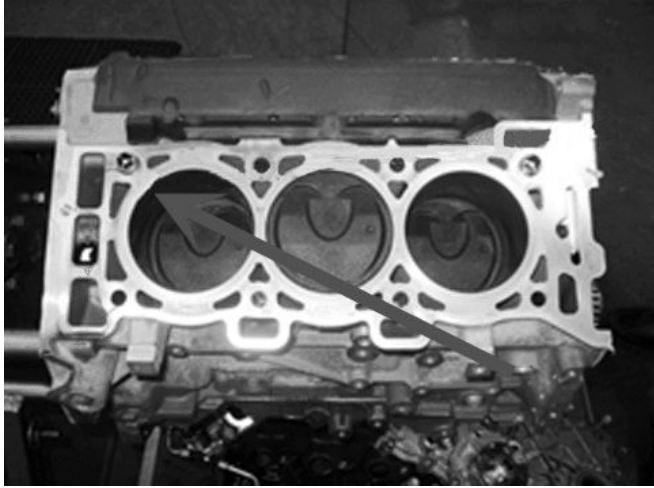
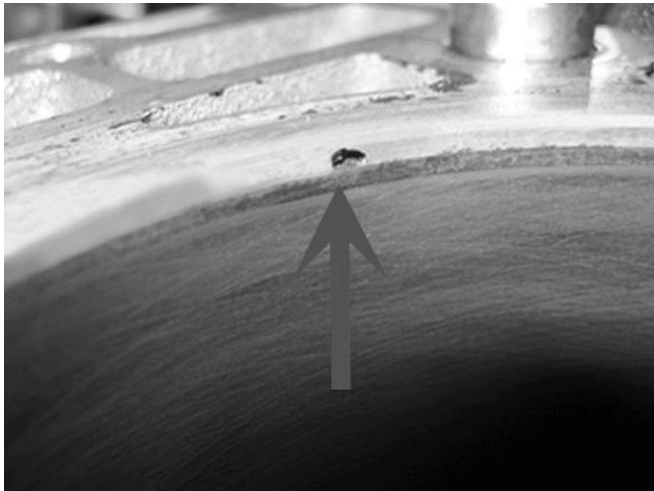
7. The two following pictures represent an example and the location of how actual engine cylinder

block porosity appears. This would be a cause of the condition.

Shown at the deck face to cylinder liner interface location is an area of engine cylinder block porosity that has caused an engine coolant leak path into the cylinder, causing medium to high misfire counts when the engine is cold.

⇒ If this condition is verified, the engine must be replaced.
