Service Bulletin

Bulletin No.: 23-NA-084

Subject: Blue Hourglass and No Gridlines on Radio Rear View Camera Display While in Reverse

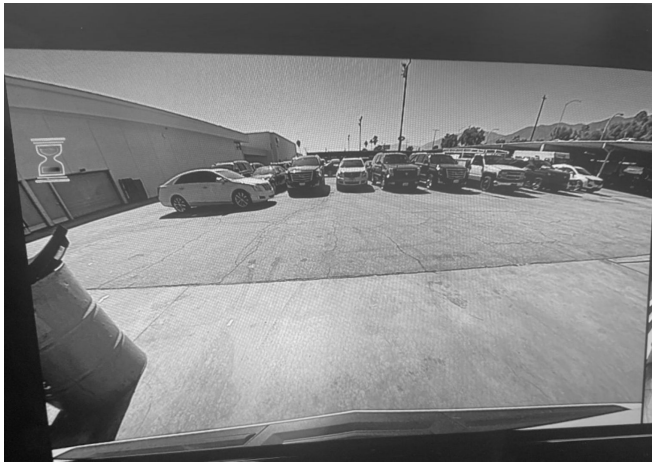
<p style="text-align: right; font-size: small;">6342841</p> <p>Some customers may comment that when attempting to reverse, the rear-view camera on the radio display will have a blue hourglass in the upper left-hand corner and no gridlines in view.</p>
Cause	The cause of the condition may be software anomalies in the Video Processing Module (VPM).
Correction	<p>Reprogram the VPM with the latest software.</p> <p>Drive the vehicle between 32-40 km/h (20-25 mph) for 5 minutes.</p> <p>Important: If the system will not learn, it may be necessary to drive the vehicle for 5 minutes between 5–8 km/h (3–5 mph).</p> <p>Note: This software update does not address this condition on 2022-2024 Escalade. Engineering is working on an update.</p>

No further action is required. Refer to the Warranty Information section of this bulletin.
1. Reprogram the Video Processing Module. Refer to *K157 Video Processing Control Module: Programming and Setup* in SI.

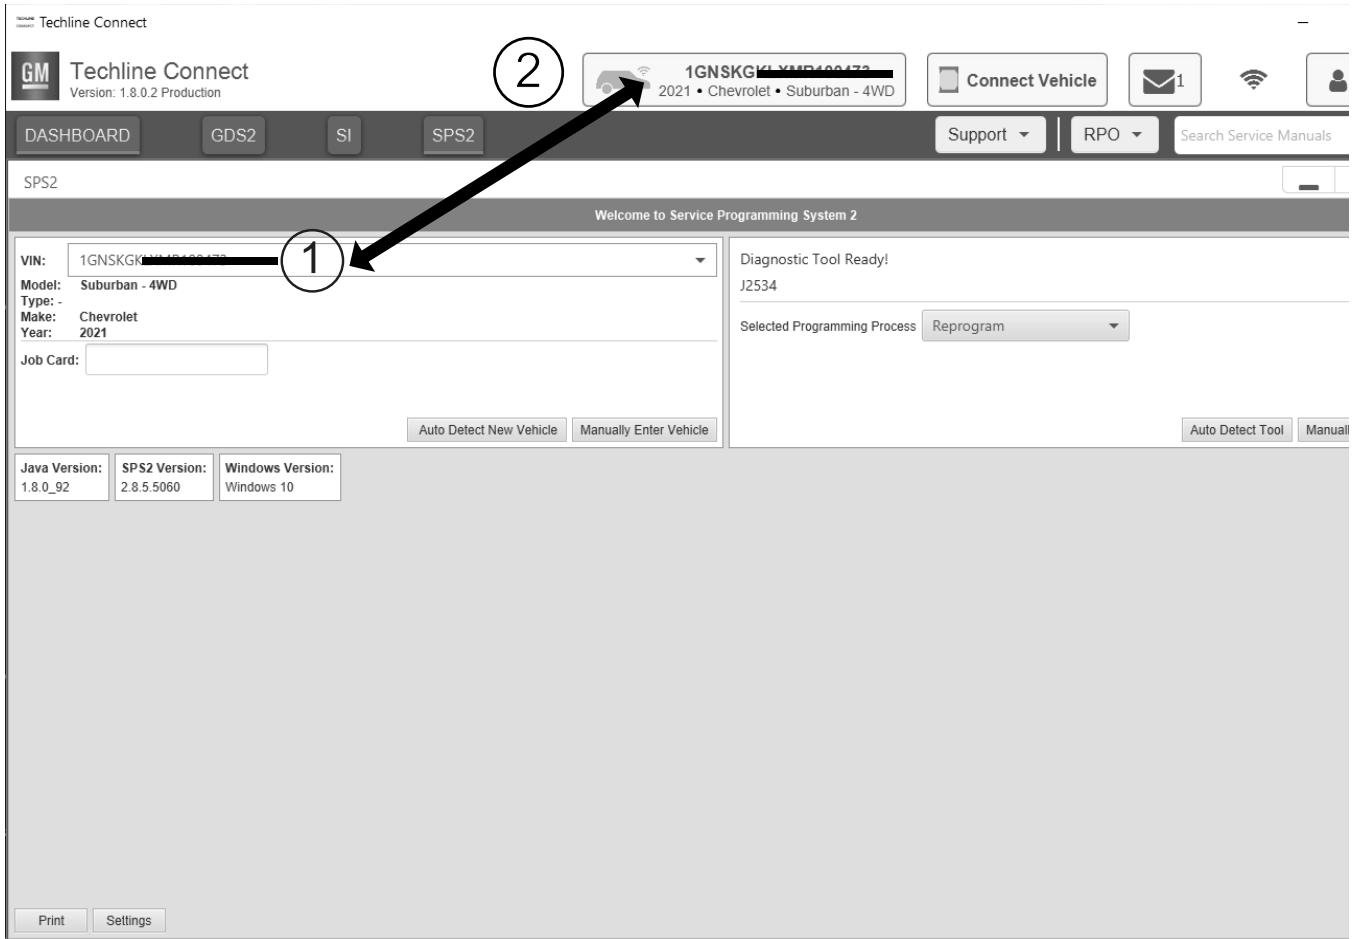
5743643

Caution: Be sure the VIN selected in the drop down menu (1) is the same as the vehicle connected (2) before beginning programming.
