GROUP	MODEL
BOD	2024MY Telluride (ON)
NUMBER	DATE
329	August 2024

TECHNICAL SERVICE BULLETIN

DOOR BELT OUTSIDE WEATHERSTRIP INSPECTION/REPLACEMENT(SA578)

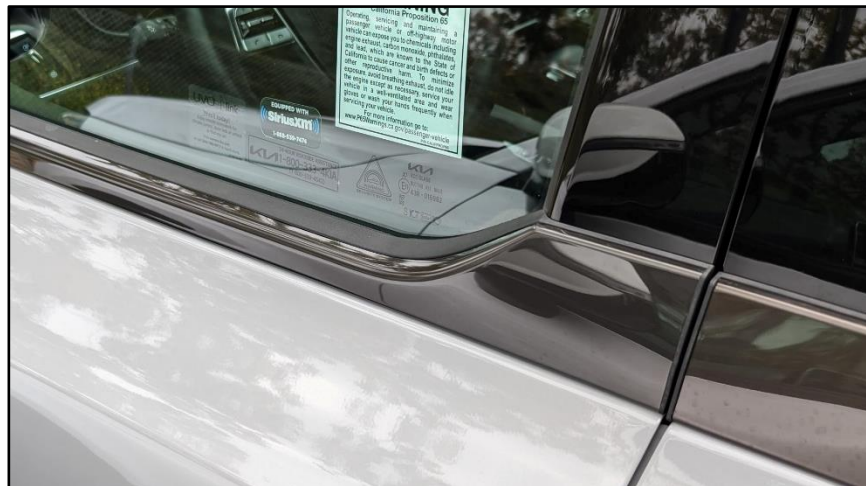
This bulletin provides information to inspect front driver door belt outside weatherstrip on some 2024MY Telluride (ON) vehicles produced from August 1, 2023 through January 18, 2024. The affected vehicles may be missing an adhesive layer causing the outer faceplate to detach/separate from the molding. Follow the procedure outlined in this publication to inspect and, if necessary, replace the driver front door belt outside weatherstrip. Before conducting the procedure, verify that the vehicle is included in the list of affected VINs.

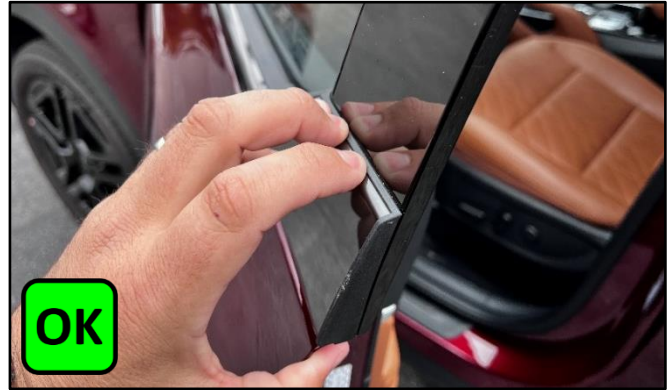
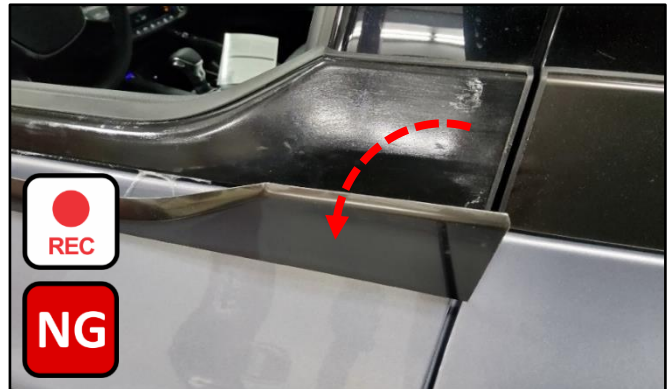
1. Confirm that the outer faceplate is not detached/separated (coming unglued) from the molding on the left front (LH FR), right front (RH FR), left rear (LH RR), and right rear (RH RR) doors by gently pulling using fingers:

- If the outer faceplate is **not** detached or separating from the molding **(OK)**, no further action required. Claim Inspection Labor Op Code 240A2010.
- If the outer faceplate **is** detached or separating from the molding **(NG)**, record a KVID video starting from the VIN label on the door and then showing **each NG** door belt outside weatherstrip and proceed to the 'Replacement Procedure' below.
