# Service Bulletin

Bulletin No.: 23-NA-198

**Subject: HVAC Not Cooling Cabin During a Remote Start**

Brand:	Model:	Model Year:		VIN:		Engine:	Transmission:
		from	to	from	to		
Chevrolet	Trax	2024	2025	—	—	—	—

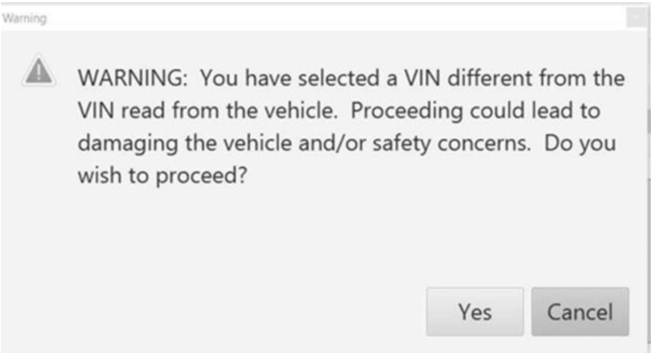
5877000

**Important:** If the vehicle VIN DOES NOT match, the message below will be shown.

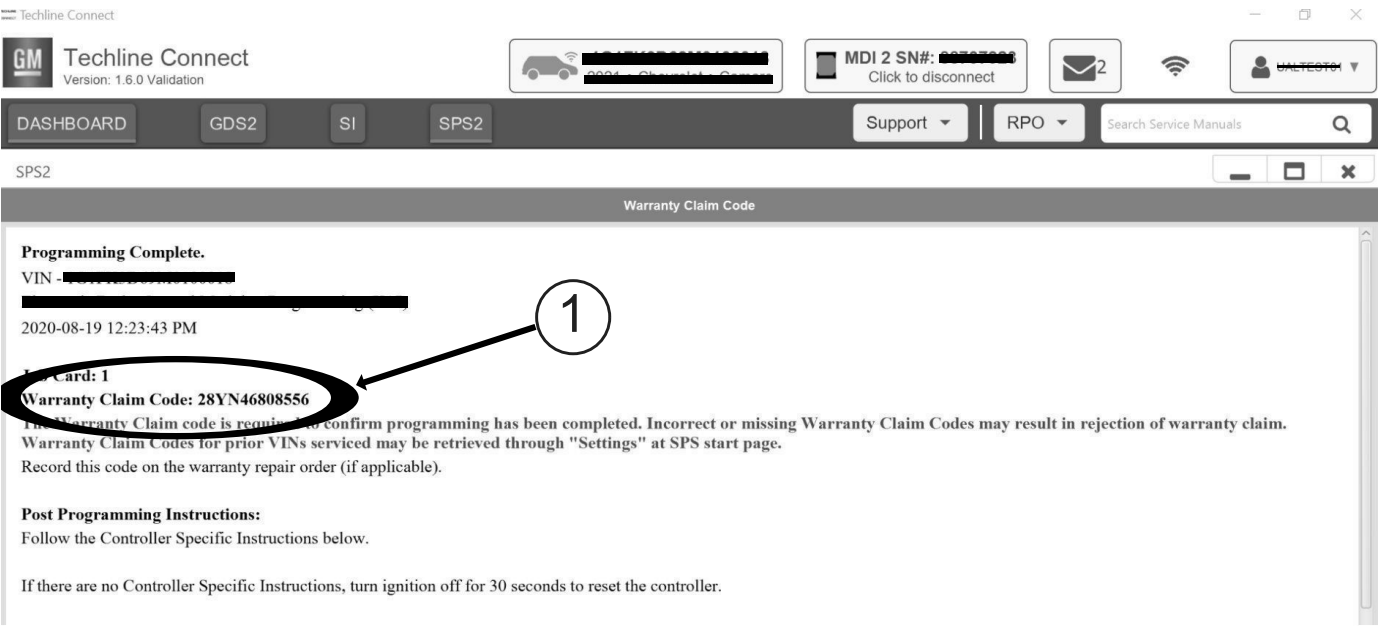
5644478

**Note:** The screenshot above is an example of module programming and may not be indicative of the specific module that is being programmed. Module selection and VIN information have been blacked out.

1. Reprogram the Body Control Module. Refer to K9 *Body Control Module: Programming and Setup*.

**Important:** To avoid warranty transaction rejections, you **MUST** record the warranty claim code provided on the Warranty Claim Code (WCC) screen shown above on the job card. Refer to callout 1 above for the location of the WCC on the screen.
