# Service Bulletin

Bulletin No.: 23-NA-115

**Subject: Ticking, Tapping or Snapping Noise from Engine - 5.5L RPO LT6 Realign Camshaft Caps as Required**

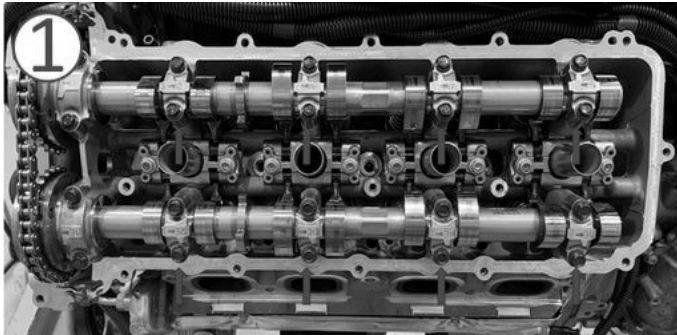
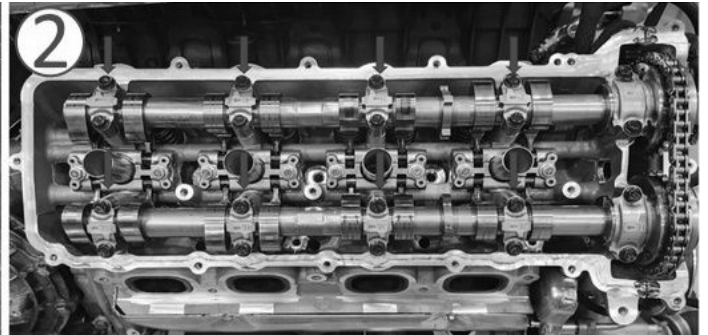
| <b>Cause</b> | This condition may be caused by the misalignment of the camshaft caps. |

- Before torquing the camshaft cap bolts to spec, it will be necessary to push on the cap (Bias) towards the direction shown in the graphic above and hold it in that direction while torquing to spec.

- LH Bank (1) - Bias caps inboard towards intake
- RH Bank (2) - Bias caps outboard toward exhaust side
