Service Bulletin

Bulletin No.: 23-NA-142

Subject: No Forward Gear When Shifting from Park to Drive and/or Reverse to Drive

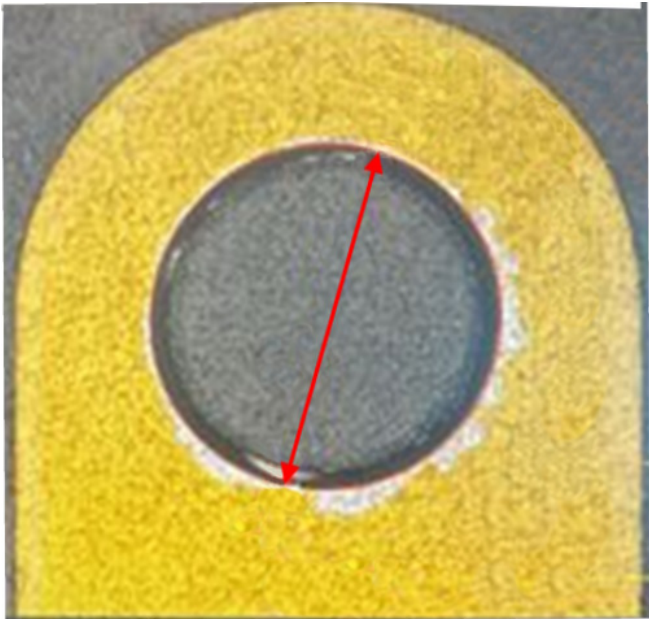
<p style="text-align: right;">6404748</p> <p>This condition may be caused by a Spacer Plate in the valve body that does not meet the specification for chamfer across the entire circumference of the coined check ball seat.</p>

Correction	Replace the spacer plate and check ball.
-------------------	--

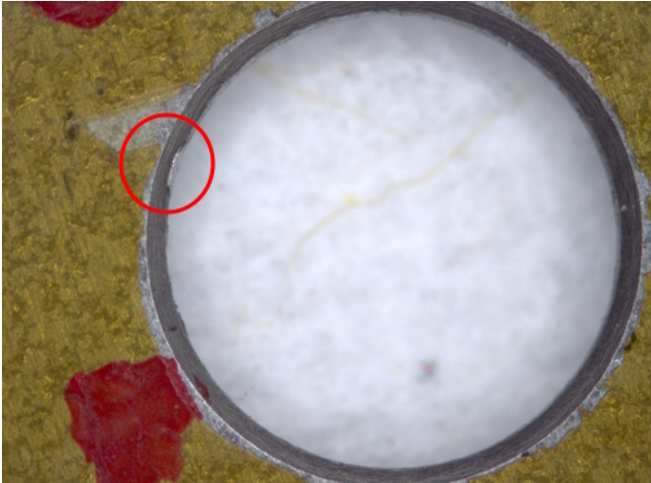
<p style="text-align: right;">6404809</p>
--------------	--

- The seat for the check ball is out of spec relative to coin depth. This potentially can cause burrs, dents, or dings, which could cause the plastic check ball to wear prematurely.
- Note:** School buses, some of which shift to Park at each student stop, may exhibit the earliest signs of failure.
- The #1 check ball has a high duty cycle and when combined with the issue, there is a possibility for the check ball to wear and then become stuck or pass through the spacer plate.

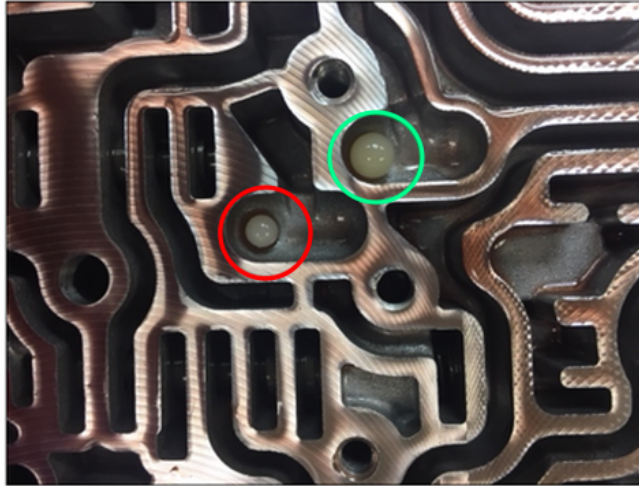
6404322

- As indicated in the graphic above, the check ball circled in RED has prematurely worn down. It should be the same diameter as the check ball circled in GREEN.
