Service Bulletin

Bulletin No.: 24-NA-128

Subject: Powertrain Control Module Fails Key Provisioning/Serial Data Authentication Configuration and Sets DTC U1962

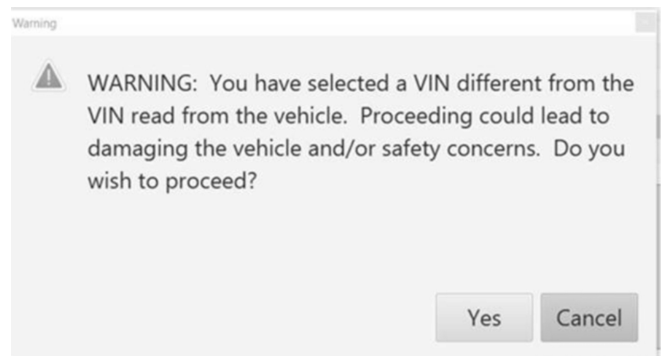
5877000

Important: If the vehicle VIN DOES NOT match, the message below will be shown
