Technical Service Bulletin (TSB)
Tail Lamp Condensation

REFERENCE:	TSB: 08-182-24 GROUP: 08 - Electrical	Date:	August 13, 2024	REVISION:	—
VEHICLES AFFECTED:	2023 - 2024 (M6) Jeep Compass 2023 - 2024 (H6) Jeep Meridian This bulletin applies to vehicles built on or after April 01, 2023 (MDH 0401XX) and on or before July 01, 2024 (MDH 0701XX).			MARKET APPLICABILITY:	
				<input type="checkbox"/> NA	<input type="checkbox"/> MEA
				<input type="checkbox"/> SA	<input checked="" type="checkbox"/> IAP
				<input type="checkbox"/> EE	<input type="checkbox"/> CH
CUSTOMER SYMPTOM:	Customers may experience one or more of the following: <ul style="list-style-type: none"> Foggy appearance in body side tail lamp (M6 & H6). Foggy appearance in exterior lamp bar (H6). 				
CAUSE:	(M6 & H6): Poor sealing in exterior lamp bar. (H6): Usage of high concentrated windshield washer fluid causing issue.

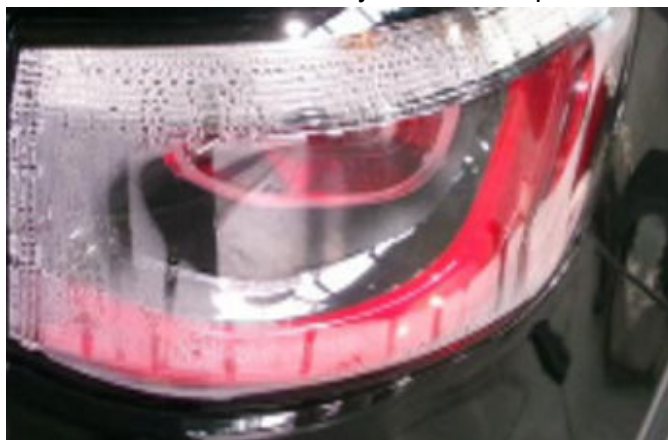
1. Wash vehicle and cover body side tail lamp or exterior lamp bar.
2. Wipe the tailgate portion.
3. Check for water entry and condensation inside the body side tail lamp and the exterior lamp bar [Fig. 1](#).

Fig. 1
Body Side Tail Lamp Water Entry

4. Is there water entry or condensation present within the body side tail lamp or exterior lamp bar?
 - YES>>> Proceed to [Step 5](#).
 - NO>>> Proceed to [Step 12](#).

10. Has the condensation/fogging begun to clear after 30 minutes of running?
- YES>>> Proceed to [Step 12](#).
 - NO>>> Proceed to [Step 11](#).
11. **For M6 and H6:** Replace the body side tail lamp. Refer to the detailed service procedures listed in DealerCONNECT Service Library under: 08 - Electrical / 8L - Lamps and Lighting / Lamps/Lighting - Exterior / Lamp, Tail Stop Turn / Removal and Installation.
For H6: Replace the exterior lamp bar. Refer to the detailed service procedures listed in DealerCONNECT Service Library under: 23 - Body / Decklid/Hatch/Liftgate/Tailgate/Swing Gate / Lamp Bar, Exterior / Removal and Installation.

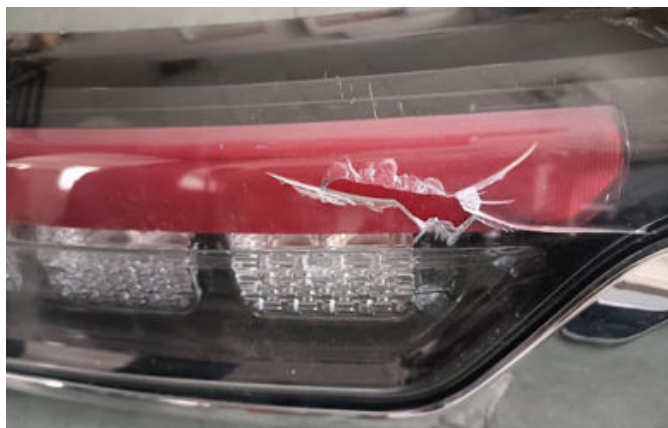
Fig. 2

5. Inspect the body side tail lamp or exterior lamp bar for external damage such as a crack or opening [Fig. 2](#).

Exterior Lamp Bar External Damage

6. Is external damage present on the body side tail lamp or exterior lamp bar?
- YES>>> Not covered under warranty.
 - NO>>> Proceed to [Step 7](#).
7. Take vehicle outside in an open environment.

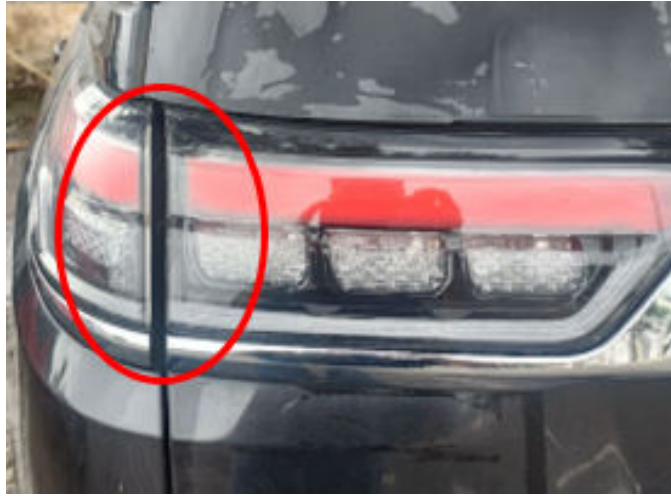
Fig. 3

12. Is there fouling and gap between the body side and inner side tail lamp (M6) or between the body side tail lamp and the exterior lamp bar for (H6) [Fig. 3](#) and [Fig. 4](#)?

Exterior Lamp Bar Fouling And Gap External Lamp Bar

- YES>>> Perform an alignment and adjust gap. Refer to the detailed service procedures listed in DealerCONNECT Service Library under: 08 - Electrical / 8L - Lamps and Lighting / Lamps/Lighting - Exterior / Lamp, Tail Stop Turn / Removal and Installation.

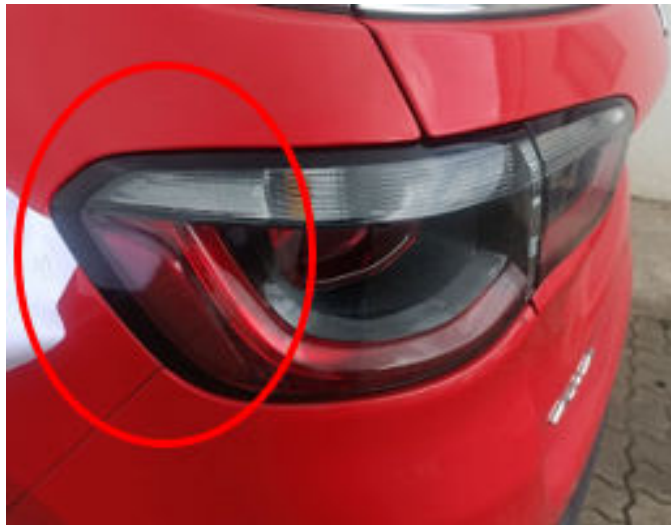
Fig. 4

Body Side Tail Lamp Fouling And Gap Tail Lamp
