GROUP	MODEL
CLI	2021-2022MY K5 (DL3a)
NUMBER	DATE
056	August 2024

TECHNICAL SERVICE BULLETIN

HEATING, VENTILATION, AND AIR CONDITIONING (HVAC) SUBJECT: BLOWER MOTOR FUSE RELOCATION (WTY037)

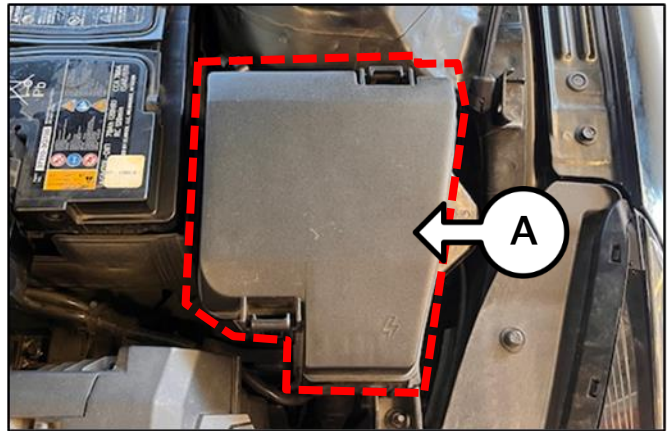
3. Using a flashlight, visually inspect if the multi-fuse location #3 (B) is blown.

- If the multi-fuse location #3 (B) is **NOT** blown, no further action required.
Claim inspection only labor op.
- If the multi-fuse location #3 (B) **IS** blown, proceed to the 'Repair Procedure' on page 2.
