## Lippert In-Wall Slide System

# REPLACEMENT OF THE INVERTED GEAR RACK IN-WALL (SCHWINTEK) SLIDE-OUT SYSTEM

| TSB Number: | 146-001-2022C | | |

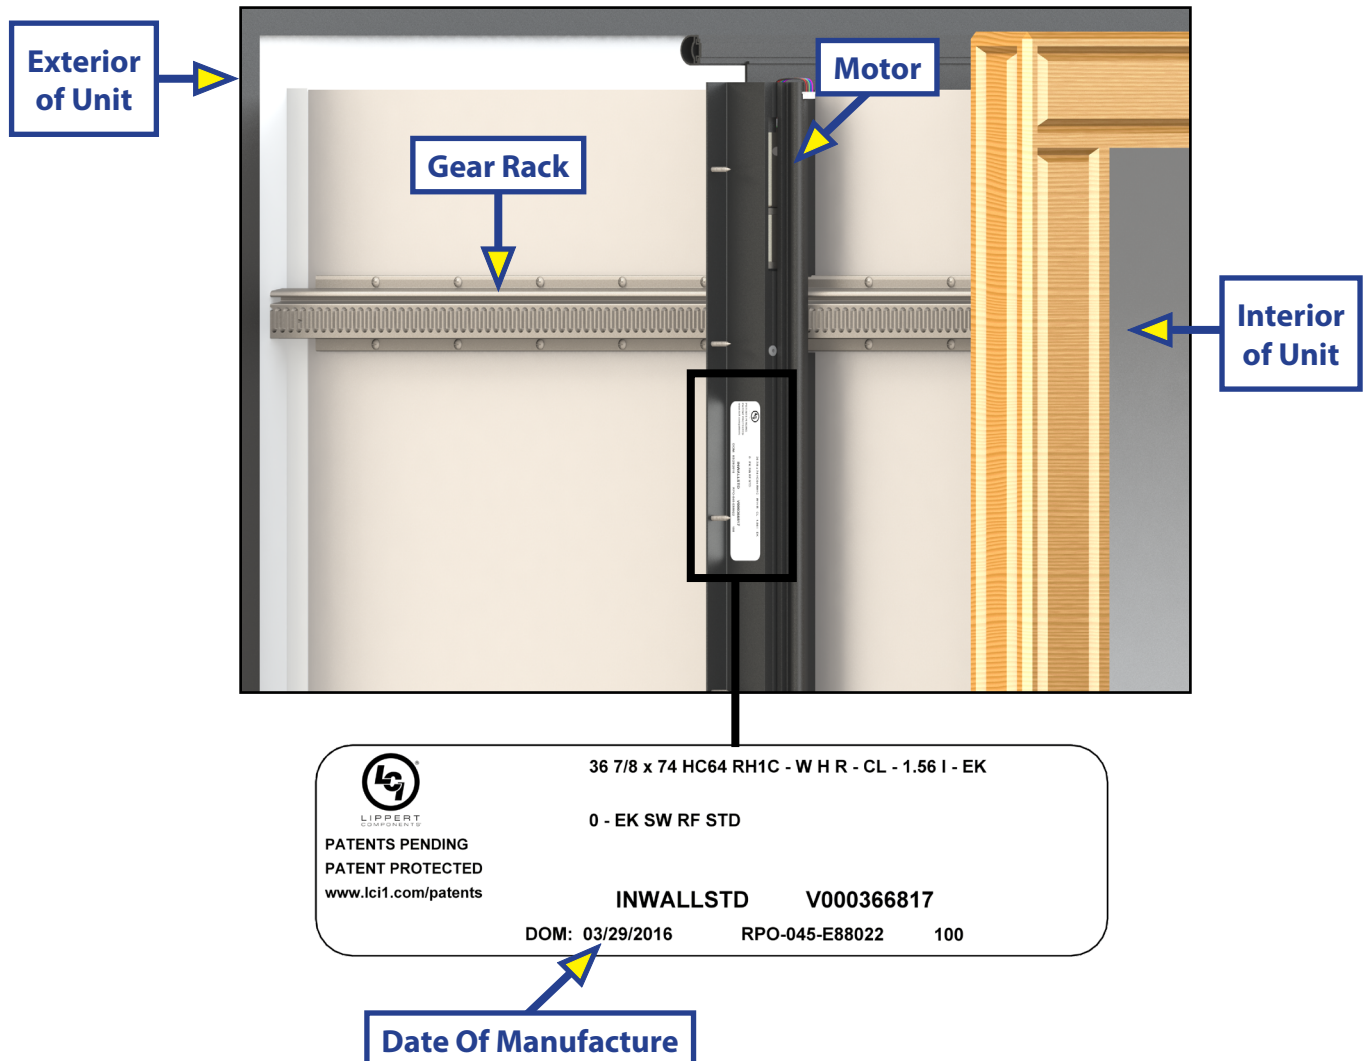
The specific inverted gear rack systems will have manufactured dates around Oct. 1, 2021, through Jan. 6, 2022. Dates are shown on the variant code tag located on the H-column. See location below.

**NOTE:** The tag featured is only a sample render and not the actual variant code tag for the inverted gear rack slide-out.

If the system has failed and has been verified as the Inverted Gear Rack In-Wall Slide-Out System, the replacement systems are available through Lippert Customer Care Center at (432) 547-7378. Have the Lippert In-Wall System tag handy as this will be needed to identify the correct replacement system.

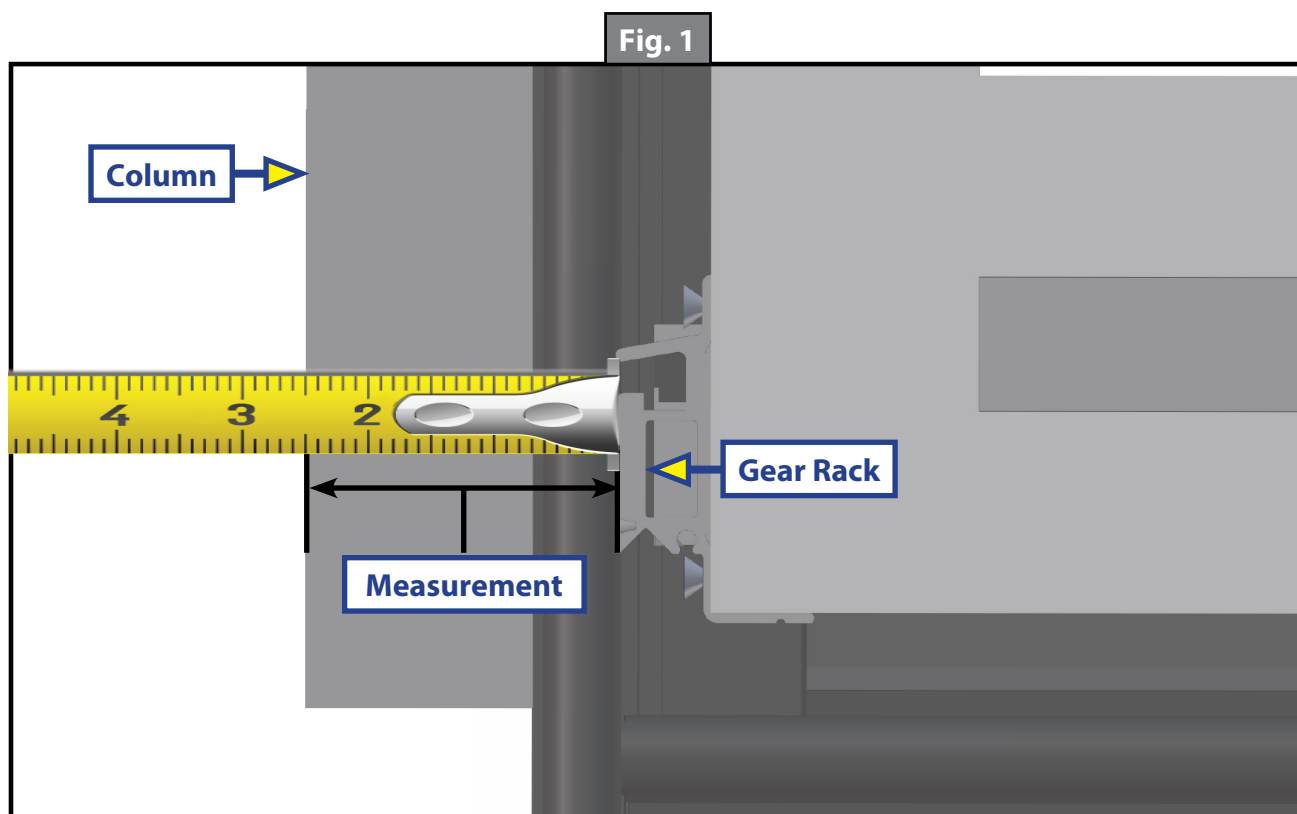
1. Measure from the outside edge of the column to the face of the gear rack at all four gear racks. The standard measurement should be  $2\frac{1}{2}"$  plus or minus  $\frac{1}{8}"$ . Take this measurement when the room is fully extended and again when the room is 3" from fully retracted.

2. Measure the gear racks for parallel. There should be less than  $\frac{1}{8}"$  difference between the parallel measurements.
3. Check for proper seal engagement (no binding).
4. Check for damage to gear rack.
