# TECHNICAL SERVICE BULLETIN

| <b>Subject</b> | 800vRR Vehicle Controller V4.10.2 and ESM V3.0.7 Update |
| <b>Service Bulletin Number</b> | SC-24-009 |
| <b>Description</b> | Software update for the 800vRRs Vehicle and Body Software to reduce the radiator fan current draw to 80%. Additionally fix a bug to properly route ESM faults away from the coolant light icon. |

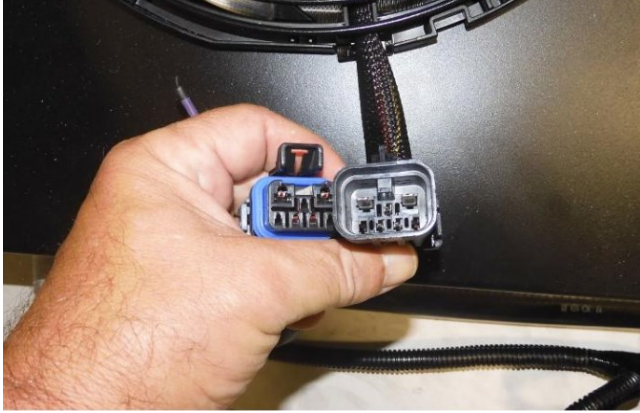
### Step 30 (Wiring Inspections):

Inspect each of the radiator fan terminals for any heat damage.

If any heat damage is found please take photos and escalate the findings to the back office support team.

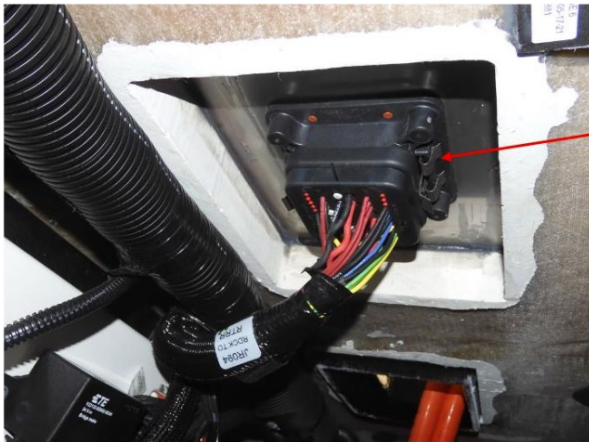
Metal Clip

Inspect the rear 48 way for heat damage in the connector body.

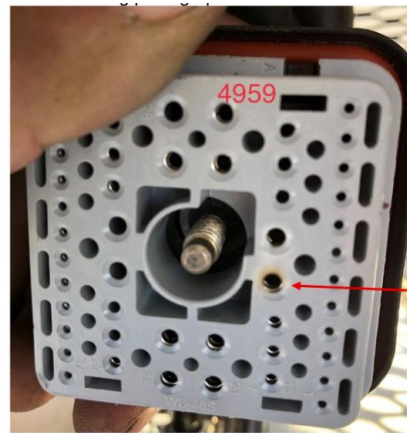
Heat Damage

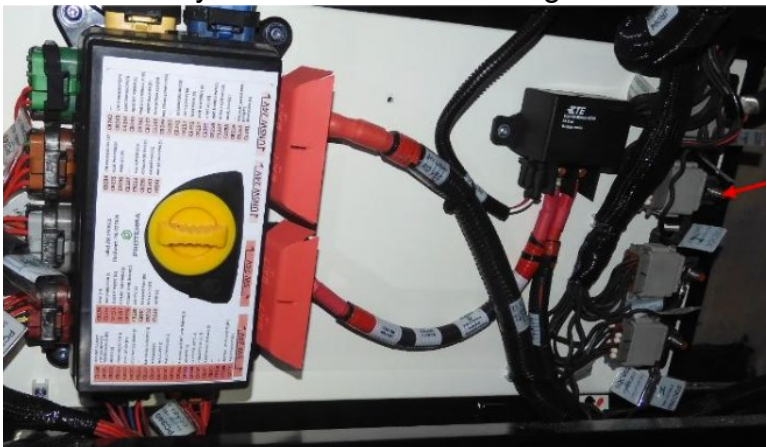
VEC Ground Bar

Finally the power and ground must be checked at the rear VEC. Please disconnect the corresponding plugs for the radiator fan circuitry and check the connector and pins for heat damage. The common plugs will be PC341, PC342, and PC337 the grounds 1QC001, 2QC001, and 3QC001. Check you schematics to verify due to model and configuration differences
