REFERENCE:	TSB: 07-008-24 GROUP: 07 - Cooling	Date:	August 20, 2024	REVISION:	-
VEHICLES AFFECTED:	2024 (VF) RAM Promaster This bulletin applies to the to vehicles built on or after January 05, 2024 (MDH 0105XX) and on or before July 18, 2024 (MDH 0718XX) equipped with a 3.6L V6 24V VVT Engine (Sales Code ERF).	MARKET APPLICABILITY:			
CUSTOMER SYMPTOM:	Customers may comment on the following: <ul style="list-style-type: none"> Coolant is leaking. 				
CAUSE:	Crack in the injection plastic due to manufacturing process

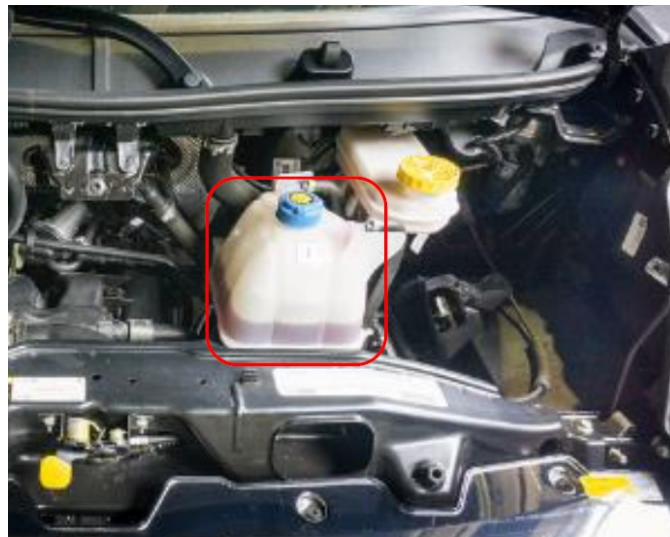
Fig. 1
Coolant Recovery Bottle Location

This bulletin involves inspecting the coolant recovery bottle and possibly replacing it [Fig. 1](#).

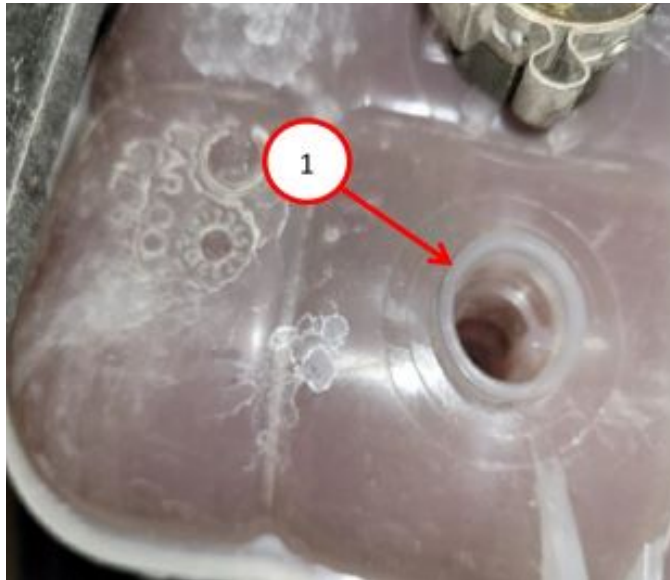
Fig. 2

- Is the vehicle on the RSU VIN list?
 - YES>>> Proceed to [Step 2](#).
 - NO>>> This bulletin does not apply.
- Using an inspection mirror, inspect the underside of the coolant recovery bottle for a coolant leak [Fig. 2](#). Refer to the detailed service procedures available in DealerCONNECT/Service Library under: Service Info > 09 - Engine, 3.6L / Engine Cooling / Diagnosis and Testing / Cooling System Leaks.

Coolant Recovery Bottle Underside Leak Location

3. Was a leak detected at the bottom side of the coolant recovery bottle?
 - YES>>> Proceed to [Step 4](#).
 - NO>>> This bulletin has been completed, use Inspect LOP (07-30-45-9E) to close this active RSU.
4. Replace the coolant recovery bottle. Refer to the detailed service procedures available in DealerCONNECT/Service Library under: Service Info > 09 - Engine, 3.6L / Engine Cooling / Bottle, Coolant / Removal and Installation.
