<b>REFERENCE:</b>	<b>TSB:</b> 23-048-24 <b>GROUP:</b> 23 - Body	<b>Date:</b>	August 20, 2024	<b>REVISION:</b>	—
<b>VEHICLES AFFECTED:</b>	<b>2024 (VF) RAM Pro Master</b> This bulletin applies to vehicles built on and after November 11, 2023 (MDH 1111XX).	<b>MARKET APPLICABILITY:</b>			
		<input checked="" type="checkbox"/> NA		<input type="checkbox"/> CH	
		<input type="checkbox"/> EE		<input type="checkbox"/> IAP	
		<input type="checkbox"/> SA		<input type="checkbox"/> MEA	
<b>CUSTOMER SYMPTOM:</b>	<b>Customer's vehicle may have been built with the following:</b>				
	<ul style="list-style-type: none"> <li>Visible gap in cargo floor <a href="#">Fig. 1</a>.</li> </ul>				
<b>CAUSE:</b>	Insufficient sealer applied between floor panels.

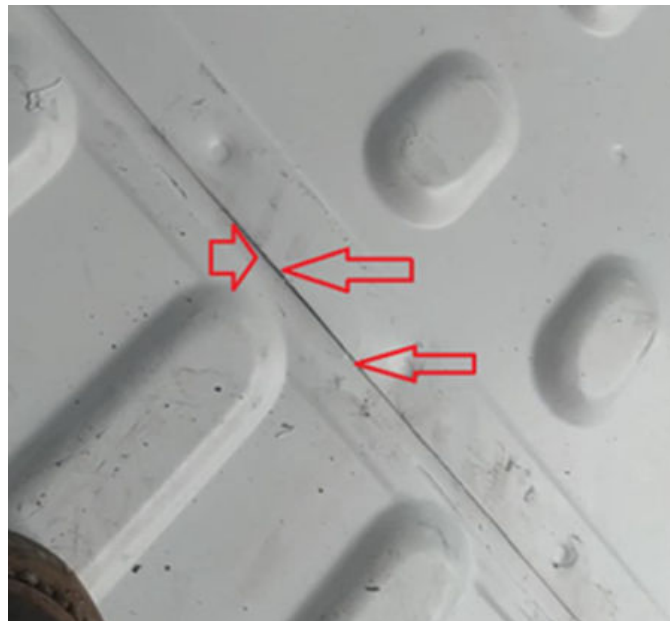
**Fig. 1**  
Cargo Floor Gap

This bulletin involves filling the gap in the cargo floor pan and painting the area to match.

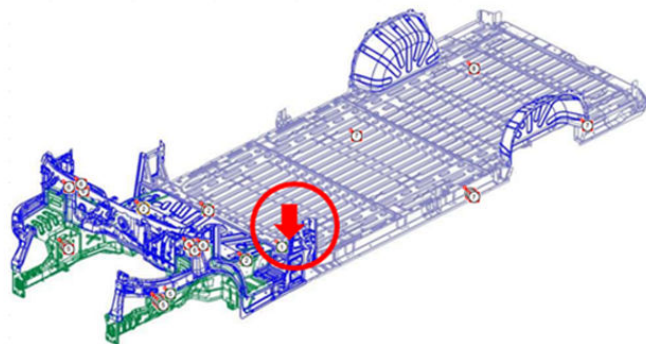
**Fig. 2**  
Area Of Gap Issue

- Clean the area [Fig. 2](#), [Fig. 3](#) with a rag. If there is dirt or other waterborne contaminants clean the area with soap and water. Wax and grease must be used to remove any solvent base contaminants.

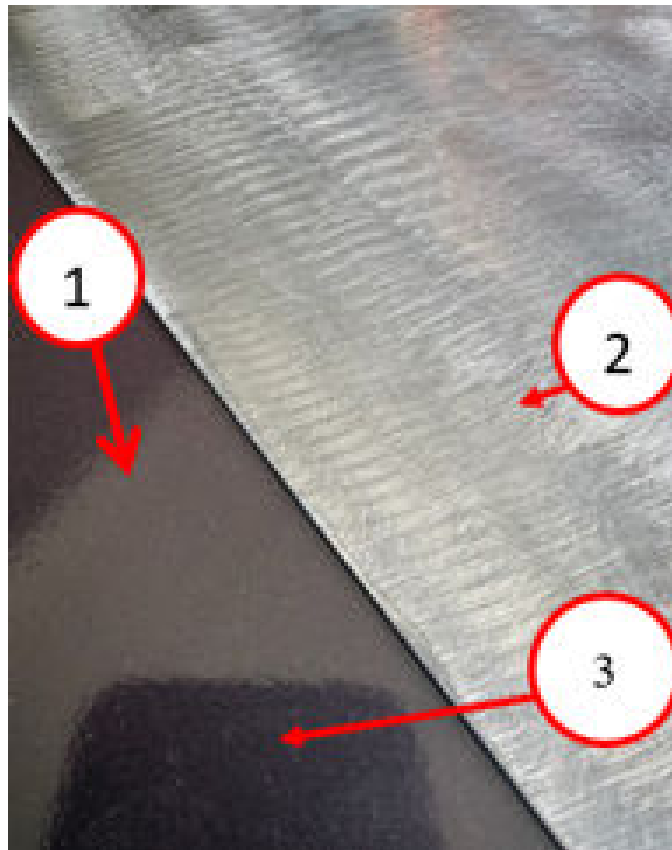
**Fig. 3**  
Floor Sheet Metal Lap Joint (Representation)

- 1 - Overlap Seam
  - 2 - Top Layer Of Sheet Metal
  - 3 - Bottom Layer Of Sheet Metal
-

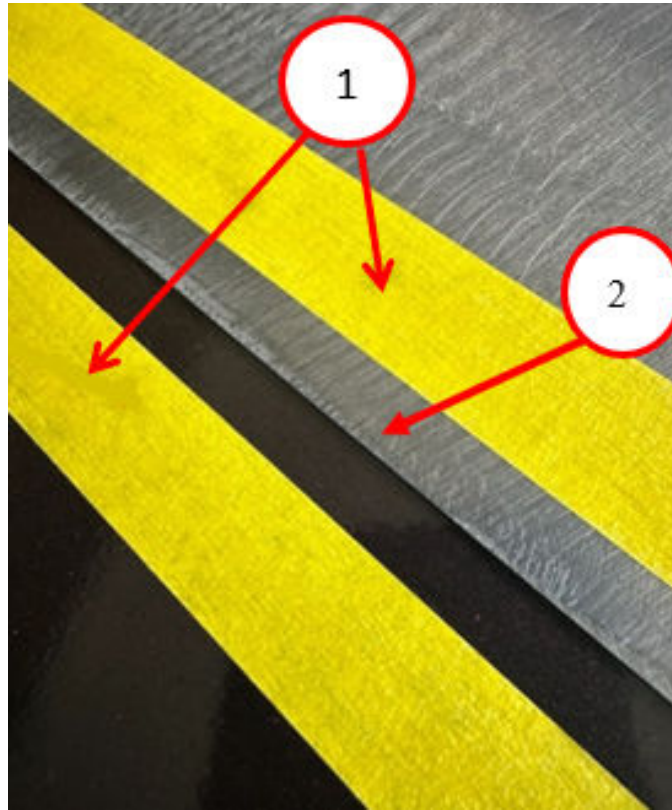
**Fig. 4**  
Tape Placement

1 - Masking Tape  
2 - Floor Seam

3. Apply 19.05 mm (¾ in.) masking tape approximately 13 mm (½ in.) on either side of the seam [Fig. 4](#).

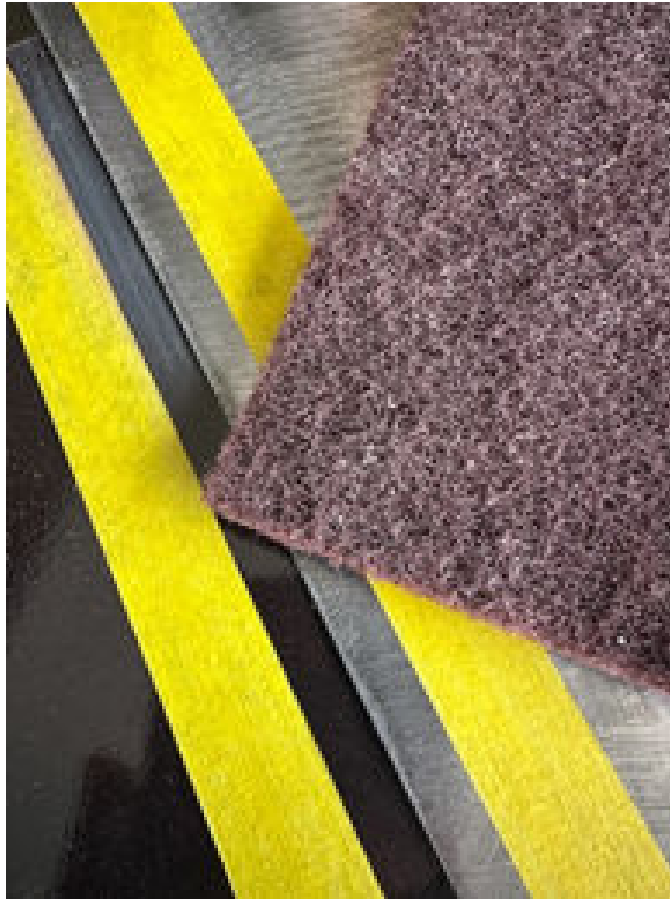
**Fig. 5**  
Scotch-Brite

4. After masking, scuff the area between the masking tape with a Red 3M Scotch-Brite to provide a rough surface for the sealer to adhere [Fig. 5](#).

**NOTE: Use Scotch-Brite on both sides of the seam for sealer adhesion.**

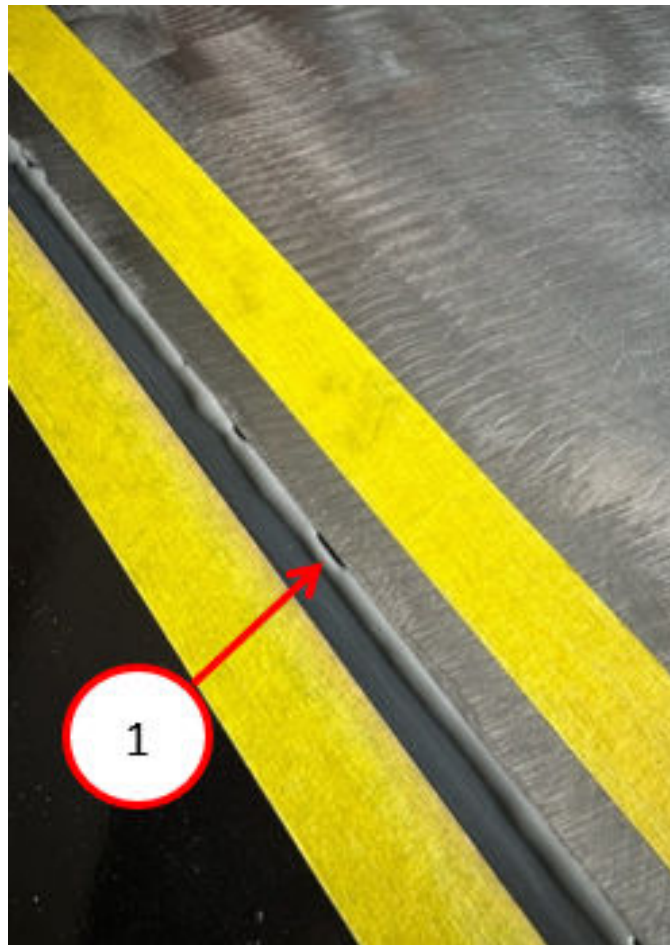
**Fig. 6**  
First Narrow Application Of Sealer

1 - Sealer

6. First application of sealer needs be narrow and pressed into any gap that may be present [Fig. 6](#).

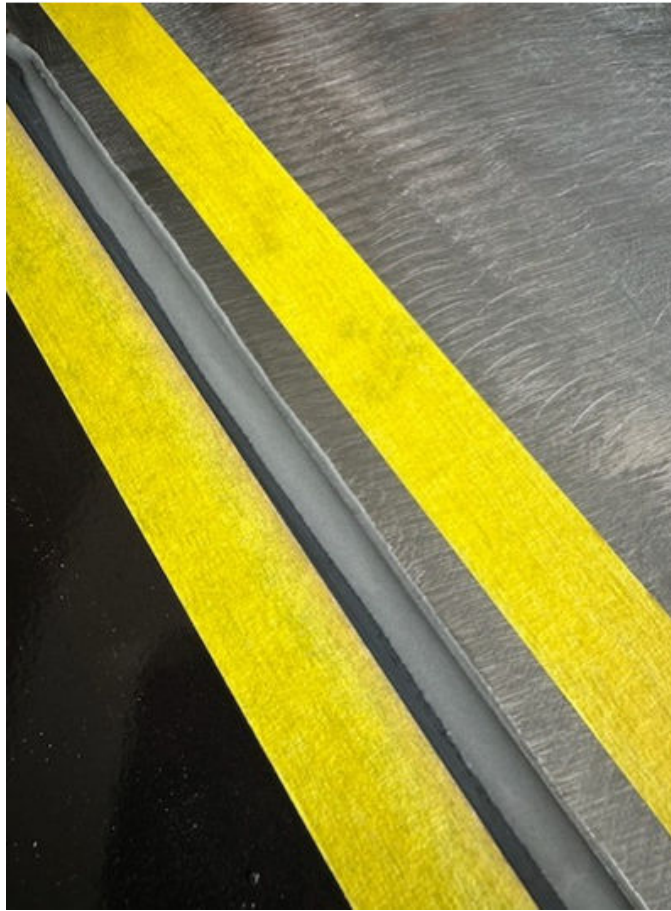
**Fig. 8**  
Pressed In Sealer

**NOTE:** Press first application of sealer into any gap that may be present [Fig. 7](#), [Fig. 8](#).

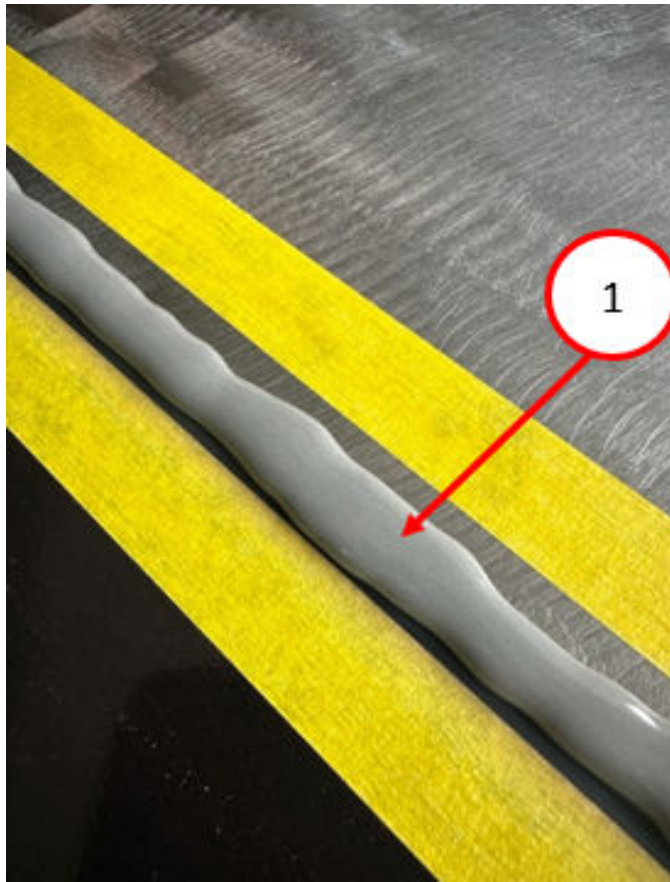
**Fig. 9**  
Second Seam

7. Apply a second seam sealer between the taped area that is slightly above the top layer of sheet metal to form a continuous seal across the seam. Follow the seam sealer's manufacturer's procedure for application and tooling process. Tool/Smooth sealer as required. [Fig. 9](#), [Fig. 10](#).

**NOTE:** The mixing tip on the sealer needs to be cut back to apply the heavier bead of sealer.

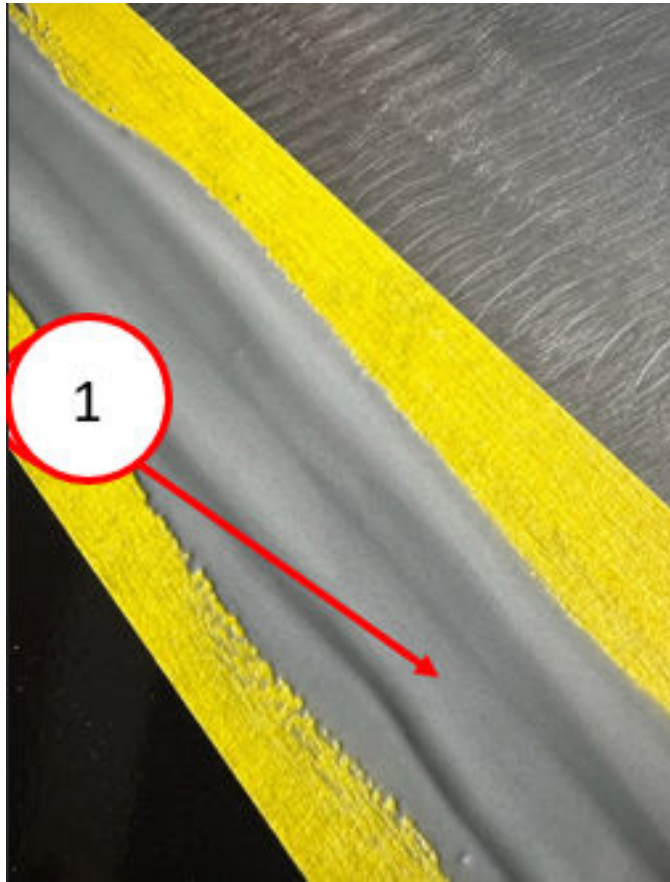
**Fig. 10**  
Tooled Seam

1 - Tooled Seam

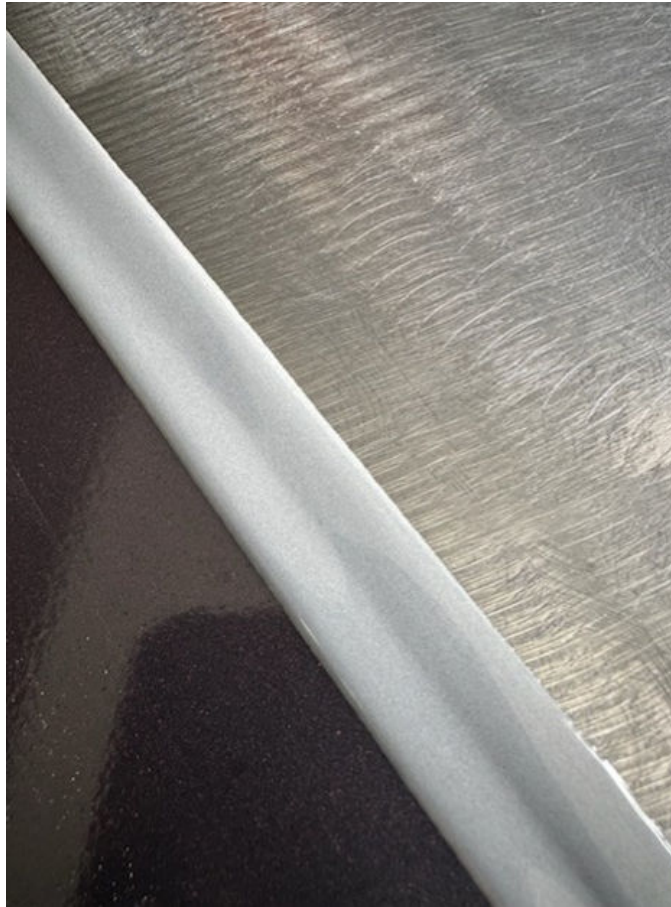
**Fig. 11**  
Finished Smooth Edge

8. Remove the masking tape as soon as the seam sealer has been applied and tooled to produce a smooth edge [Fig. 11](#).

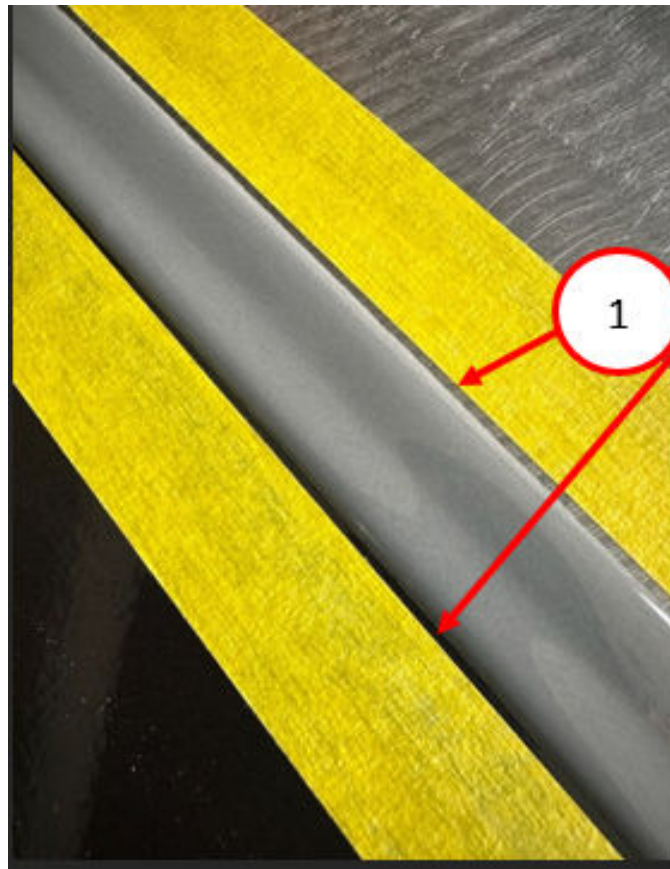
**Fig. 12**  
Reapplied Masking Tape

1 - Space between Sealer And Tape

10. Reapply masking tape. Leave 1.58 - 3.17 mm (1/16 in. – 1/8 in.) space between the sealer and tape so that when the base coat and clear coat are applied the sealer is completely covered and does not show Fig. 12.

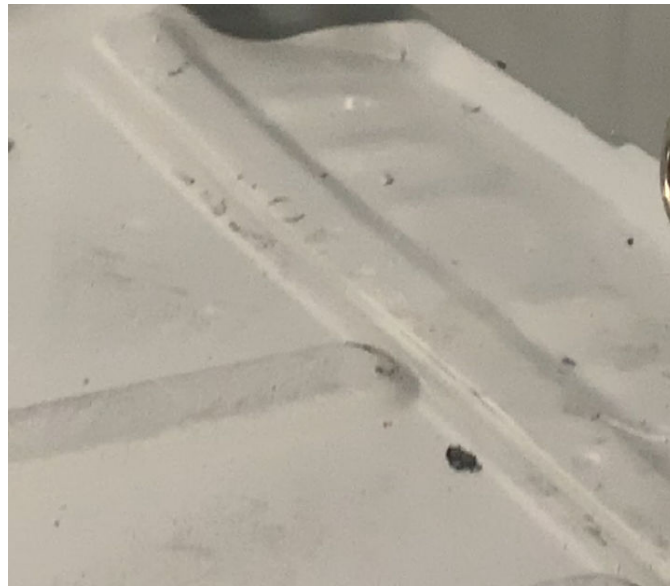
**Fig. 13**  
Finished Area

**NOTE: Remove the masking tape carefully. Keep in mind the repair is on the floor of the vehicle – do not step on the repaired area.**
