GROUP	MODEL
BOD	2023-2024MY K5 (DL3a)
NUMBER	DATE
322 (Rev 2, 8/26/2024)	November 2023

TECHNICAL SERVICE BULLETIN

SERVICE ACTION: TRUNK LID AND C-PILLAR GARNISH INSPECTION & REPLACEMENT (SA552)

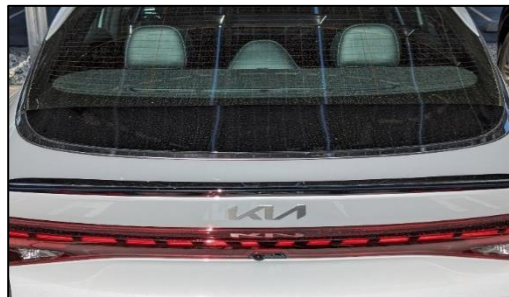
This bulletin provides information to inspect the rear trunk lid chrome garnish trim and the C-Pillar(s) chrome garnish trim on certain 2023-2024MY K5 (DL3a) vehicles produced from May 1, 2023 through September 29, 2023, which may be loose due to an insufficient lamination layer. Follow the procedure outlined in this publication to inspect the rear trunk lid chrome trim, and both left and right side C-pillar chrome trims, and replace the affected rear trunk lid chrome trim and/or the (left and/or right side) C-Pillar(s) chrome trim on the applicable vehicle. Before conducting the procedure, verify that the vehicle is included in the list of affected VINs.

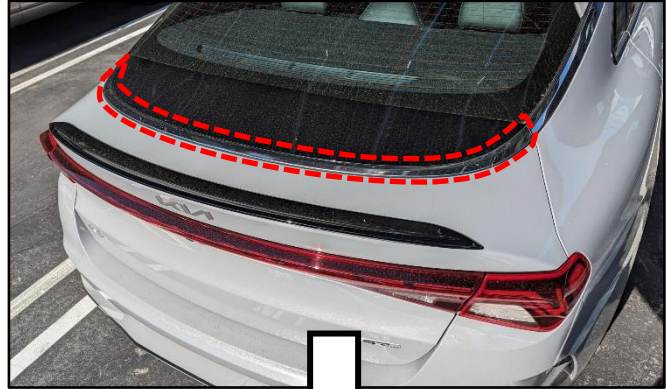
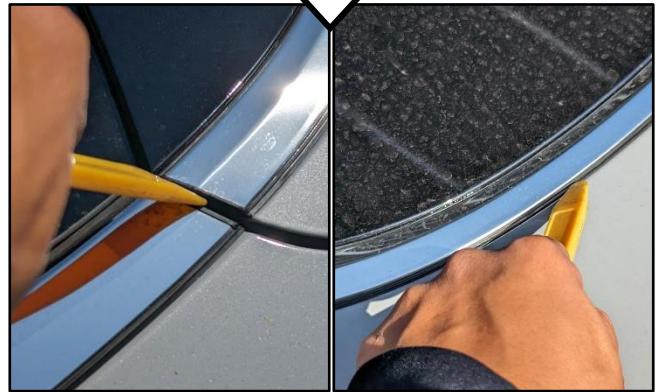
- Using a non-marring plastic trim tool, carefully pry with 'light' upward pressure in between the rear chrome trunk lid garnish rubber and the trunk lid.

- If the rear chrome trunk lid garnish is not separated (loose) when inspected **(OK)**, then proceed to step 2.
- If the rear chrome trunk lid garnish is separated (loose) when inspected **(NG)**, then refer to the rear trunk lid garnish by referring to the 'Replacement Procedure' on page 3 and proceed to step 2.

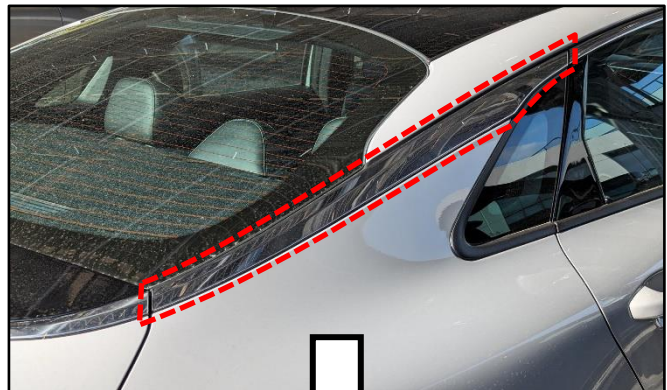
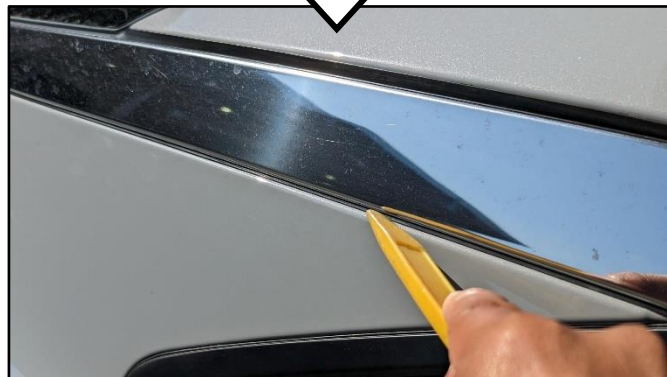
- Using a non-marring plastic trim tool, carefully pry with 'light' upward pressure in between the rear C-Pillar chrome garnish rubber and the body.

- If the rear chrome C-Pillar garnish is not separated (loose) when inspected **(OK)**, then no further action is required unless the rear trunk lid garnish requires replacement.
- If the rear chrome C-Pillar garnish is separated (loose) when inspected **(NG)**, then replace the rear trunk lid garnish by referring to the 'Replacement Procedure' on page 4.
