# Service Bulletin

Bulletin No.: 21-NA-271

**Subject:** Information on Malfunction Indicator Lamp (MIL) Illuminated - DTC P026A Set

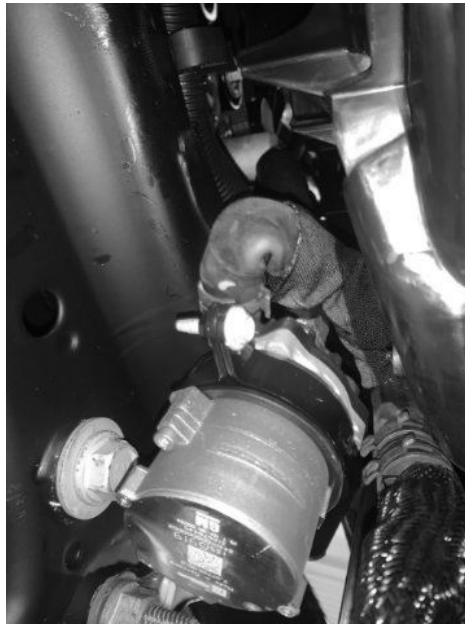
5635568

<b>Involved Region or Country</b>	North America, Uzbekistan, Russia, Middle East, Chile, Columbia, Ecuador, Paraguay, Peru, Uruguay, Japan, S. Korea, Thailand, Australia, New Zealand, Europe.
<b>Condition</b>	Some customers may comment that the MIL is illuminated. Some technicians may find DTC P026A set in the Engine Control Module (ECM).
<b>Cause</b>	This may be due to a kinked hose at or near the low temperature auxiliary coolant pump.

If this condition is encountered, loosen the hose clamp and rotate the hose to allow for proper coolant flow.
