GROUP	MODEL
BOD	2024MY Sorento (MQ4a PE)
NUMBER	DATE
330	August 2024

TECHNICAL SERVICE BULLETIN

SERVICE ACTION: REAR SPOILER LOWER TRIM INSPECTION/REPLACEMENT (SA584)

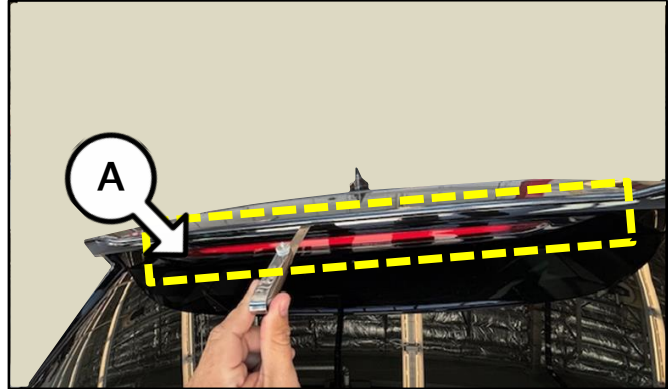
1. Using a feeler gauge, set a thickness of 1mm.
2. Inspect for a gap between the upper and lower rear spoiler (A) panels along the outlined area shown.

Note: The feeler gauge should NOT be able to be inserted between the 2 panels.

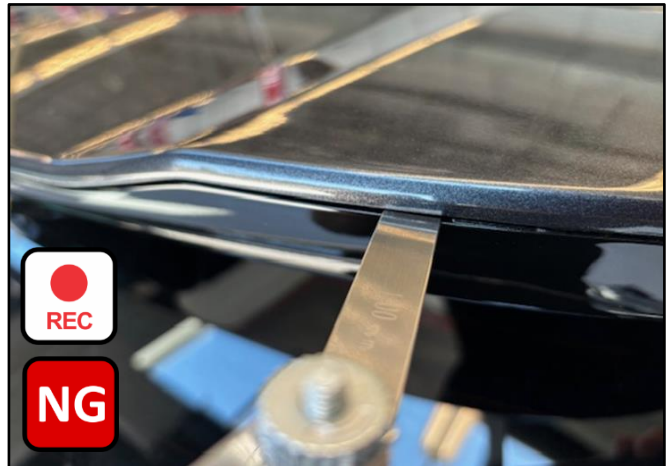
- If the feeler gauge is able to be inserted between both of the spoiler panels exceeding more than 1mm (NG), attach a KVID video showing the VIN label and the NG condition before proceeding to the 'Replacement Procedure' on page 3.

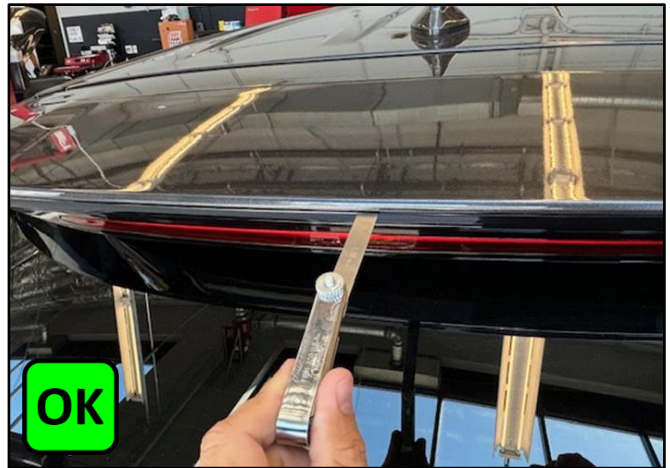
- If the feeler gauge is NOT able to be inserted between both of the rear spoiler panels using the 1mm setting (OK), no further action is required. Claim the inspection Op Code 240A2510.
