Service Bulletin

Bulletin No.: 24-NA-099

Subject: Clunking Noise from Front of Vehicle

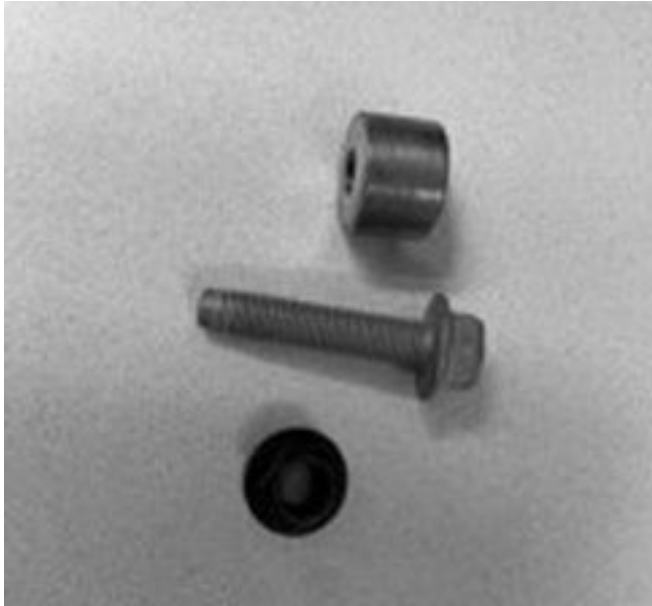
Involved Region or Country	North America, Europe, Kazakhstan, Uzbekistan, Russia, Middle East, Iraq, Israel, Palestine, Argentina (Mercosur), Brazil (Mercosur), Bolivia (West), Chile (West), Colombia (West), Ecuador (West), Paraguay (West), Peru (West), Uruguay (West), Venezuela (West), Other Central America, Japan, Cadillac Korea (South Korea), GM Korea Company, China - SGM, Taiwan, Thailand (ASEAN), Singapore, Philippines, Australia/New Zealand, Caribbean
Condition	Some customers may comment of a clunk noise coming from the front end of the vehicle.
Cause	This condition may be caused by the stabilizer bar retaining nut has come loose from weld internally in the frame.
Correction

<p>Replace only the affected bolt with a retaining bolt, spacer, and nut assembly. Refer to the Service Procedure. 6664288</p>
