Service Bulletin

Bulletin No.: 23-NA-176

Subject: Dead Battery, No Start, and/or Vehicle Will Not Shut Down

Brand:	Model:	Model Year:		Breakpoint Date:		Engine:	Transmission : (Automatic)
		from	to	from	to		
Chevrolet	Corvette	2020	2023	SOP	February 23, 2023 (Wixom)	—	M1L, M1M
				SOP	May 15, 2023 (St. Catharines)

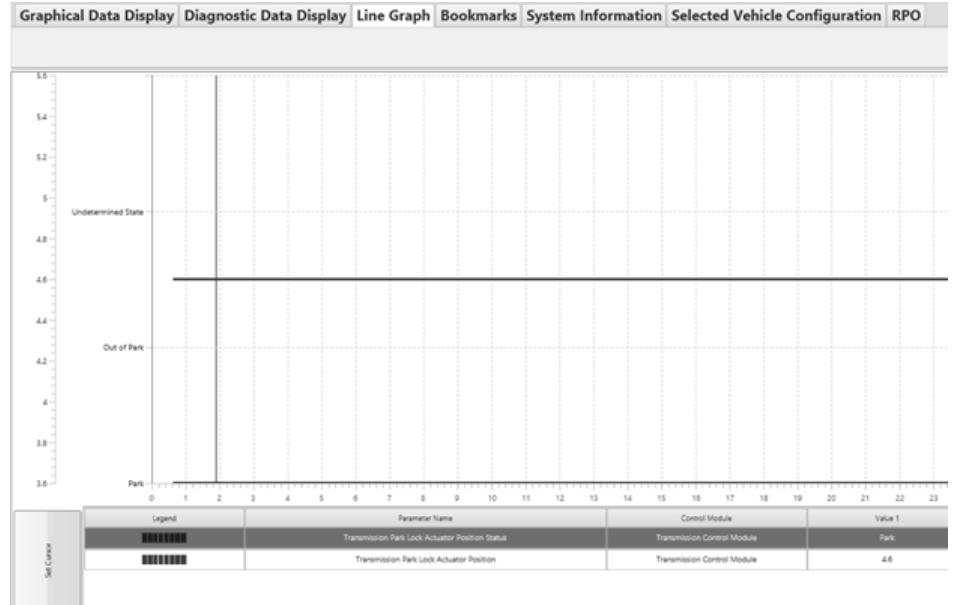
6444770

The technician is advised to start a TAC case immediately, prompt into the transmission group, and forward the park sensor measurement found in GDS transmission data if the transmission is built prior to these dates. Screenshots below define the information TAC is requesting.

The TAC agent will use this data to request that engineering verify the park position at birth. Comparison of this data will confirm whether the transmission has park sensor drift that will require transmission replacement, or the correct direction of vehicle repair.
