Service Campaign Bulletin

Campaign No. 2024020009, August 2024

SUBJECT: **Model EQE, EQS (295, 296 & 297 platform)**
Model Year 2023 – 2024

Update Battery Management System (BMS) Control Unit Software

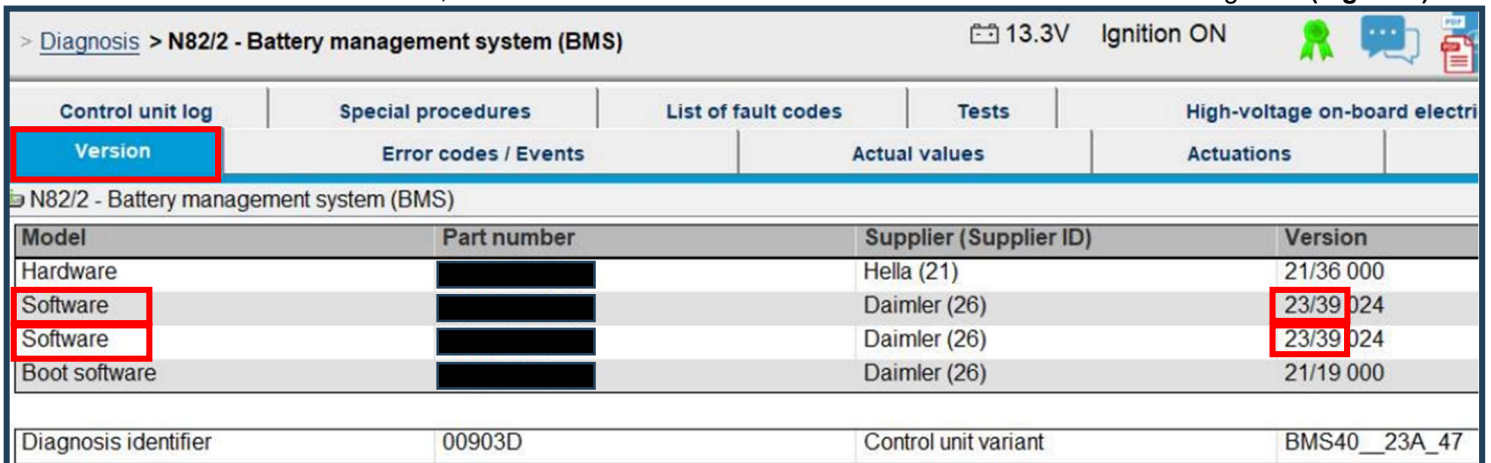
Figure 1

NOTE: To confirm the BMS software, the Software **Version** will read "**23/XX**" or newer in XENTRY Diagnosis (**Figure 1**).
