"Coolant level too low" warning message is shown in the instrument cluster

Topic number	LI20.30-P-078333
Version	1
Function group	20.30 - Coolant expansion/overflow tank
Date	8/29/24
Validity	MODEL 243
Reason for change

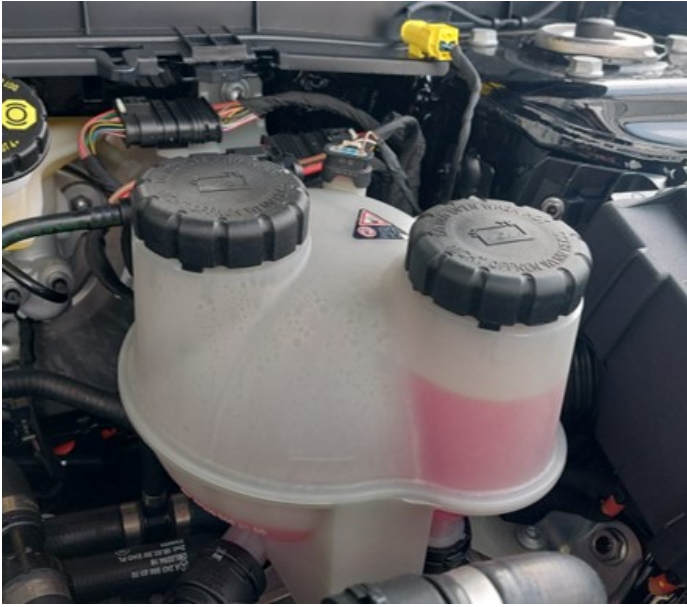
"Coolant level too low" warning message is shown in the instrument cluster.

Fault code P25567B (The 'Coolant level' sensor has a malfunction. The fluid level is too low) is stored in the signal acquisition and actuation module (SAM) control unit N10.

Attachments	
File	Description
Beanstandung Kühlmittelstand zu gering.jpg	Problem after driving and before opening the cap

The electric drive motor of the vehicle conveys air into the cooling system.

The air conveyed into the cooling system leads to an air cushion forming in the expansion reservoir, which in turn causes the coolant level to fall below the warning threshold of the coolant level sensor during travel.

Replace the black cap A210 501 06 15 of the large working chamber of the expansion reservoir with a red cap A297 500 51 00

and increase the coolant level by 20 mm over the max. marking.

On vehicles where this process does not remedy the issue, the expansion reservoir A 243 500 41 00 is replaced by the modified container A243 500 41 00 28.

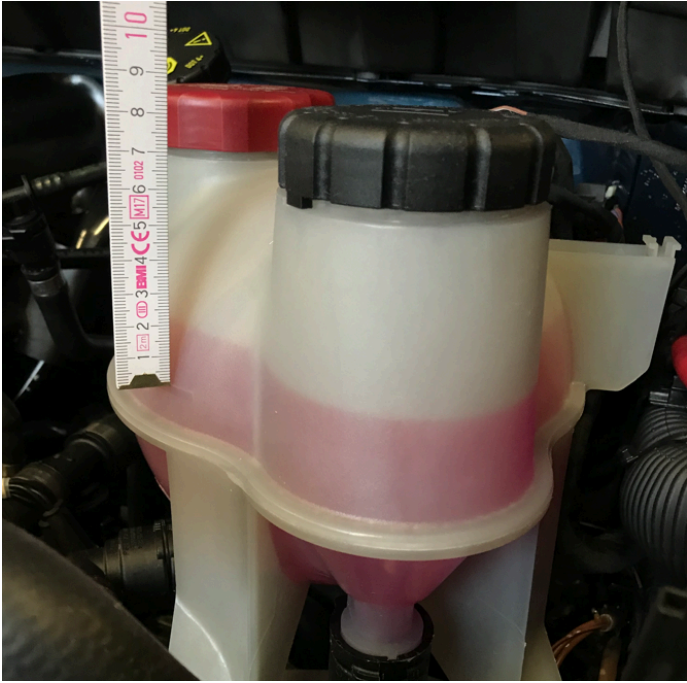
Attachments	
File	Description
Ausgleichsbehälter BR243 Kühlmittel 20mm über Max.PNG	Expansion reservoir with red cap on large chamber, fill level 20 mm over max.
