STAR ONLINE PUBLICATION

Case Number: S2424000007

Symptom/Vehicle Issue: Driver Side Air Vent No Air Flow

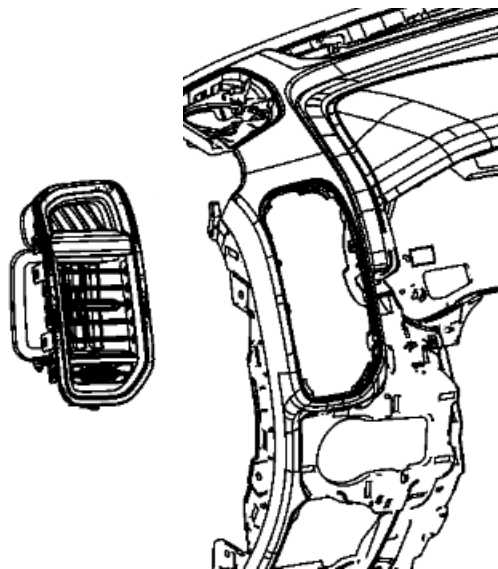
Discussion: Upon further inspection it was found that the dash harness is out of position behind the dash, the harness is routed between the duct and the driver side vent blocking air flow. Remove the vent from the dash, reroute the harness back into proper positioning and reinstall the vent.
