## STAR ONLINE PUBLICATION

**Case Number:** S2424000006

**Symptom/Vehicle Issue:** Drivers Side Left Rear Floor Ducts No Air Flow

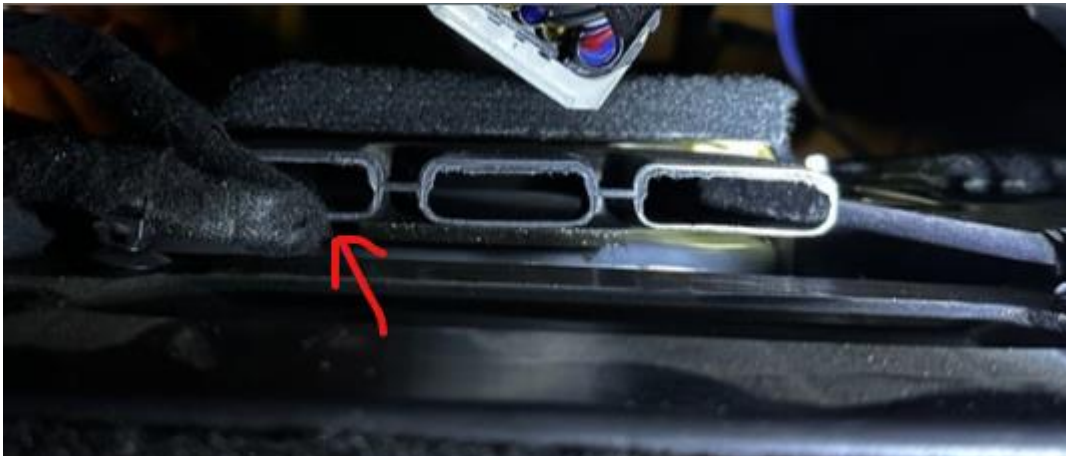
**Customer Complaint/Technician Observation:** Customer indicates that the driver side rear floor ducts have low or no air flow.

**Discussion:** Upon further inspection determine if the body harness is out of position and routed in front of the rear duct blocking air flow. Locate the body harness and reposition the harness away from the front of the duct outlet to allow for proper air flow.
