STAR ONLINE PUBLICATION

Case Number: S2408000095

Symptom/Vehicle Issue: Check Engine Lamp (CEL) On

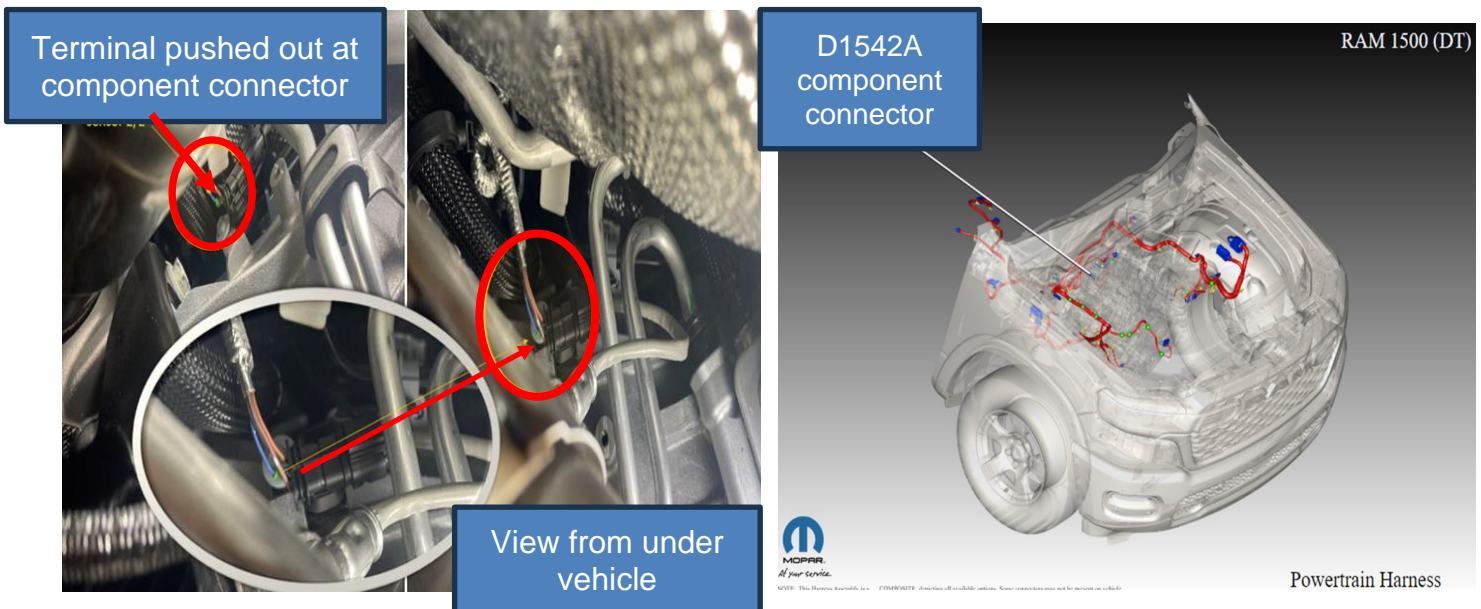
Pg 1

Customer Complaint /Technician Observation: The owner complains the CEL is on and the engine is running rough. The technician observed the Powertrain Control Module (PCM) has set P0158-02 O2 Sensor 2/2 Circuit High.

Repair Procedure: Inspect the black 4-way O2 Sensor component connector for any signs of a Terminal Pushed Out (TPO) and/ or a connector not latched. Insert any loose or pushed out circuits, use the push, pull, push to latch, and secure the connector. Test the operation to complete pg 1 and 2.
