Service Bulletin

Bulletin No.: 20-NA-104

Subject: Malfunction Indicator Lamp (MIL) Illuminated - 5V Reference, Reduced Power, Extended Crank, StabiliTrak Message on, Body Harness to Fuel Tank Damage

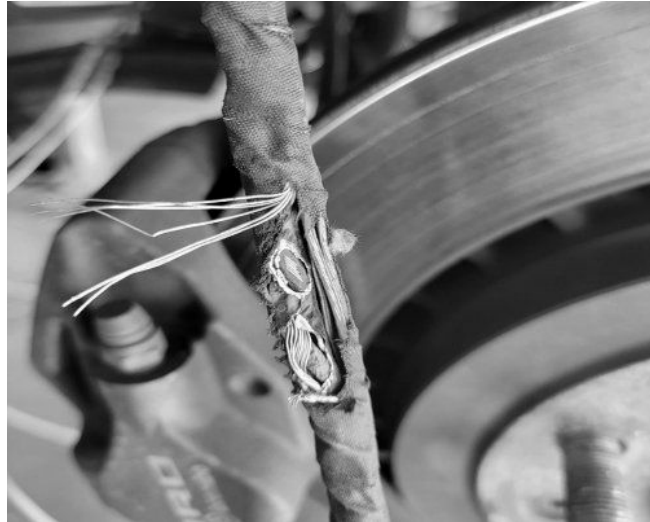
5599085

This concern may be caused by a damaged body to fuel pump harness and/or the use of oversized tires that may damage the Chassis module to fuel pump connector X350. ⁶¹⁶⁴⁹²⁰

The harness damage may also cause an intermittent short during heavy acceleration if vehicle is not exhibiting the other concerns. Upon inspection, the F35RA fuse in the rear fuse block may also be blown.

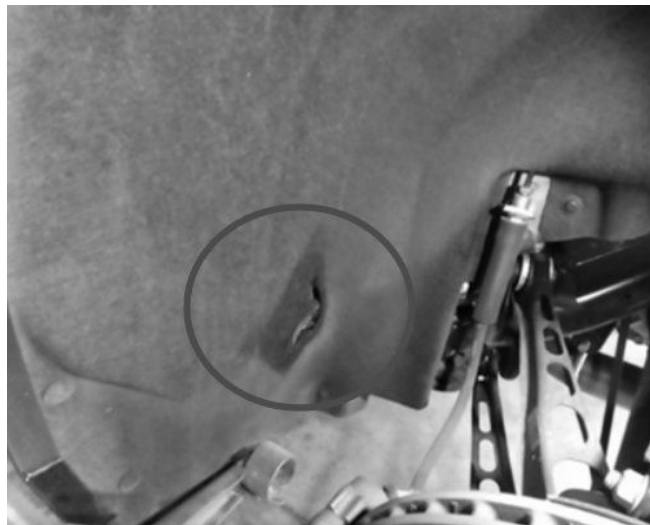
Inspect the left rear wheelhouse liner for a rub through condition due to incorrect tire size. ⁵⁵⁹⁹⁰⁸⁸

If you encounter a vehicle with the above concern, inspect the left rear wheelhouse liner for a rub through condition.

- If the concern is caused by a rub through condition and the vehicle is not equipped with original equipment (OE) tires, then advise the customer of the importance to use the same tire size and manufacturer as the vehicle was originally equipped with. The repair is not covered as a warranty claim.

- If the concern is caused by a rub through condition and the vehicle is equipped with the OE tires, please submit a field product report, and include pictures and tire information.
