Service Bulletin

Bulletin No.: 22-NA-173

Subject: Information on Transmission Fluid Leak

Brand:	Model:	Model Year:		VIN:		Engine:	Transmission:
		from	to	from	to		
Chevrolet	Corvette	2020	2025	—	—	All	All

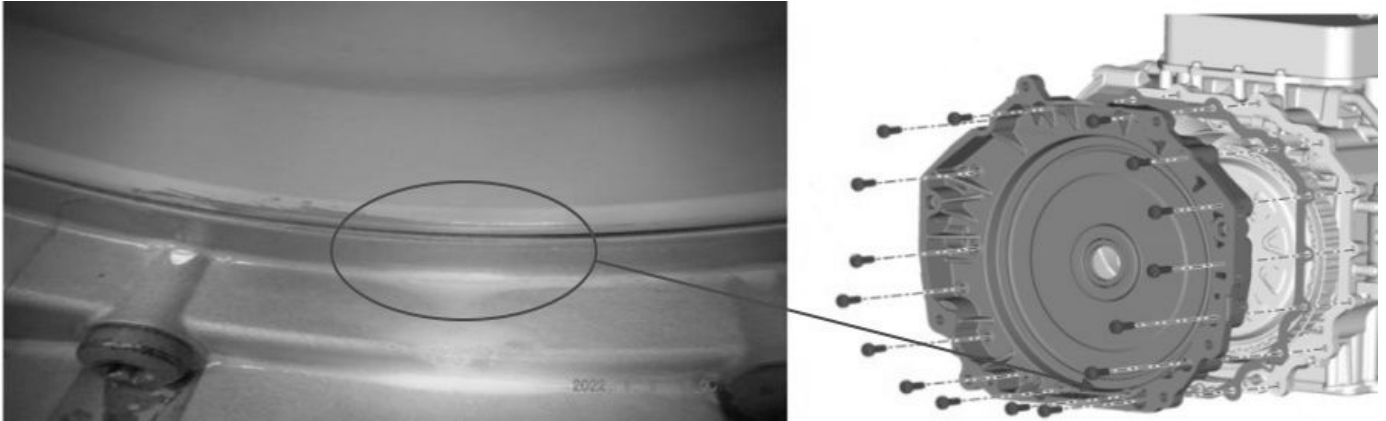
6142752

A leak between sealing plate and Bell Housing.

- If this leak is found, it will be necessary to replace the clutch differential housing assembly. Be sure to also order all the one-time use parts in the service information repair instructions.

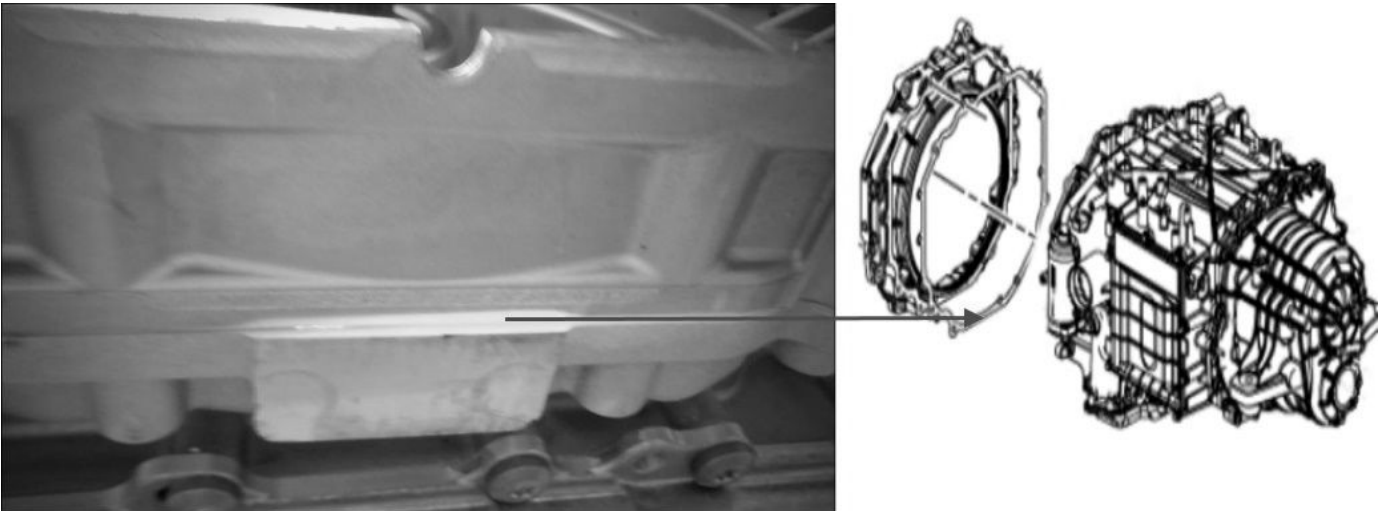
6142966

Leaks at the gasket area between the clutch and differential cover and the main case. There is a gasket in this area.

- The gasket in this area is serviceable. Be sure to follow service information for which parts are one-time use and order these components. Also be sure to inspect the machined surfaces and attempt to verify that the leak is actually caused by the gasket rather than a bolt torque or surface finish issue that may cause a duplicate repair.

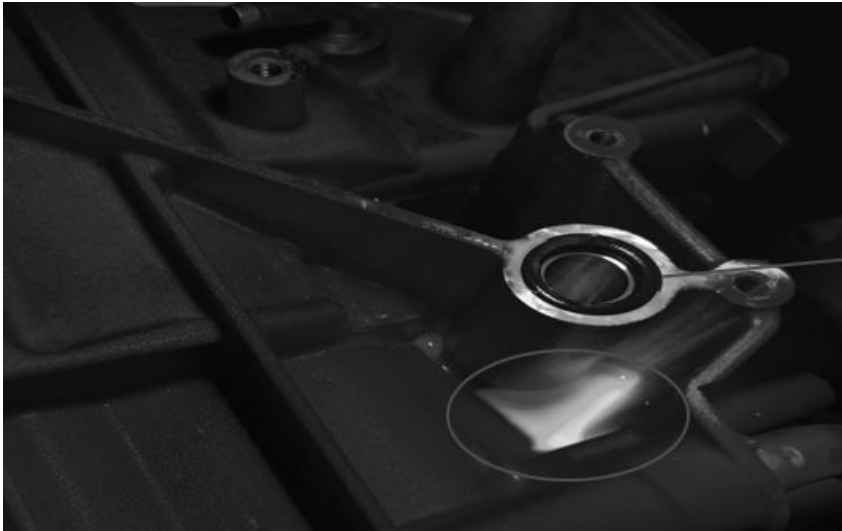
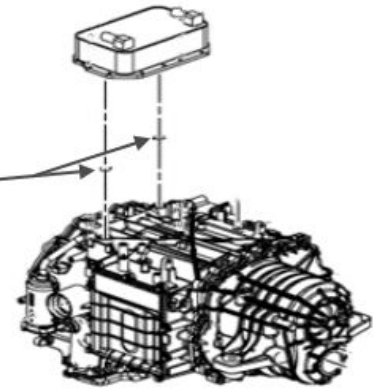
6142841

This is an area that is often mis-diagnosed as a transmission cooler issue. It was found that in most cases, leaks in this area are caused by transmission case porosity under the transmission cooler. Proper diagnosis in this area would be to inspect the cooler for any signs of physical damage. If no damage is found, carefully remove the cooler, and inspect the two (14) O-rings for damage and proper sealing. The dye photo shows a puddle of oil just under the cooler sealing area in the pocket, the fluid is being pushed through the case due to material porosity. This concern will require transmission assembly replacement. This leak can often be confused with transmission SAV cover and MCV cover leaks because the leaking fluid from above tends to get captured by the rails and follow that path. Be sure to powder test these areas well and with the understanding that fluid tends to flow down across the transmission.

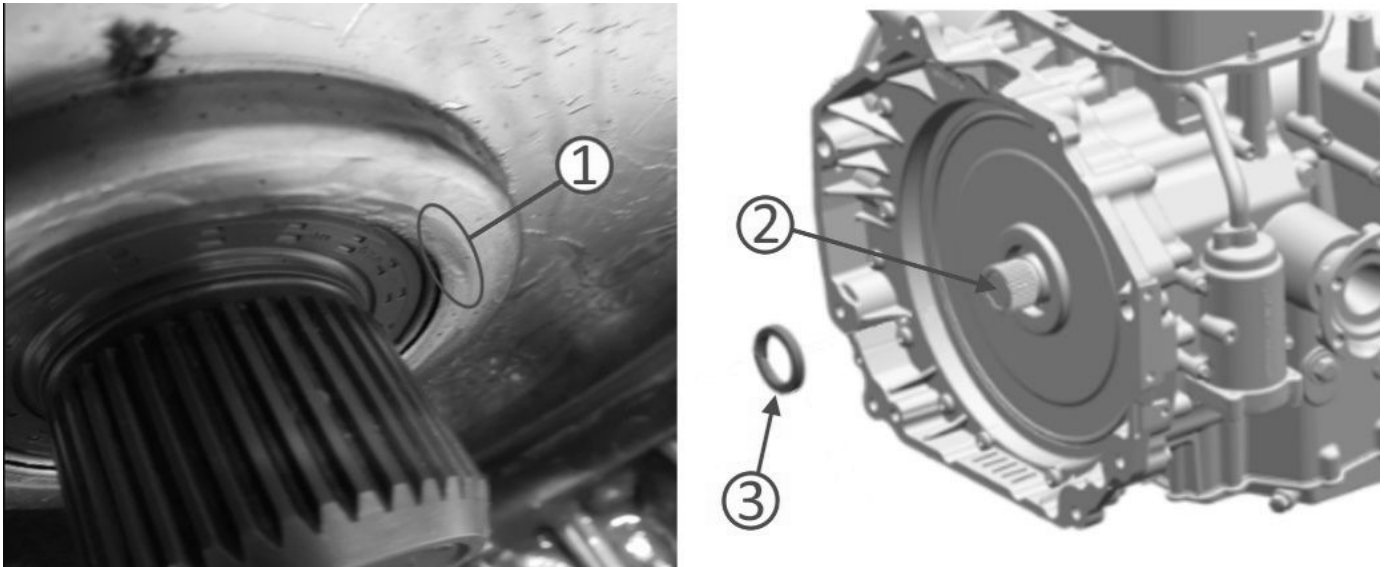
6142814

A small crack in the clutch cover area (1) of the input shaft seal can be mis-diagnosed as an input shaft seal leak (3). Additional cases have been verified at the input shaft end plug/seal (2), was damaged during transmission to engine mating. The input shaft end plug and the input shaft seal can be serviced separately if a crack is not witnessed in the clutch cover. If the area is cracked the clutch differential housing assembly will need replacement as an assembly. The input shaft end plug does not come with the clutch differential cover assembly.

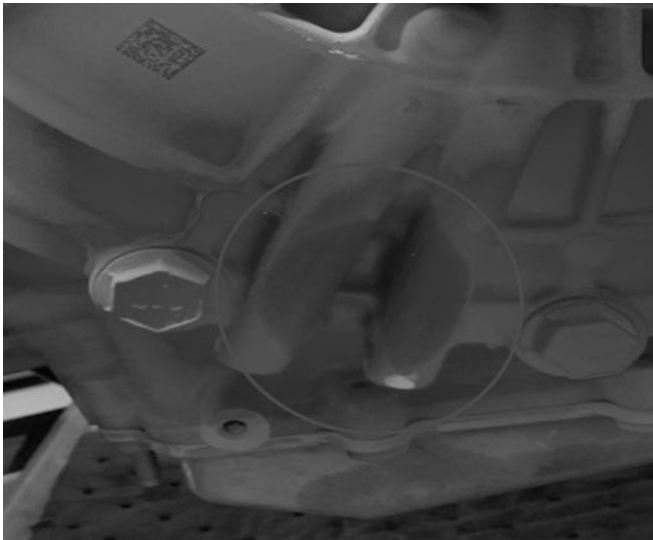
6142818

Porosity concerns with the differential cover. This area needs to be carefully powder tested to verify the leak is not associated with the cover seal (16) or the dog-bones and seals. Technicians have stated that they have found the cover double-gasketed when they confused the metal differential shims with what they thought were gaskets. All shims need to be re-installed to retain proper bearing load on differential. If porosity is found in the cover, the transmission will require replacement.

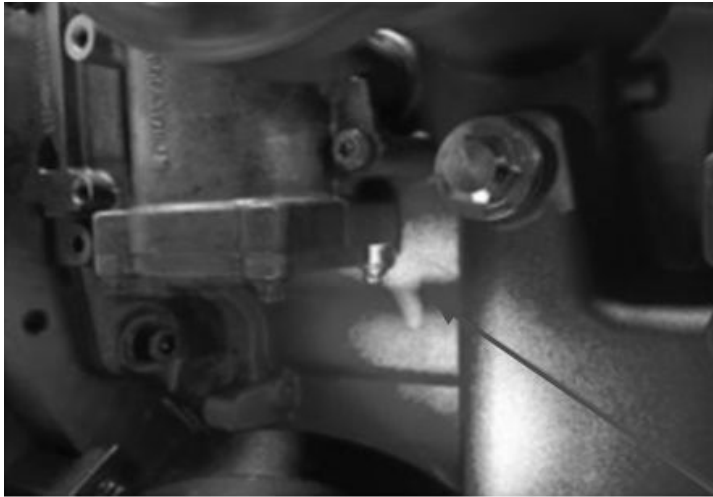
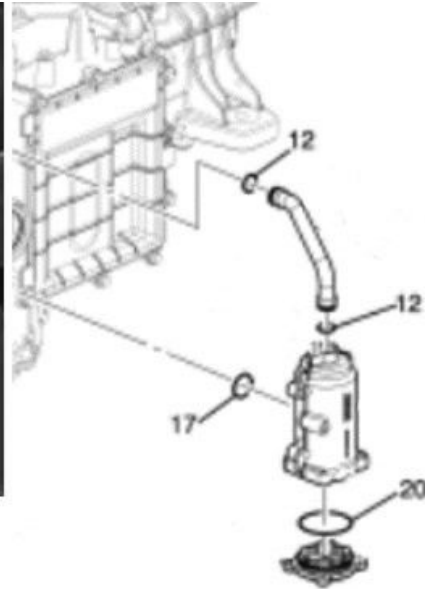
6142744

The auxiliary canister filter can create leaks in several areas. The most common area is cover seal (20), O-ring installation issues after filter replacement. Other areas of concern can be found at the are O-rings (12) and (17).

The photo above shows the red arrow pointing to a case porosity issue that was found lying behind the auxiliary canister housing. With any case porosity issue, the transmission will require replacement. The photo below shows the red arrow pointing to the auxiliary canister filter cover O-ring groove. There have been known cases with porosity found in the O-ring groove causing leaks in this area.

Note: Inspect the cover prior to replacement of the seal for porosity issues in the O-ring groove area.

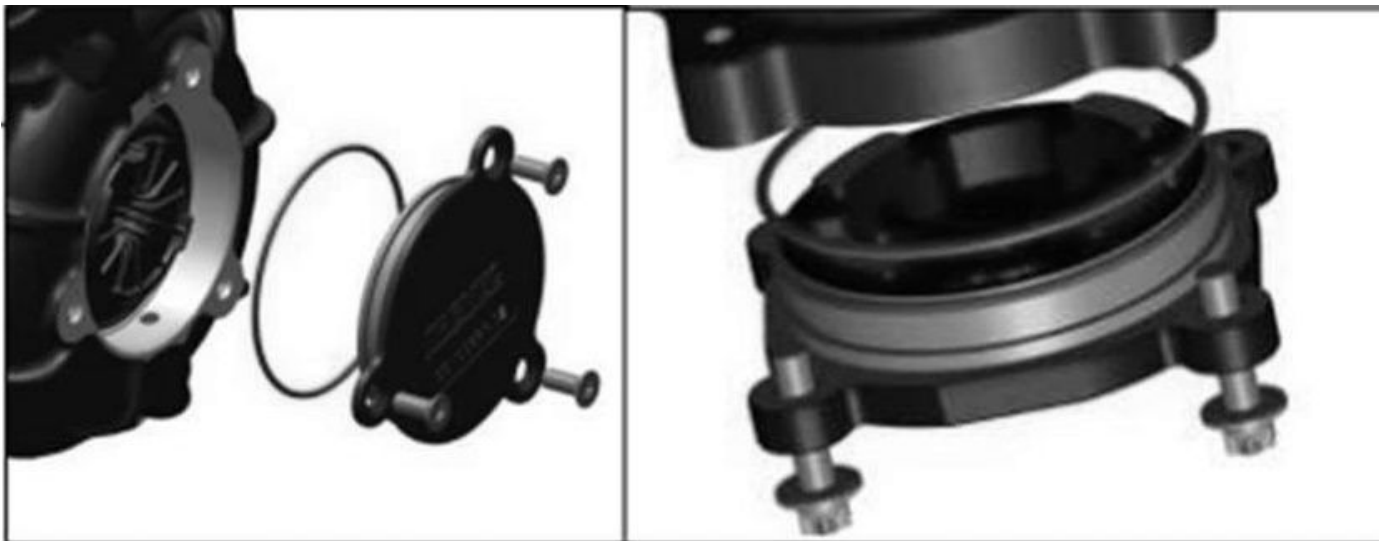
6456550

Transmission rear cover area leak. (Tremec name plate):

- If there seems to be a leak in this area, be sure to clean the area thoroughly. Residual oil can get trapped between the outer surface and the O-ring.
- After powder testing, if a leak re-occurs, remove the cover, and inspect the O-ring for damage.
- If no obvious damage is found with the O-ring, be sure to inspect the cover itself for porosity issues in the O-ring groove. It is critical to identify the difference between a leak and dampness.

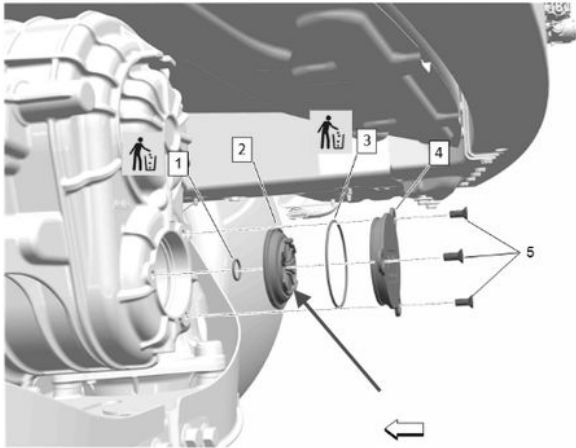
6637446

- The red arrow in the graphic above, points to the oil dam that may come off when the cover (Tremec name plate) is removed. If it is removed, it is necessary to replace the associated O-ring and align properly with cover prior to re-assembly. Damage will occur if the oil dam is not aligned to match the cover.

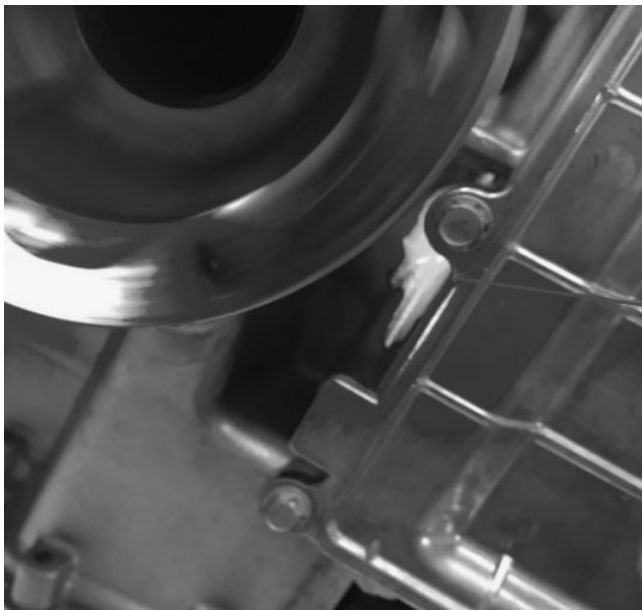
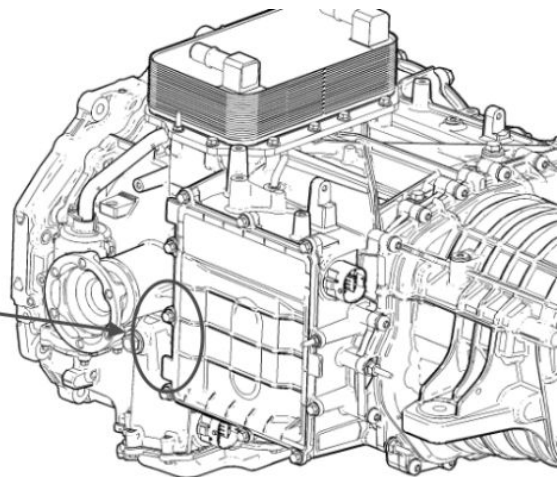
6142979

Transmission case porosity concerns have been found in the SAV cover area of the transmission. This is often the most misdiagnosed leak on this transmission. The fluid seeps through the case and runs down between the SAV cover and case to the pan rail, and often the transmission pan, and gasket get replaced, then the SAV cover, and finally the transmission. Often these leaks will not develop by just allowing the engine to run. Usually, the vehicle will need to be lifted safely on a hoist with the wheels raised to allow the vehicle to run in gear. This action applies to most porosity leaks.

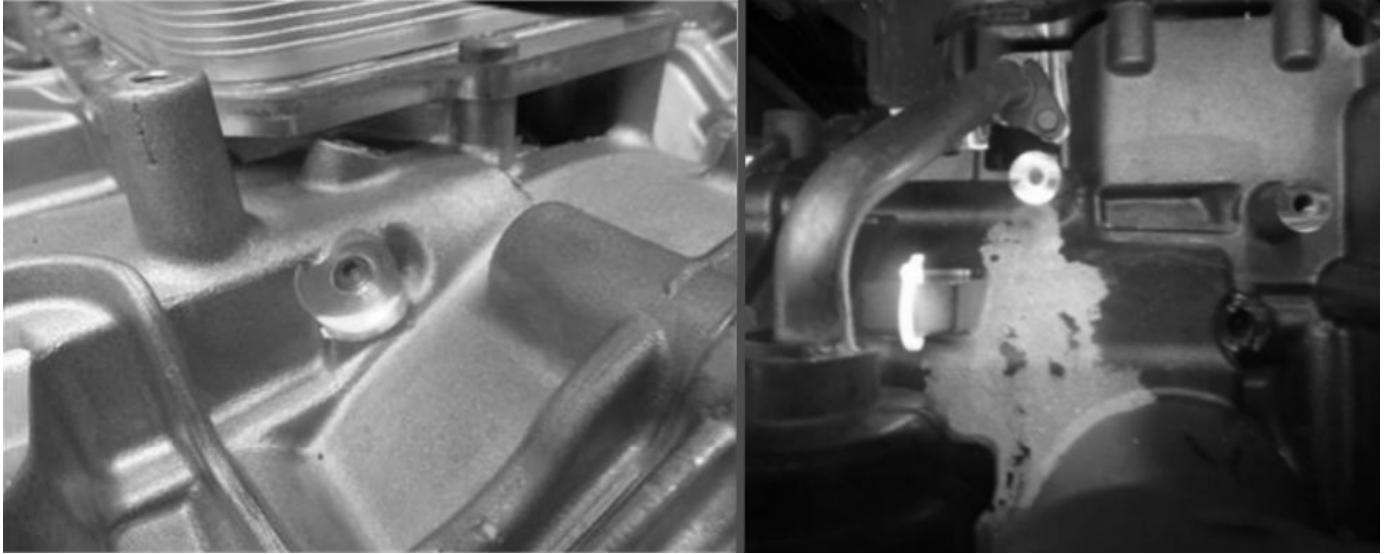
6636539

Plug leakage and fluid leaking from blind holes will require transmission replacement.

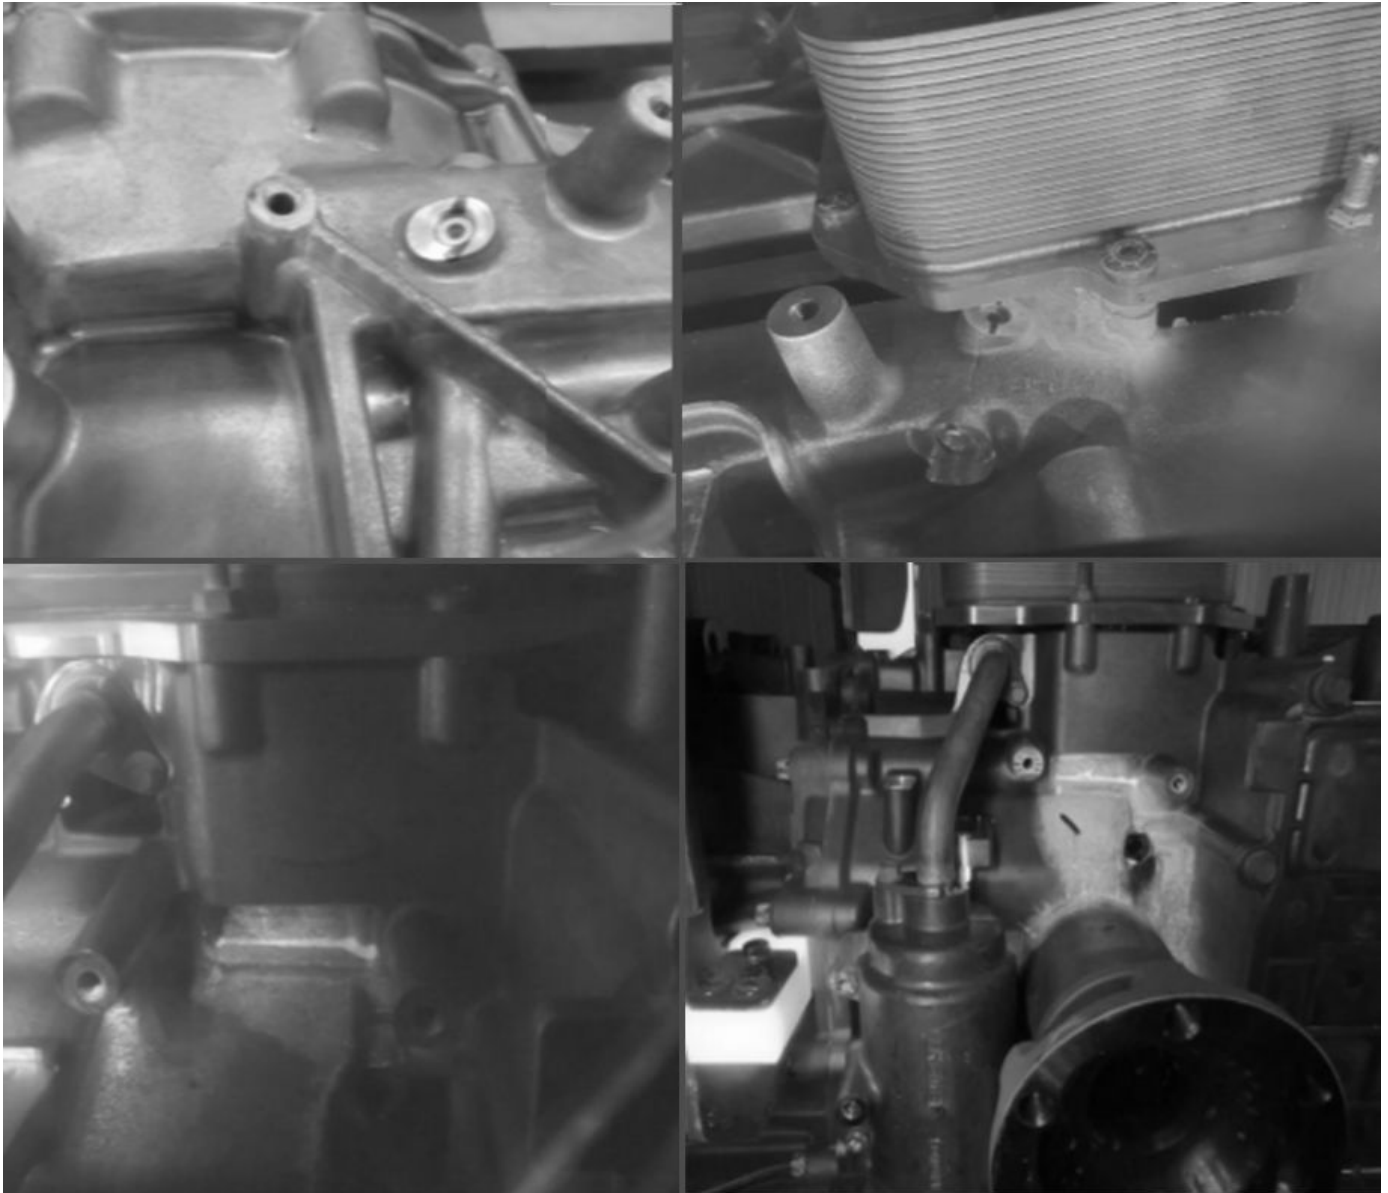
6636536

Examples of case porosity in front of the SAV cover and above that left axle stub that may present as an axle seal leak or SAV cover leak. Powder testing should allow identification by the technician. If leak is porosity in these areas the transmission assembly will need replacement.

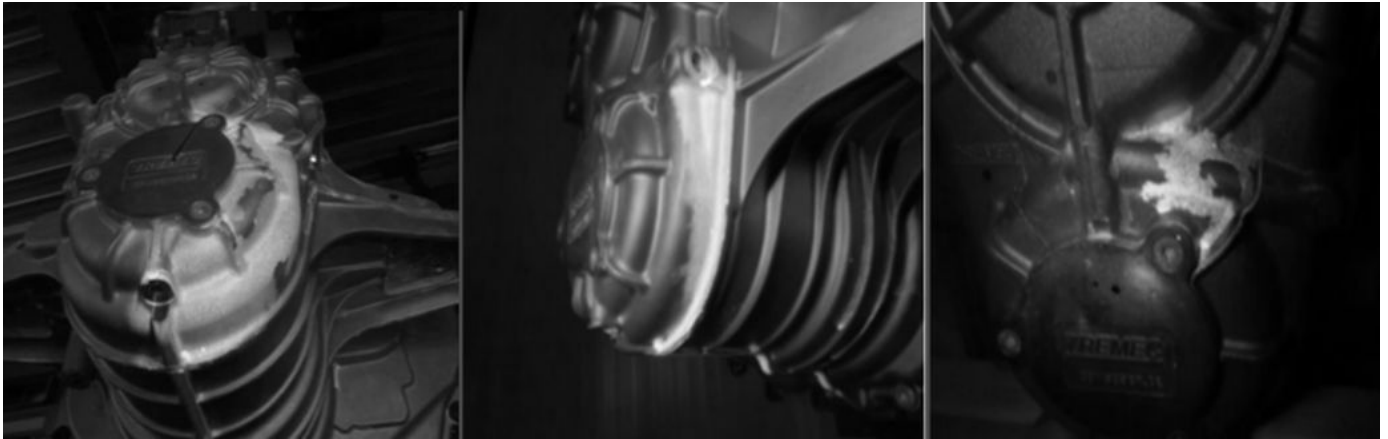
6636545

The graphics represent new areas that may exhibit porosity. The last photos show the difference between rear case porosity and rear cover (Tremec nameplate) leaks.
