**SIB 28 02 24**

**SERVICE ACTION: DOUBLE CLUTCH TRANSMISSION REWORK AT TRANSFER CASE**

U11 (X1 Sports Activity Vehicle)	U10 (X2 Sports Activity Coupe)
----------------------------------	--------------------------------

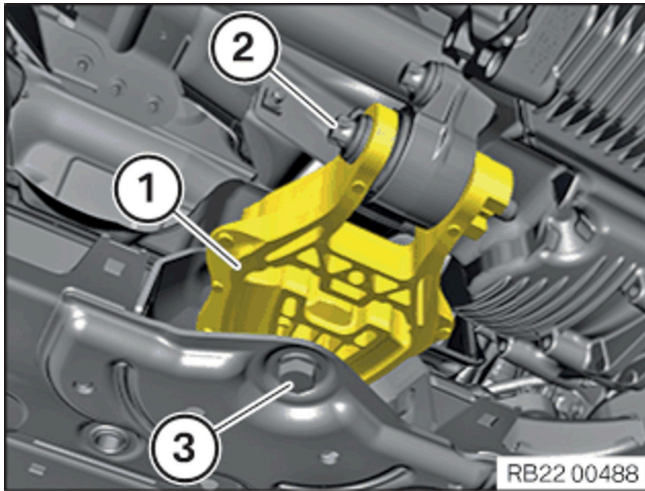
Remove the stabilizer link (1).

**Reinstallation:** Replace bolts 2 and 3

Tighten to 100 Nm and torque angle 90°

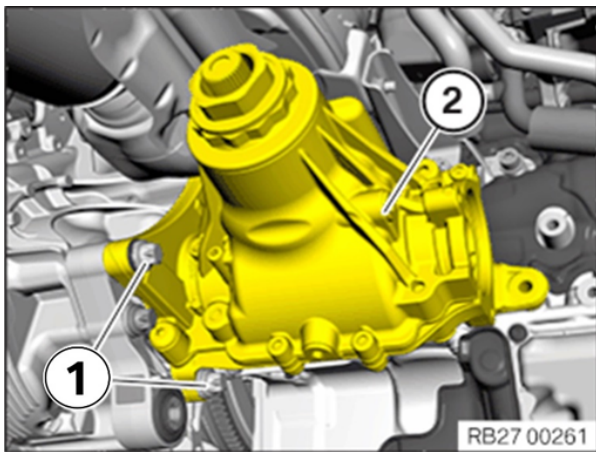
Remove the two bolts (1) on the transfer case.

**Reinstallation:** Replace both bolts

Tighten to 100 Nm and torque angle 90°

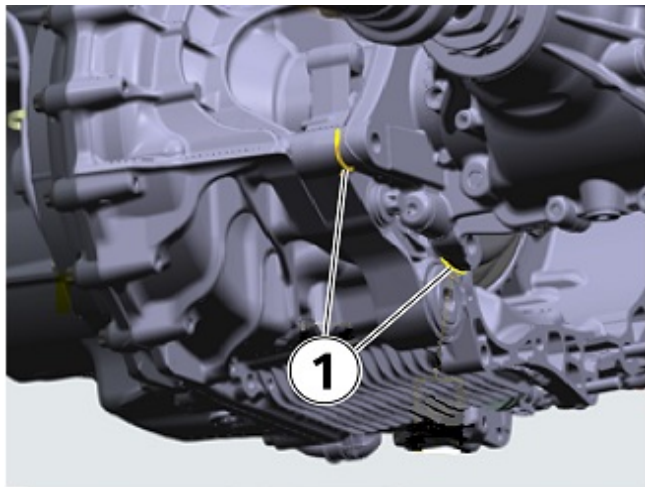
Install washers between the link and transfer case. It may be necessary to slightly push the transfer case to the side to install the washers.
