SIB 61 15 24  
RATTLING NOISE ORIGINATING FROM THE TAILGATE

2024-08-05

E-Series	Model Description
i20	iX Sports Activity Vehicle

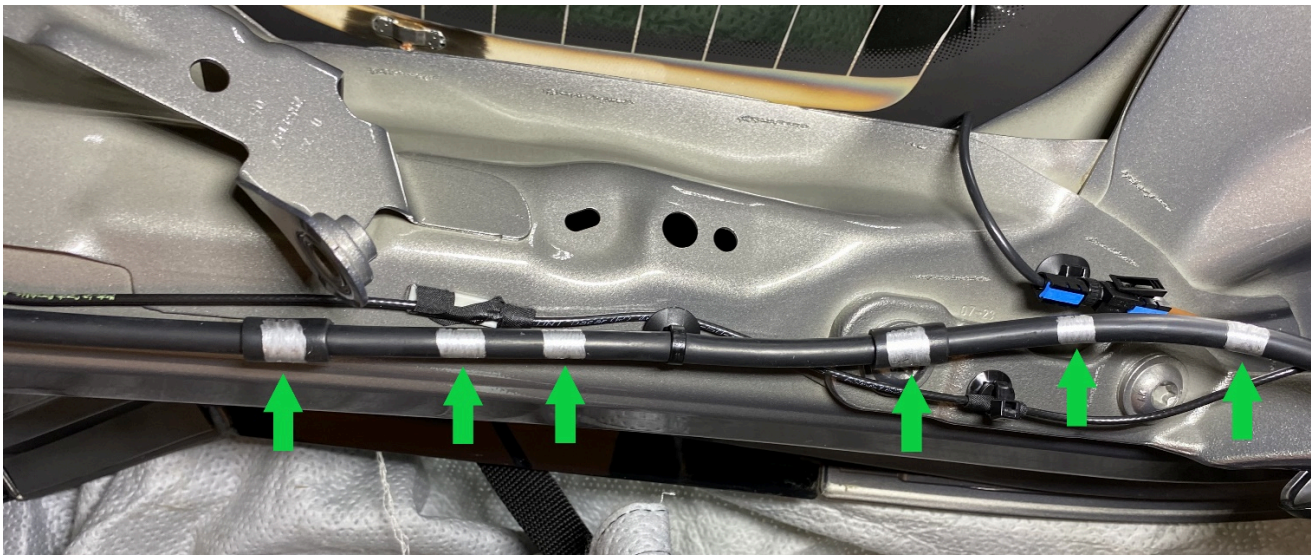
While driving over rough surfaces, a rattling noise can be heard in the area of the tailgate.

The rear washer fluid hose may not be fitted tightly.

4. Locate the washer fluid hose and attach self-adhesive felt strips at the six (6) locations exhibited by the silver markings (arrows) in the image below.
