SIB 63 10 23

MOISTURE/CONDENSATION IN THE REAR TAILLAMPS

E-Series	Model Description
U11	X1 Sports Activity Vehicle
G60	5 Series Sedan

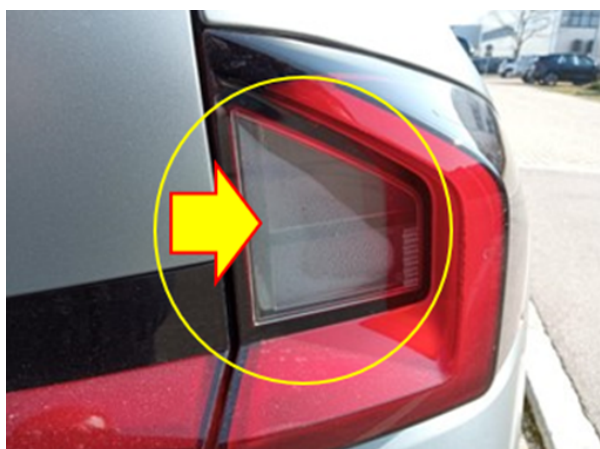
- A. Thermal/environmental conditions that result in the formation of condensation is not a defect.
- B. Water/moisture in the taillamp housing is considered a defect.

A. Normal/natural condensation.

If normal environmental conditions are the cause of the condensation, no correction is required.

- The taillamps will dissipate the condensation through venting. This venting process should be completed within 24 hours with the vehicle sitting in temperatures of 68 – 77 degrees Fahrenheit.

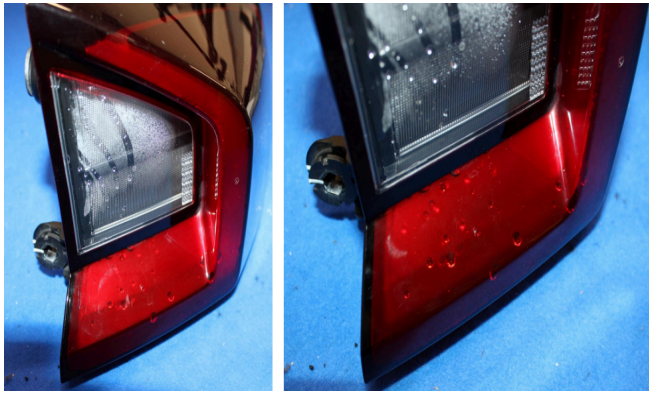
B. Water/moisture in the taillamp.

If the taillamps do not vent/dry within the described time frame, inspect the taillamp for leaks/damage and replace it if necessary.
