SIM 52 01 24
COMFORT ENTRY AND SEAT
BACKREST INOPERATIVE

2024-08-29

E-Series	Model Description	Production Date	Affected Option Code
F66	MINI Cooper S Hardtop 2 Door	Vehicles produced up to May 24, 2024	459 Seat adjustment, electrical, with memory

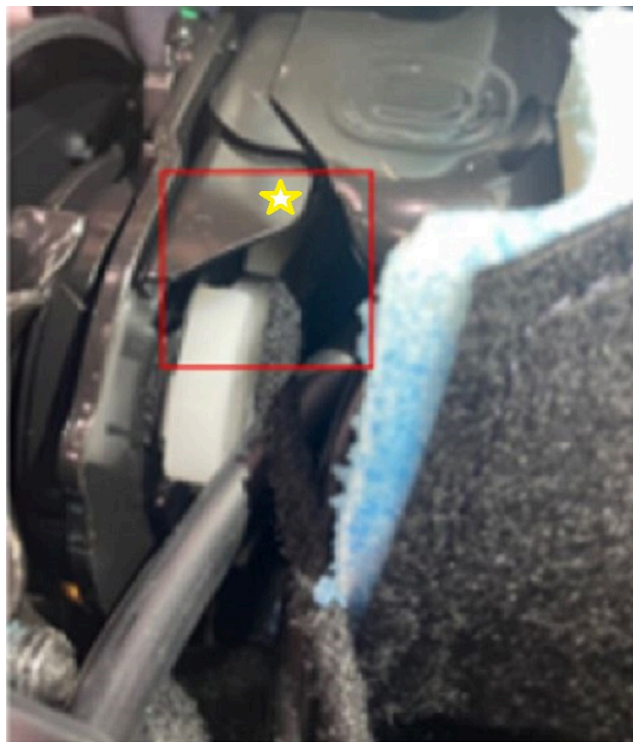
The seat harness wiring is trapped in the microswitch inboard of the seat backrest pivot.

Reposition the seat wiring harness and secure it with a plastic cable tie.

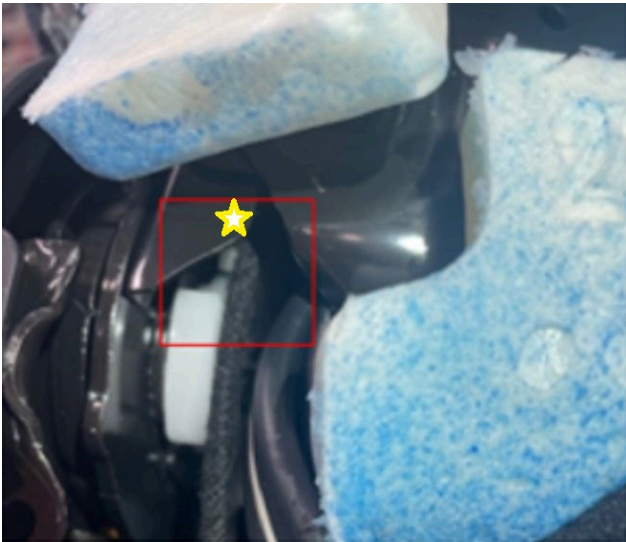
2. Check whether the seat wiring harnesses are stuck in the microswitch inboard of the seat backrest pivot.
