SIB 11 03 24

SERVICE ACTION: Replace Crankcase Screw

Model	Model Description	Model Code	Production Dates
KA1	R 1300 GS	0M23	Aug 21, 2023, to June 3, 2024

0M21 - R 1300 GS

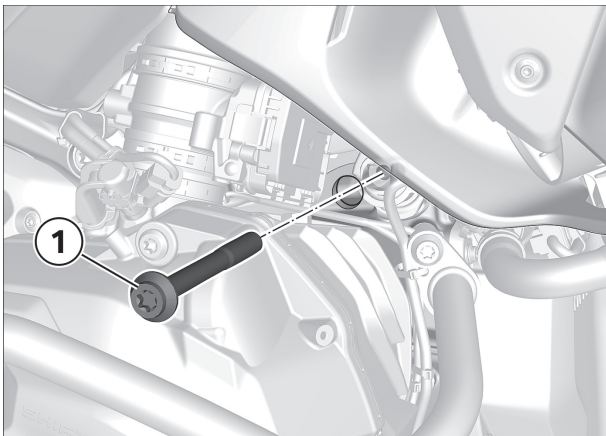
2

After quality inspection it has been found that the bolting torque process of the engine crankcase to frame was not adequate. As a result, there may be an effect on the rigidity of the general engine to frame combination.

► **Replace crankcase bolting.**

- Remove screw (1).
- Install new screw (1).

Tightening torques		
Assembly of crankcase		
M10 × 95	Tightening torque, 25 Nm	
	Additional angle of rotation, 90°
