SIB 46 04 24
SERVICE SOLUTION: Rattling Fairing Side Panel

Model	Model Description
K83	F 900 R
K84	F 900 XR

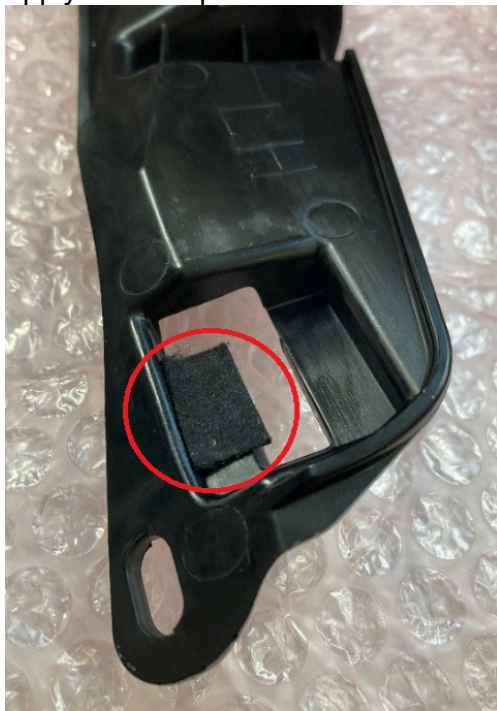
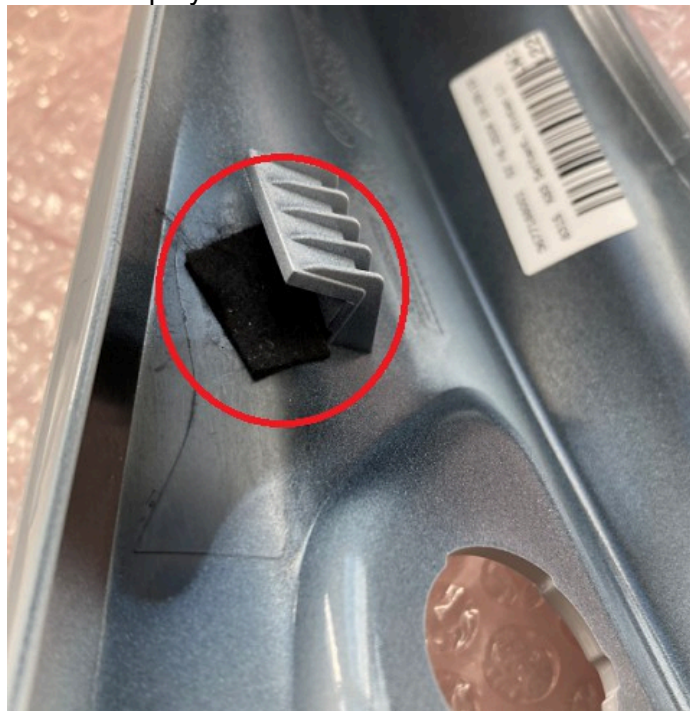
Rattling of the rear side panels caused by play in the push fit connections.

Apply a felt strip in these locations to reduce this play.
