**TECHNICAL SERVICE BULLETIN****Transmission Downshift When In Drive (D) And Shifting To A Higher Gear Will Be Unavailable In The Instrument Panel Cluster (IPC)****24-2253**21 August  
2024**Model:**

<b>Ford</b> 2021-2024 F-150	Non-Lighting
--------------------------------	--------------

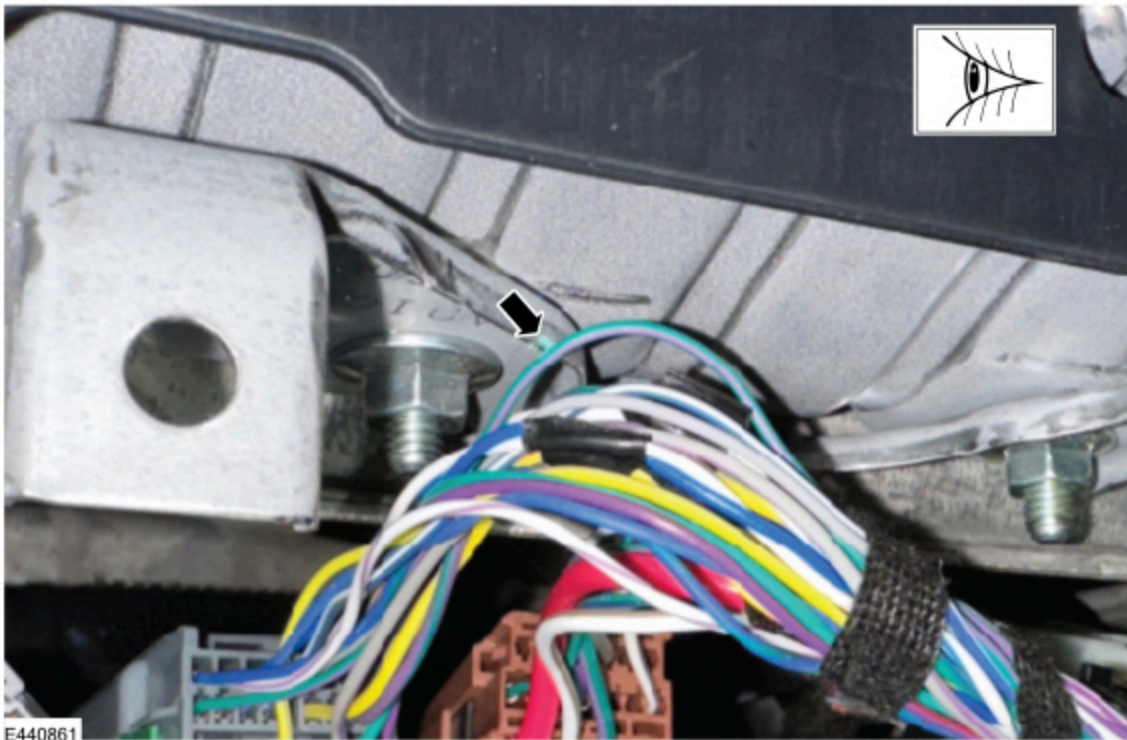
Figure 1

**Issue:** Some 2021-2024 F-150 non-Lightning vehicles may exhibit a condition where the SelectShift®/SelectShift™ transmission will downshift to a lower gear when in drive (D) and shifting to a higher gear will be unavailable in the IPC. Downshifting may continue, when safe entry conditions are met for each gear, and the IPC display will show the available gears counting down one by one as the vehicles' speed and engine rpm decreases. This may be due to a chafed wire harness in the SelectShift® +/- circuit. To correct the condition, follow the Service Procedure to repair the circuit.

1. Remove the right side insulation panel as outlined in WSM, Section 412-00, Removal And Installation, Blower Motor Control Module.
  - (1). It is not necessary to remove the blower motor control module.
2. Remove the glove compartment storage bin assembly as outlined in WSM, section 501-12, Removal And Installation, Glove Compartment.
3. Inspect CET42/pin 14, from connector C210 behind the glove compartment and further inspect surrounding wires and harness for a rub/pinch condition against the instrument panel frame. (Figure 1)

4. Is any damage present to CET42 or the surrounding wires? (Figure 1)
  - (1). Yes - proceed to Step 5.
  - (2). No - proceed to Step 6.
5. Repair the damaged wiring. Refer to Cell 005, page 5 of the Wiring Diagram.
6. Wrap Coroplast Electrical Wire Harness Tape around the 12A581 harness starting 1 in. (25 mm) from back side of the connector to the harness retainer. (Figure 2)
7. Position the harness and secure it to the connector bracket utilizing a wiring strap to prevent future contact/damage against the instrument panel frame. (Figure 2)
