TECHNICAL SERVICE BULLETIN

3.5L PowerBoost - Lariat/XLT/XL Trim Levels - Right Side Turbocharger Concerns

24-226423 August
2024**Model:**

Ford 2024 F-150	Engine: 3.5L PowerBoost Lariat/XLT/XL trim level
---------------------------	---

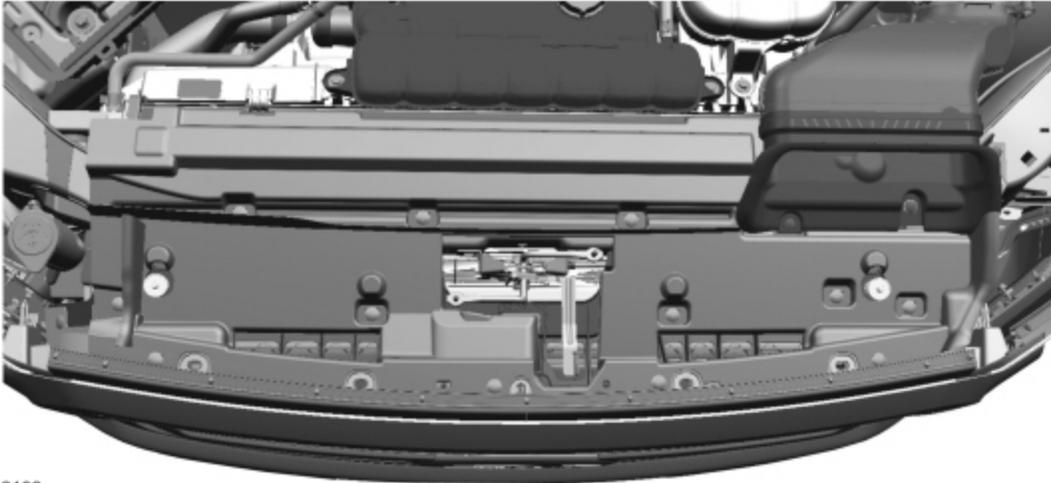
Figure 1

1. Does the upper air deflector match the one outlined in Figure 1?

(1). Yes - proceed to Step 2.

(2). No - this article does not apply. Refer to the WSM for additional diagnostics.
