TECHNICAL SERVICE BULLETIN

Soft Top Roof - Headliner Detaching From Soft Top Material

24-226528 August
2024

Ford 2021-2023 Bronco	Factory soft top roof
---------------------------------	-----------------------

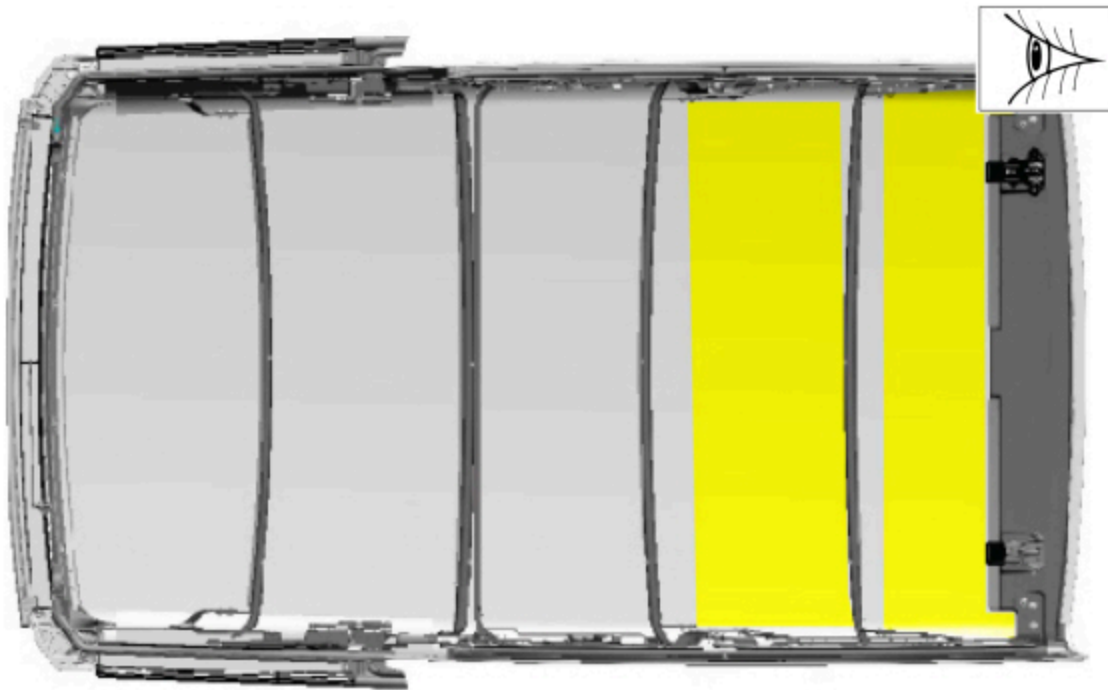
- The soft top material has 2 separate sections of headliners, refer to Figure 1 for locations. Are either of the 2 headliners completely detached from the soft top material and/or damaged, such as stretched, cut and/or warped? (Figures 1-3)
 - Yes - replace the soft top material. Refer to WSM, Section 501-18A. Repair is complete.
 - No - proceed to Step 2.

Figure 1 - View from underside of the soft top assembly. Both headliner locations shown.

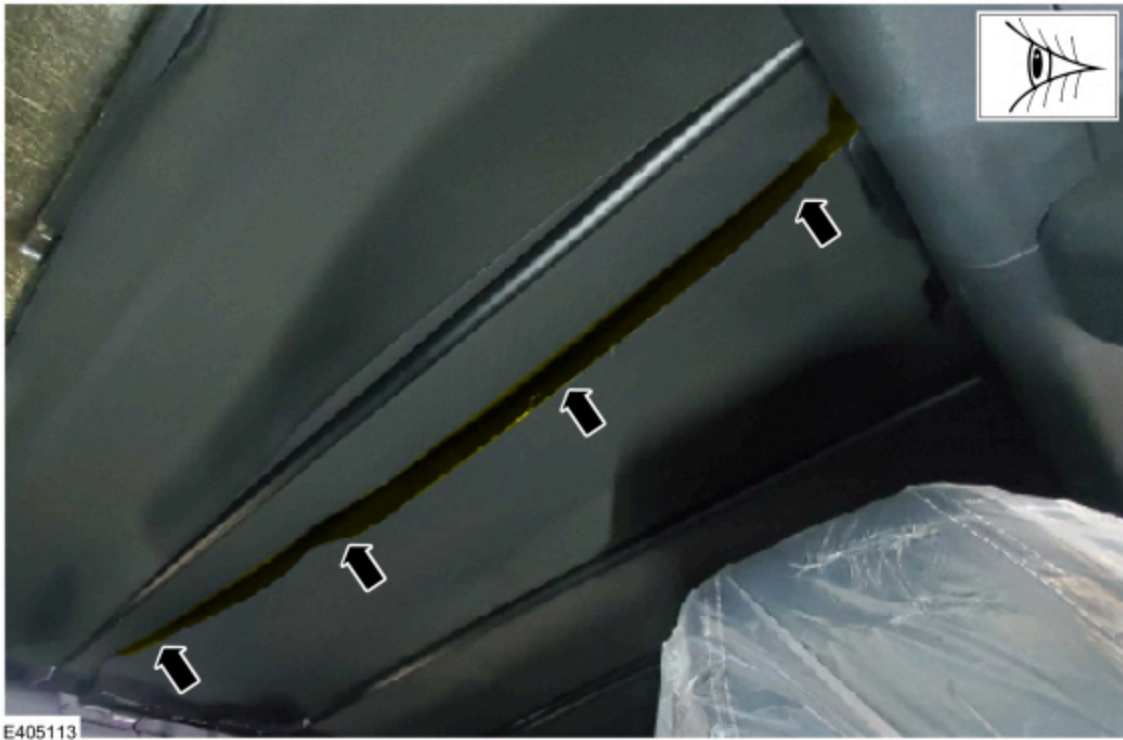
Figure 2 - Example of an undamaged, partially detached headliner that can be repaired

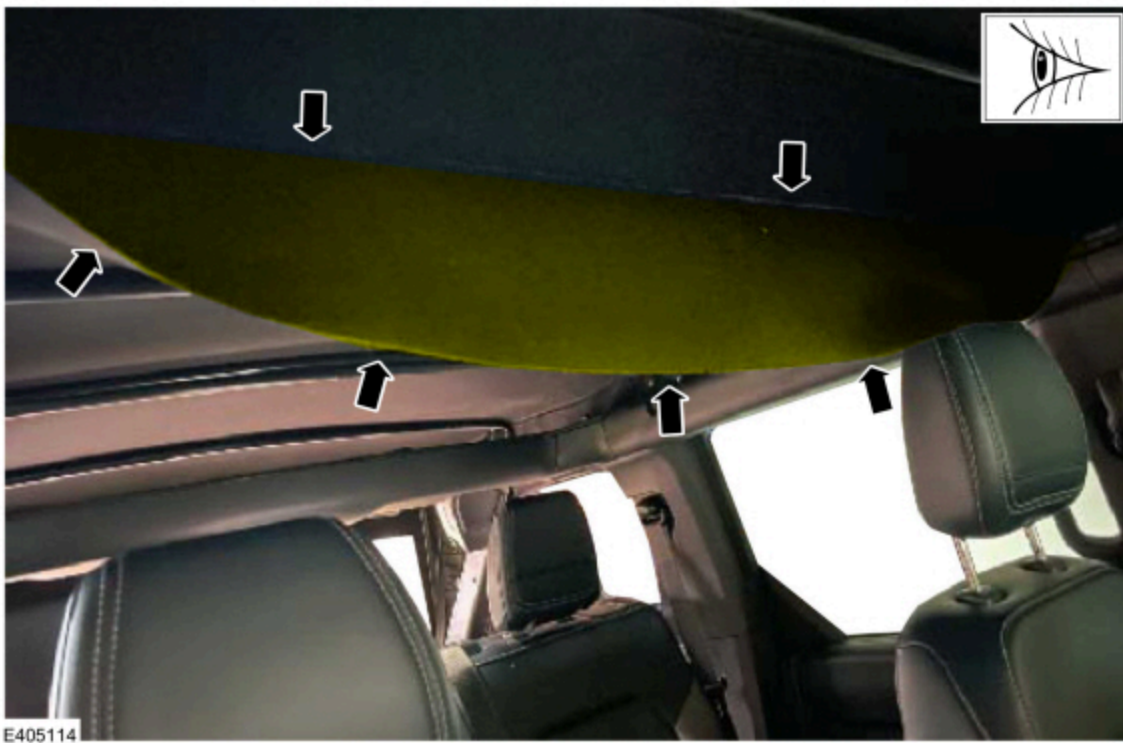
Figure 3 - Example of an undamaged, partially detached headliner that can be repaired

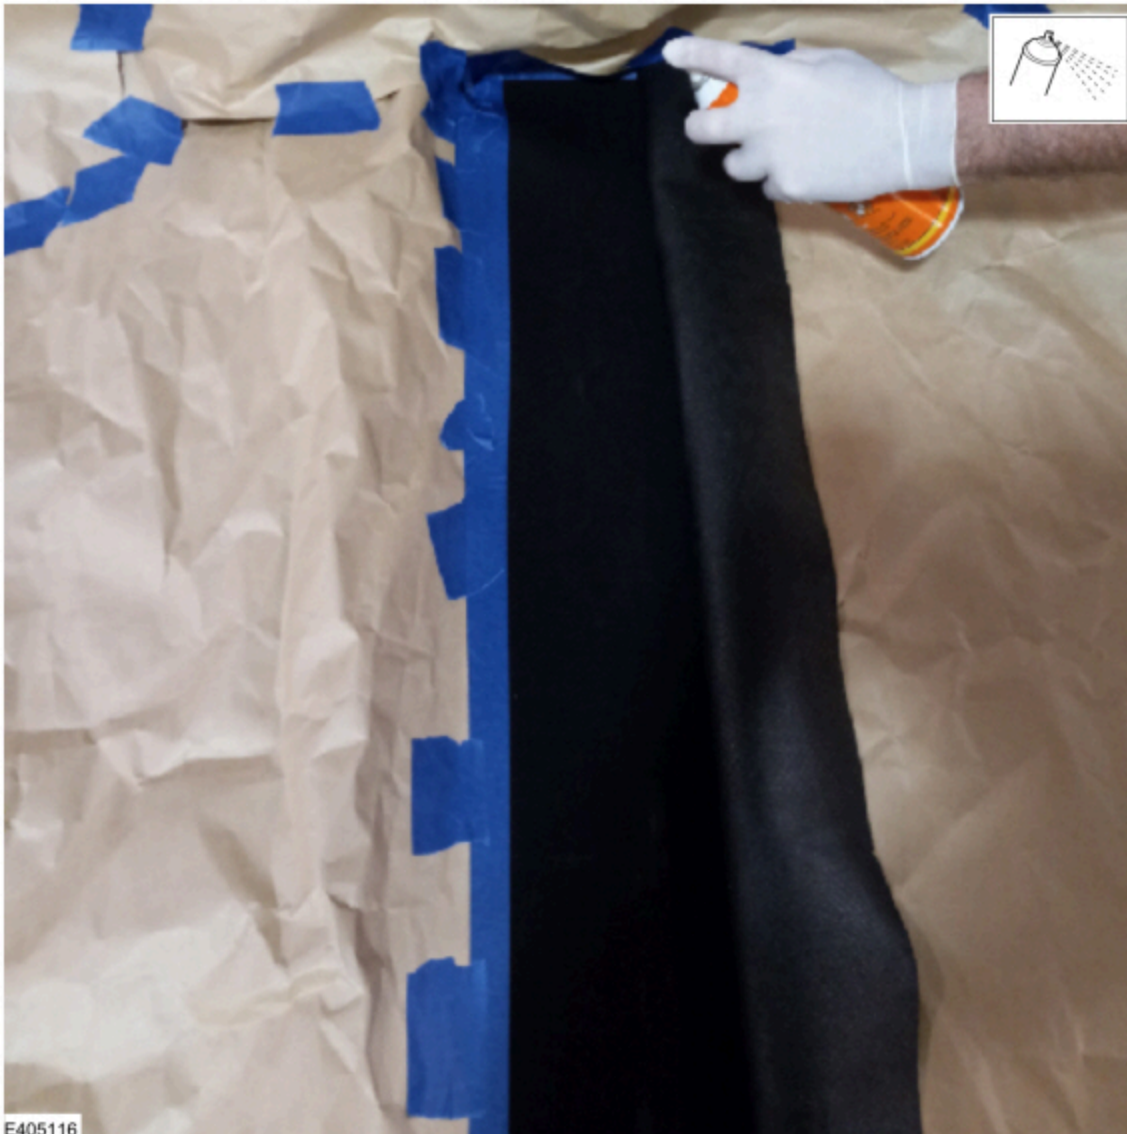
Figure 5 - Showing a properly covered area ready for spray adhesive

5. Use a damp, clean, lint-free cloth to wipe down the entire inside fabric of the soft top material and headliners. If needed, a vacuum can be used to assist with cleaning.
6. Reattach the applicable headliner(s) to the soft top material using the Gorilla® Heavy Duty Spray Adhesive.
 - (1). Perform this step on all sections of the headliner(s) that have become partially detached.
 - (2). Prepare the soft top material and headliner(s) for reattachment with the spray adhesive by taping off the surrounding areas with painter's tape. Use paper and/or cardboard to add further protection. Only the inner section of the headliner (that has detached) and the mating surface of the headliner (soft top material) are sprayed with the adhesive. Make sure that adhesive overspray does not occur to the surrounding areas or components, or soft top material replacement may be required. (Figure 5)

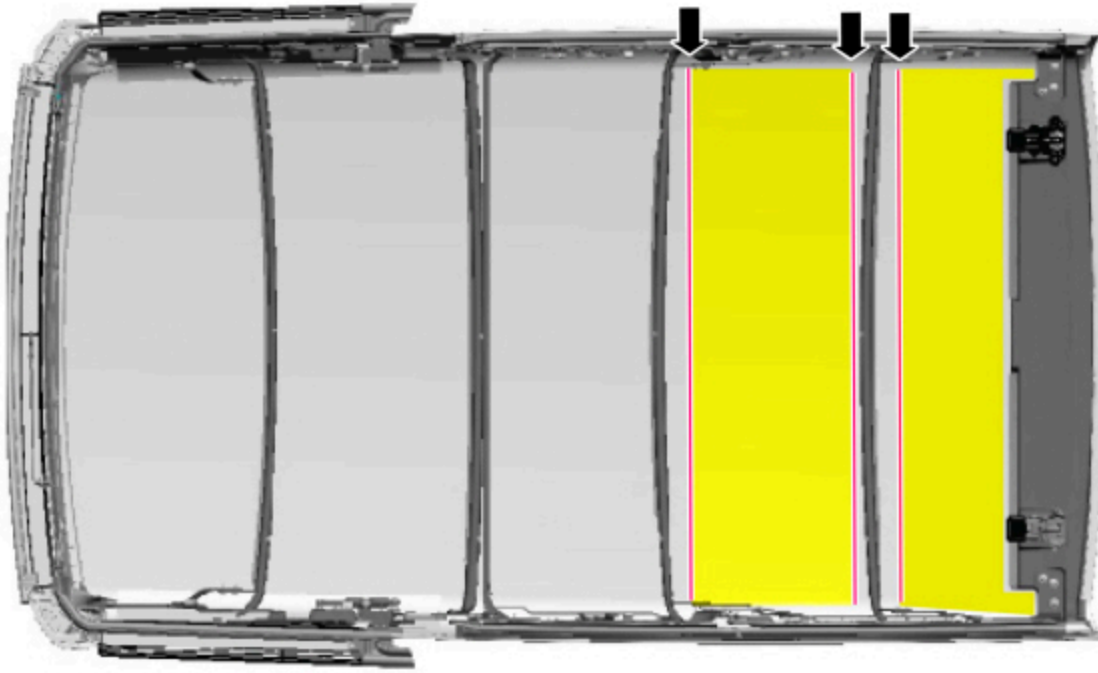
Figure 6 - Showing all 3 headliner seams that must be taped

(1). Tape all 3 cross-car headliner seams regardless of if they were becoming partially detached or not. Refer to Figure 6 for cross-car headliner seam locations.

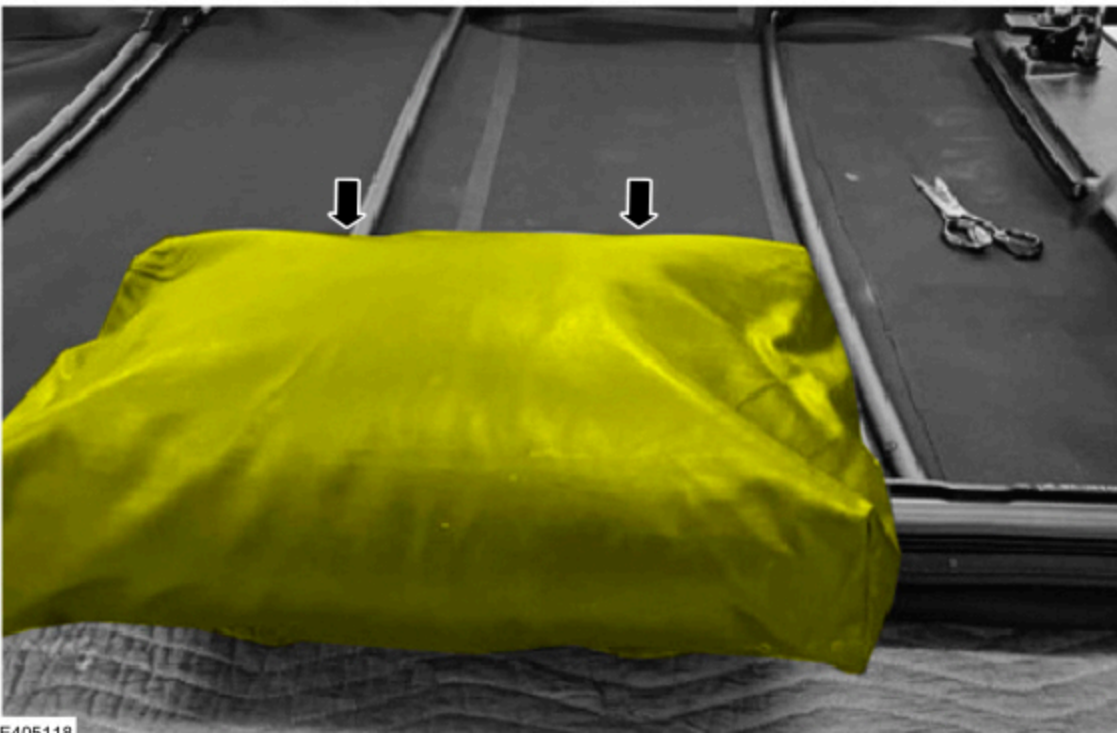
Figure 7 - Sandbag shown on top of frame hinge location. Left side shown, right side similar.

(2). Place a 50 lb. (22.6 kg) sandbag (or similar item) on each the side of the frame to weigh down the raised hinged sections of the frame. This flattens the soft top assembly for easier application. If needed, place a clean cloth underneath the sandbags to prevent the soft top assembly from getting dirty. Refer to Figure 7.

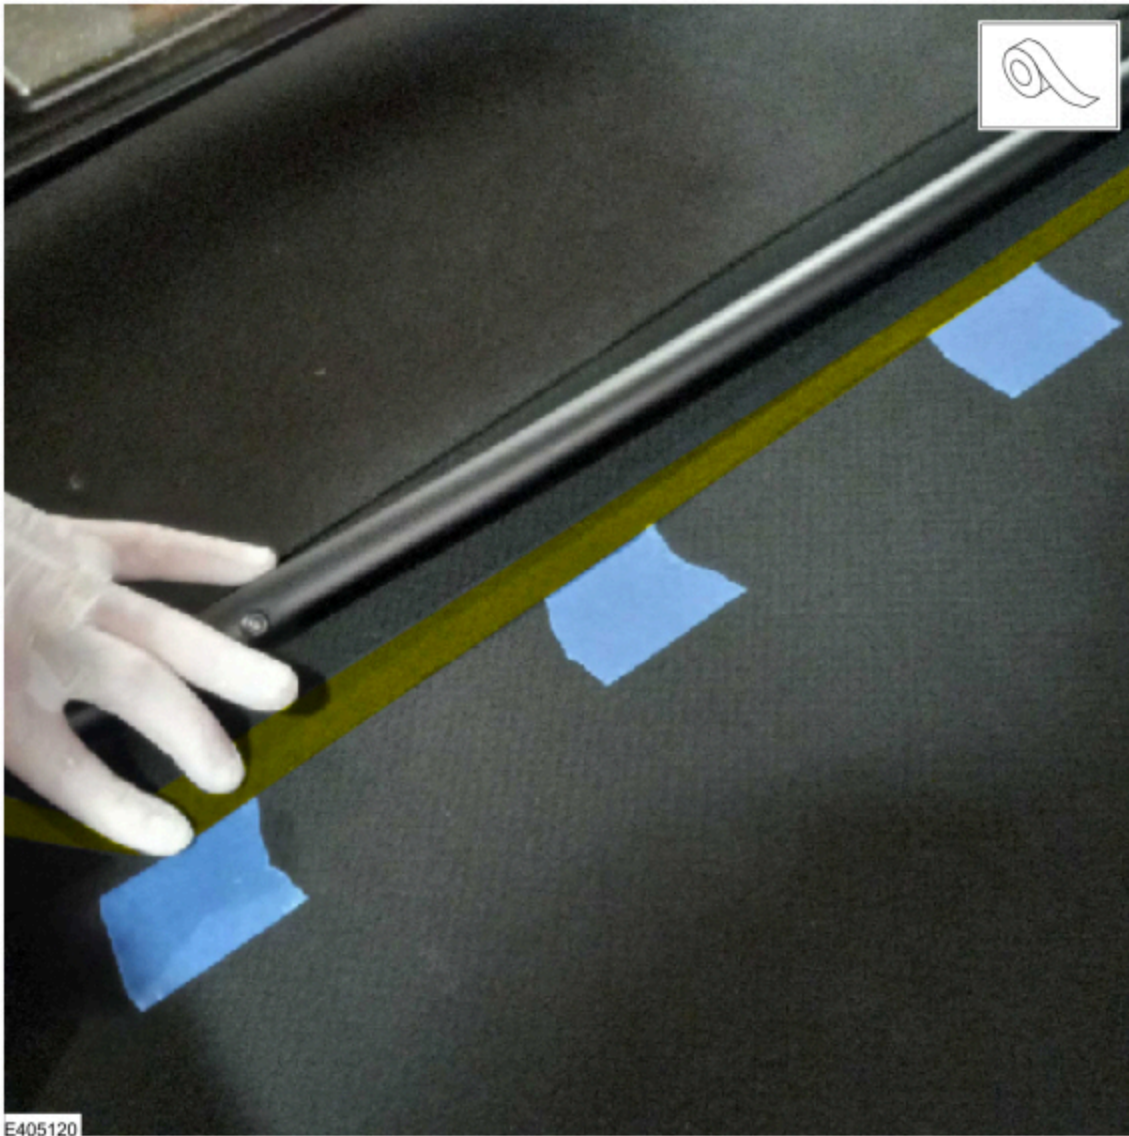
Figure 9 - Showing proper tape Installation following the taped guidelines.

(6). Set the center point of the cut section of film tape on the middle of the soft top assembly. This leaves extra tape on each end of the soft top assembly. Beginning on one side, approximately 12 in. (30 cm) away from one edge of the seam, peel the tape backing in small increments as needed (do not remove the entire length of the tape backing all at once) and lightly install the tape following the 0.5 in. (13 mm) tape guidelines. Be sure that half of the tape width is on the headliner and the other half on the soft top material, creating a straight/uniform line, refer to Figures 9-10. Do not stretch the tape at any point before or during the application. Film tape is extremely pliable which allows it to have excellent adhesion to the fabric. If it is installed while being stretched, it retracts over time which causes it to lose adhesion, refer to Figure 10.

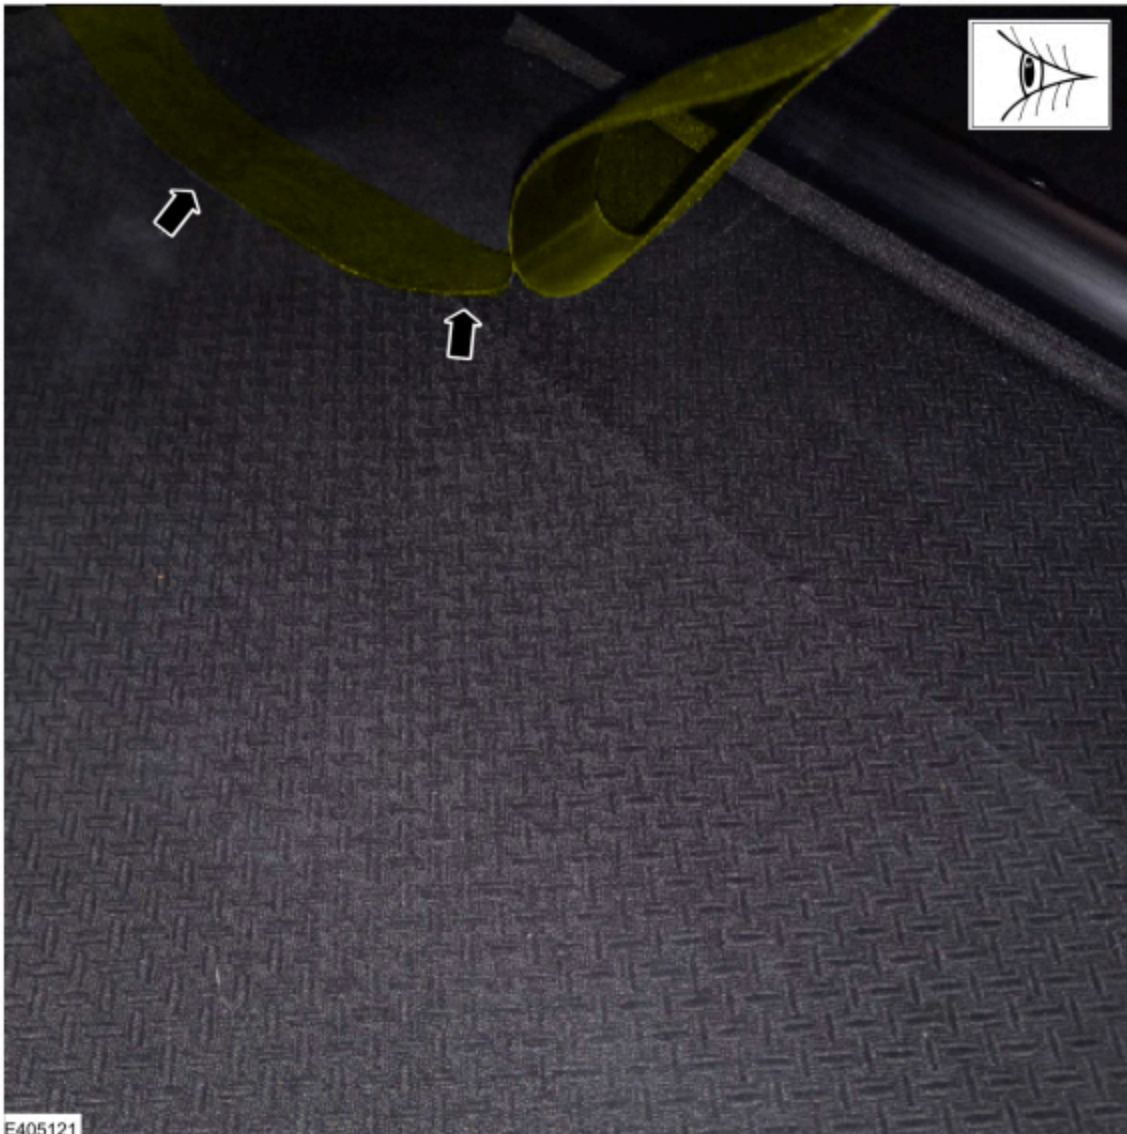
Figure 10 - Showing proper tape installation. Do not stretch tape and only remove backing as needed.

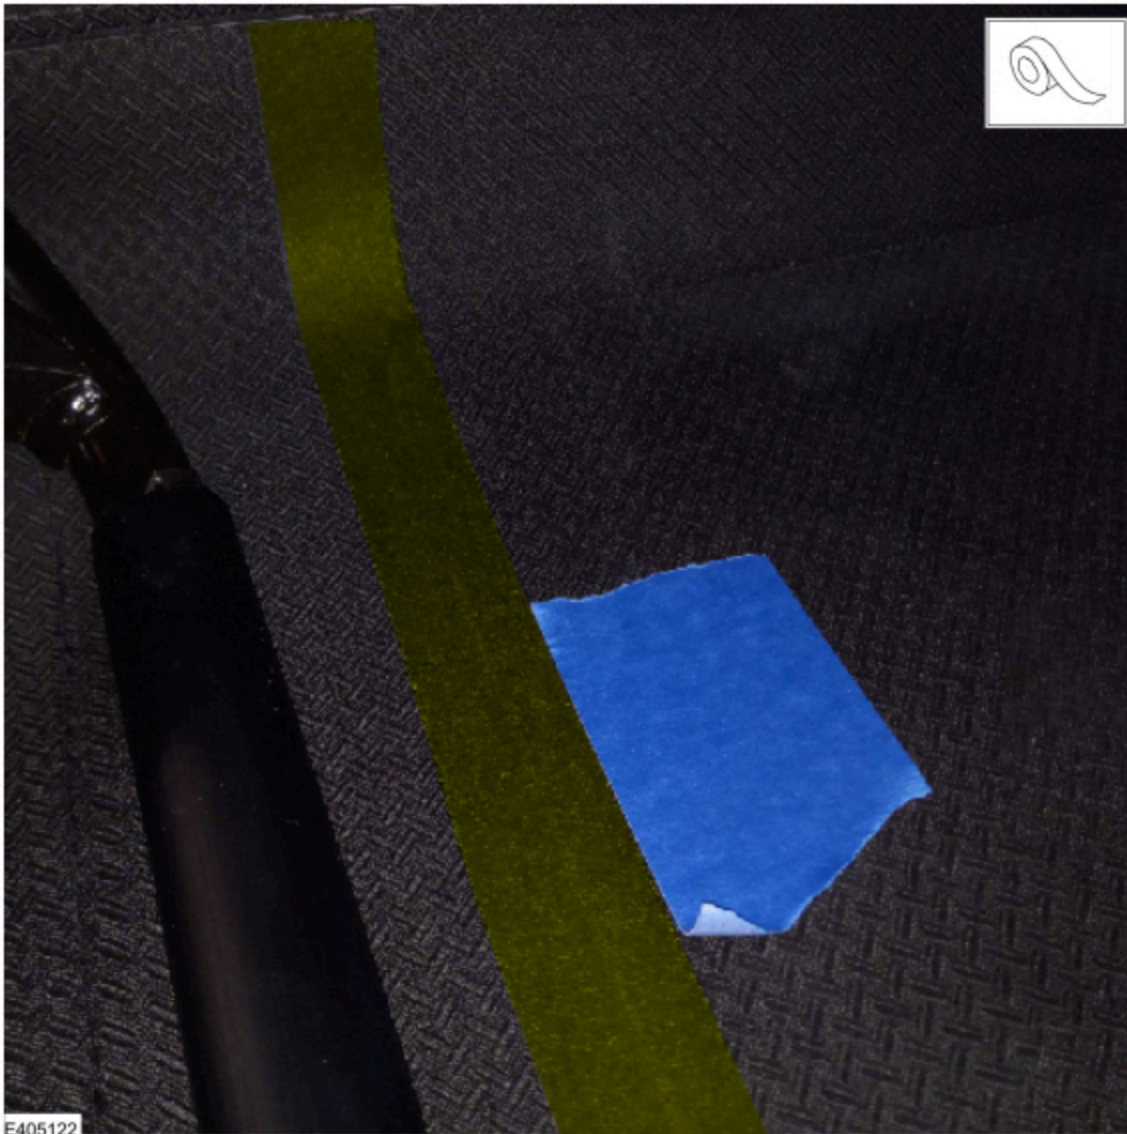
Figure 11 - Showing proper tape installation on the edge of the soft top material.

(7). When the section of film tape reaches the end of the headliner seam, continue to tape in a straight line all the way to the edge of the soft top seam. Allow the tape to stay loose during application. Cut the end of the film tape so that it ends just before the soft top material edge but do not tape past the edge, which runs perpendicular to the tape routing. Be sure that 100% of the film tape is secured and flat to the surface. Do not leave any sections of tape loose/unattached, as this causes tape to peel over time. Perform this step on the opposite edge of the section of film tape, then proceed to the next step. (Figure 11)

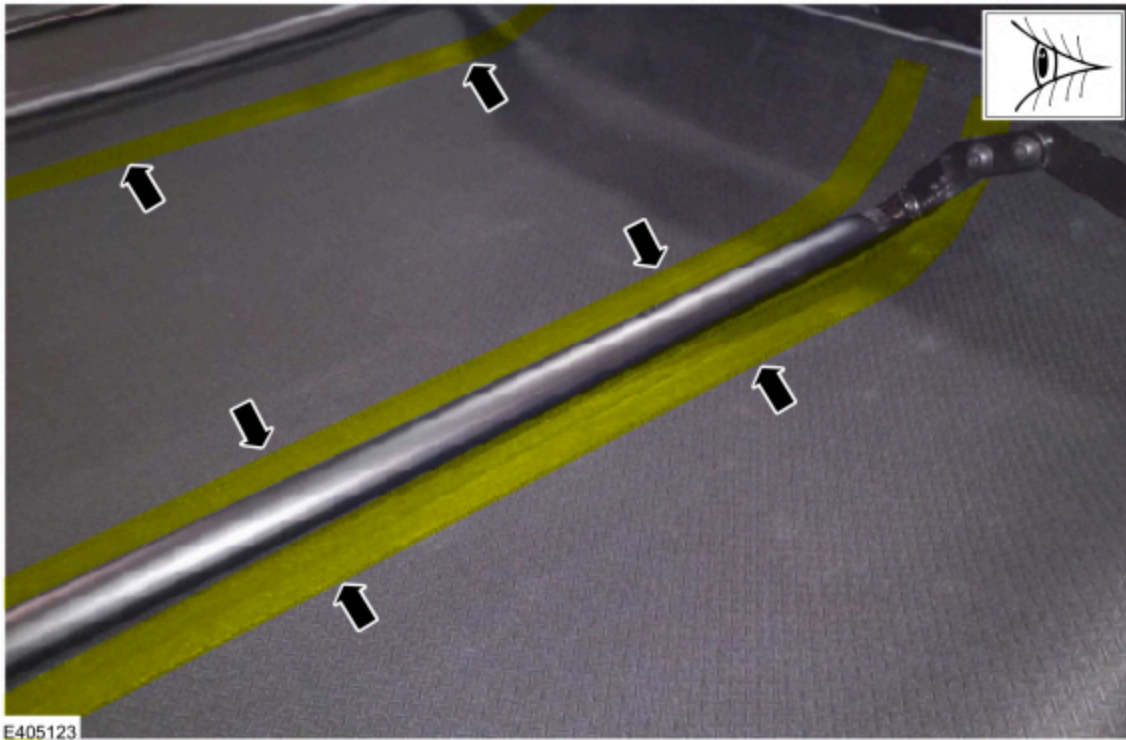
Figure 12 - Showing a complete installation of film tape along all three cross-car headliner seams

(12). Reinspect all 3 installed sections of film tape. Inspect for tape straightness, proper 50/50 adhesion to the headliner and soft top roof material across the entire length of the headliner, film tape peeling (occurs when tape is stretched during installation), and both vertical edges to ensure proper adhesion with no lift of the tape present. If any of these problems exist, repeat Step 7 on any failed sections using a fresh piece of tape.
