Service Bulletin

Bulletin No.: 24-NA-153

Subject: Rear Seat Back Wrinkled/Wavy Appearance

Brand:	Model:	Model Year:		VIN:		Engine:	Transmission:
		from	to	from	to		
Chevrolet	Camaro Con-vertible	2016	2024	—	—	All	All

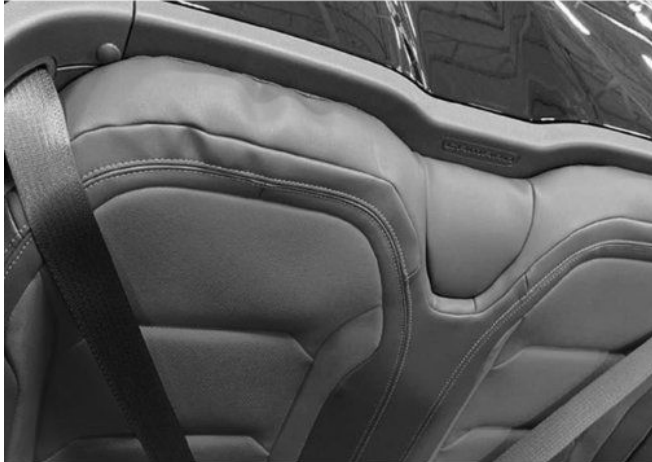
<p style="text-align: right;">6713252</p> <p>Some customers may comment that the rear seat back leather covers are wavy or wrinkled and appear to be a loose fit.</p>
Cause	The rear seat covers may not have been properly stretched out either from poor installation at the factory or from a prior service repair.
Correction	Please follow the Service procedure below to tighten the cover around the base of the seat and eliminate the wavy/wrinkled appearance. Note: This procedure can be followed assuming no damage to the cover has been found.

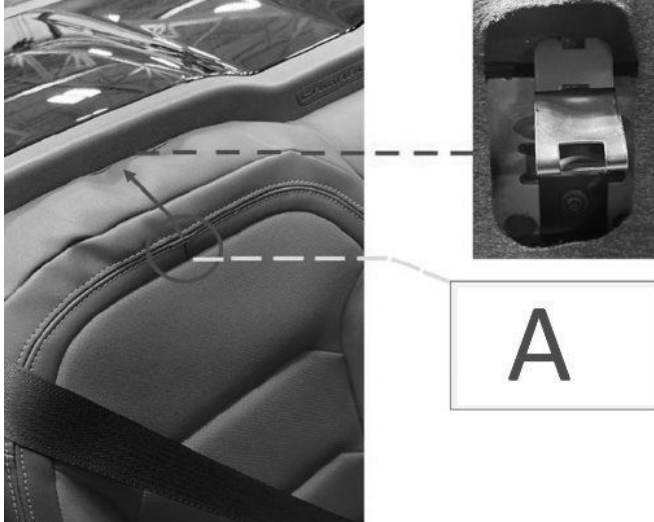
6713253

Note: (A) — Clip location is directly aligned to this center stitching area.

1. Locate the clip (bracket/latch). This can be found in the center of the RSB on the top.
