# Service Bulletin

Bulletin No.: PIE0798

**Subject:** Engineering Information - (EI Lite) - (Pictures Only) Upper and/or Lower Steering Column Trim Cover Contacting the Steering Wheel

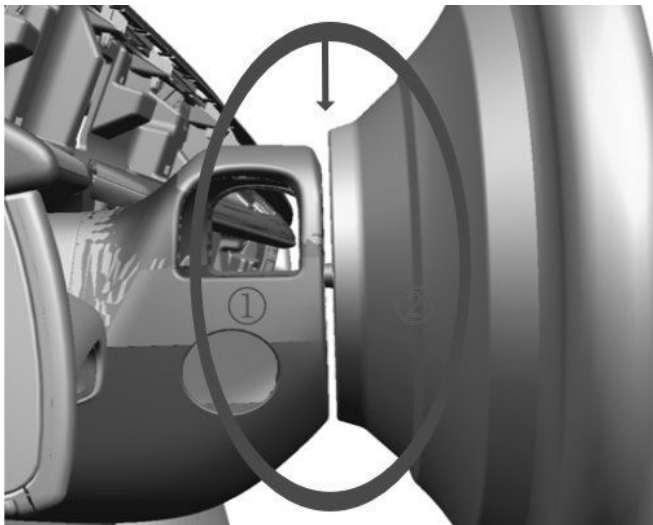
6713478

1. Take a clear picture of where the Upper and/or Lower Steering Column Trim Cover (1) is contacting the Steering Wheel (2).

**Note:** Use colored tape or other type of stick-on marker to indicate area of concern.
