GROUP	MODEL
Subsequent Repair Action	2020-2024MY Telluride (ON)
NUMBER	DATE
SC303Z	August 2024

# RIGHT FRONT DRIVESHAFT INSPECTION AND REPLACEMENT (SC303Z)

This bulletin provides information to inspect and, if necessary, replace the right front driveshaft on certain 2020-2024MY Telluride (ON) vehicles manufactured from January 9, 2019 through October 19, 2023 that previously had the campaign SC303 completed. If the subject vehicle exhibits abnormal driveline noise on the right side while driving, open a Techline Repair Assistance (RA) case. Follow the procedure outlined in this publication to inspect and, if necessary, replace the right front driveshaft and bearing bracket assembly on the applicable vehicle. Before conducting the procedure, verify that the vehicle has completed the previously released campaign SC303 and is included in the list of affected VINs.

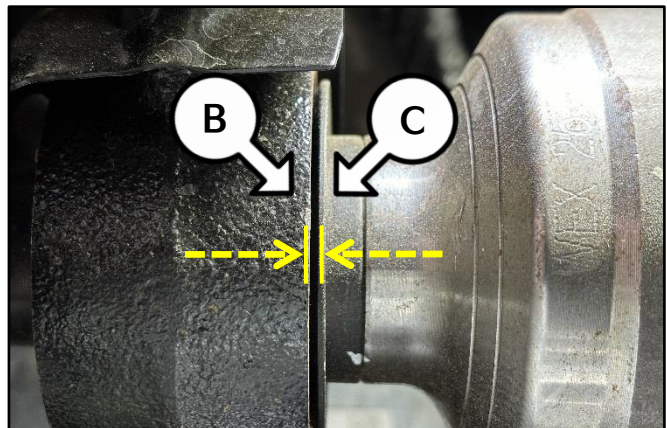
4. The inspection area is shown on the right:

**Note:** It is normal for the end lip of the front driveshaft (C) to either rest flush with the bearing bracket (B) outer edge or be exposed as shown. The exposed distance should not exceed 2mm.

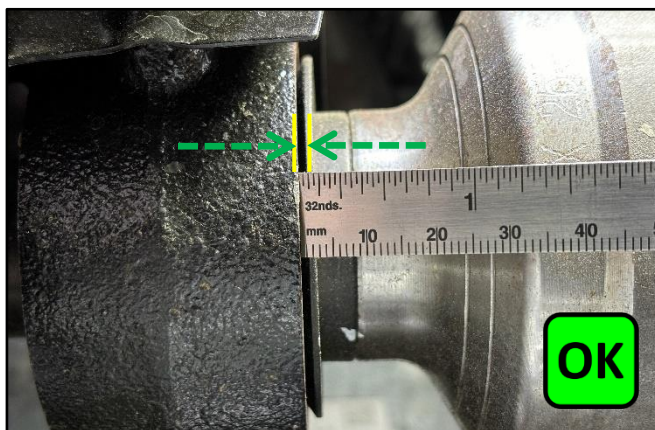
5a. Using a small ruler or feeler gauge, measure the gap clearance shown and confirm that it does not exceed 2mm:

- **Using a Ruler:**  
If the gap measurement is 2mm or LESS (OK), the inspection is complete. No further action applies to this campaign. Claim Inspection labor op 240A2910.

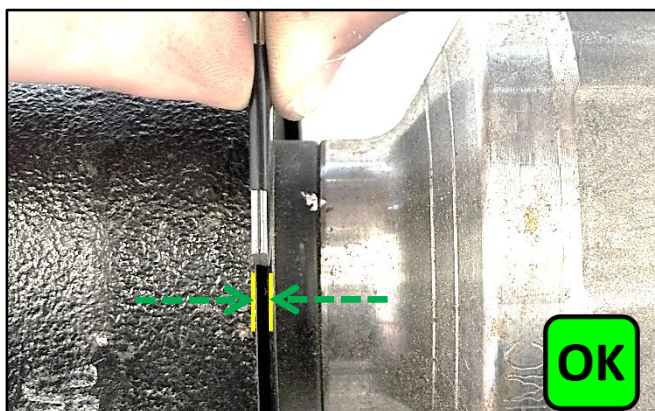
- **Using a Feeler Gauge:**  
If the gap measurement is LESS than 2mm (OK), the inspection is complete. No further action applies to this campaign. Claim Inspection labor op 240A2910.

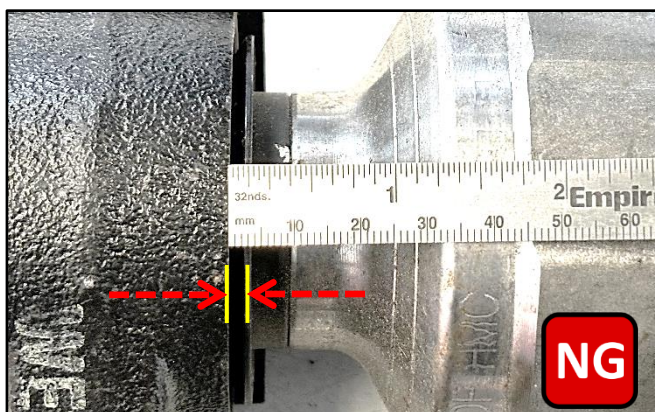
5b. • If the gap measurement is **GREATER than 2mm (NG)**, (ex. 2.1mm or more) then proceed to 'Inspection Procedure #2: (Bearing Bracket Spline Teeth)' below.

Sample shown above measures 2.5mm gap

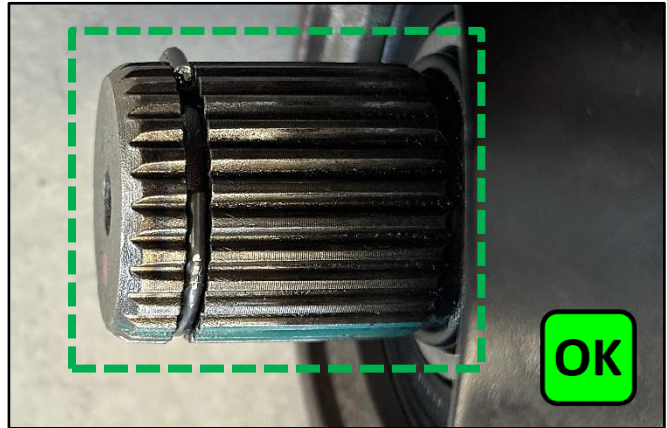
11a. Inspect the bearing and bracket assembly spline teeth condition:

- If the spline teeth are **NOT** damaged or worn (**OK**), especially in the outer spline area; then any concerns related to noise or vibration must be diagnosed normally by referring to KGIS. **This remedy is not applicable.** Reinstall all removed parts in the reverse order of removal including new non-reusable parts. **Claim Inspection Op code 240A2911.**

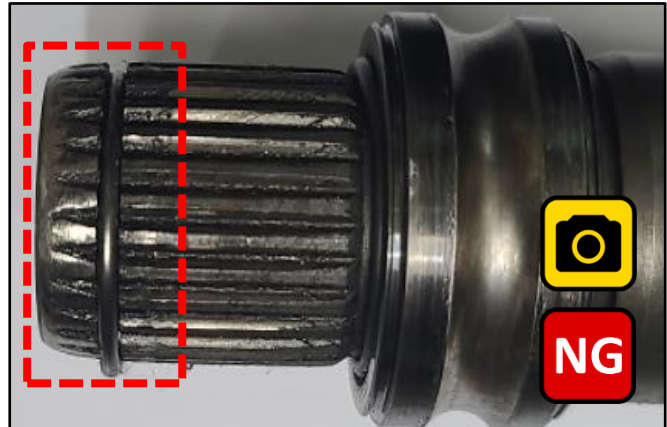
If the spline teeth **ARE** damaged or worn (**NG**), take one clear KVID photo of the damaged splines as shown including the RO information and replace both the right-side driveshaft and bearing & bracket assemblies with new parts.

12. Reinstall all other removed parts in the reverse order of removal including new non-reusable parts.
