**992 – Instrument Cluster Navigation Arrow Off-Center**

Models	Model Year	Model Type	VIN Range	Vehicle-Specific Equipment
911	As of 2020	992	N/A	N/A

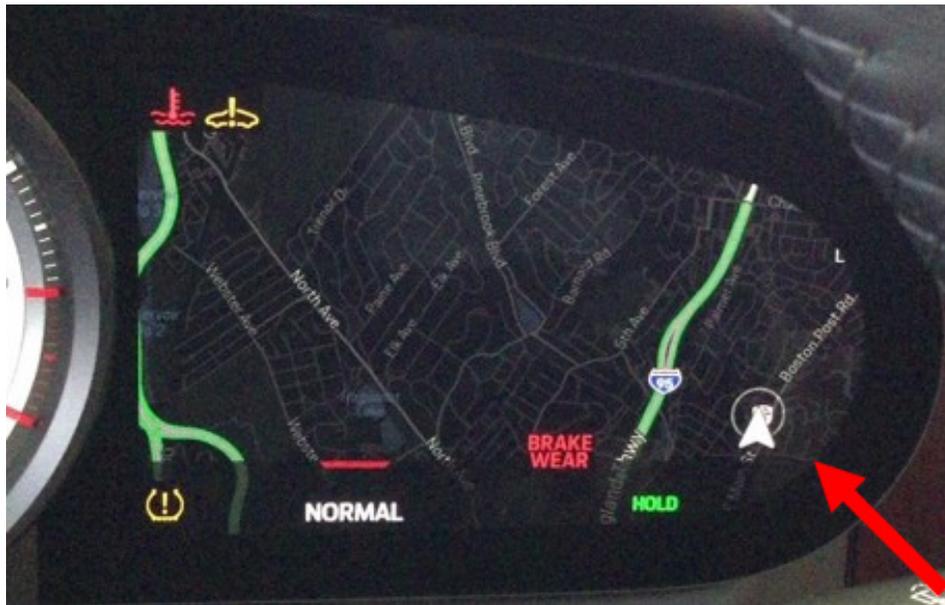
Customer complains of the navigation arrow in the instrument cluster not being centered.

Figure 1 - Navigation Arrow Off-Center

Due to the lower resolution of the instrument cluster display for the 992, the navigation display becomes unproportional. This leads to the image becoming oversized and the navigation arrow off centered.

Create a PCSS job for the concern. Follow the listed conditions below for the PCSS job:

- Cause location: 90250 Instrument cluster
- Cause symptom: 4041 Incorrect display

This topic is currently under investigation. No parts are to be replaced at this time.
