Technical Service Bulletin

GROUP	NUMBER
ENGINE	24-EM-005H
DATE	MODEL(S)
AUGUST 2024	KONA (OS)

SUBJECT: RADIATOR COOLANT LEAK INSPECTION AND REPLACEMENT

Description: Certain 2022MY Kona (OS) vehicles may exhibit a slight radiator coolant leak. Follow the procedure outlined in this bulletin to inspect and if necessary, replace the radiator to correct the condition.

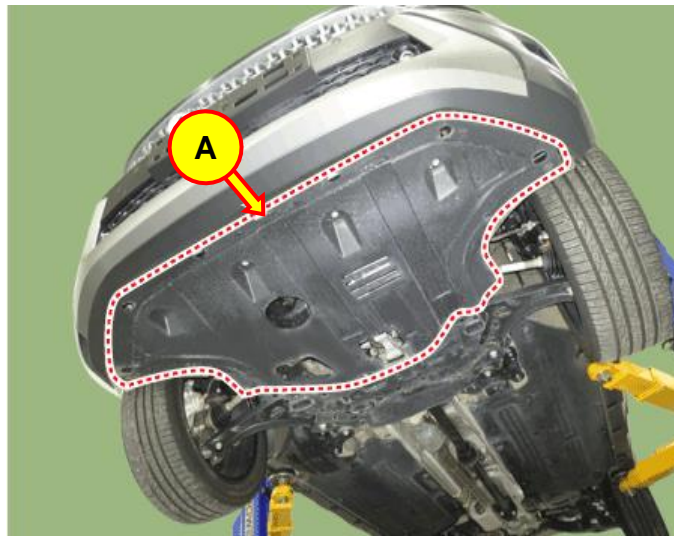
Lift the vehicle and remove the engine room undercover (A).

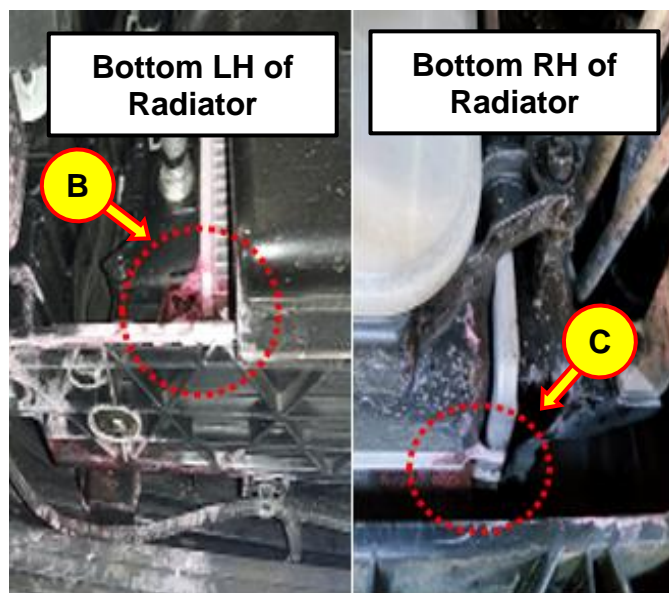
- Check the bottom LH (B) and RH (C) of the radiator for a coolant leak.

- If there is **NO coolant leak**, then **STOP**. Do not continue with this service procedure in this TSB. Follow standard diagnosis.
- If a coolant leaking condition is found at any of the indicated areas, then follow the next steps to take STUI photo(s) and complete the repair.

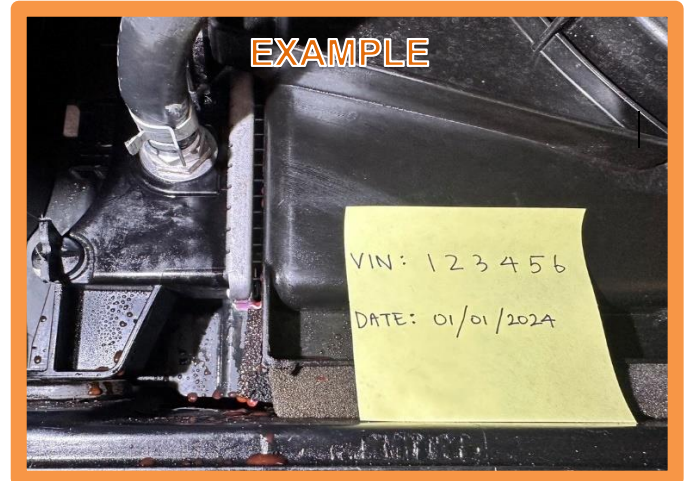
Using STUI, take a photo of the leaking area(s) of the radiator with the last 6 digits of the VIN and the date of repair on a piece of paper.
