WRL3 - Check Trailing Arm on the Rear Axle (Upper Left) and Replace if necessary (Stop Delivery)

Model Line: **Cayenne (9YA) / Cayenne Coupé (9YB)**

Model Year: **As of 2024**

Concerns: **Rear-axle trailing arms**

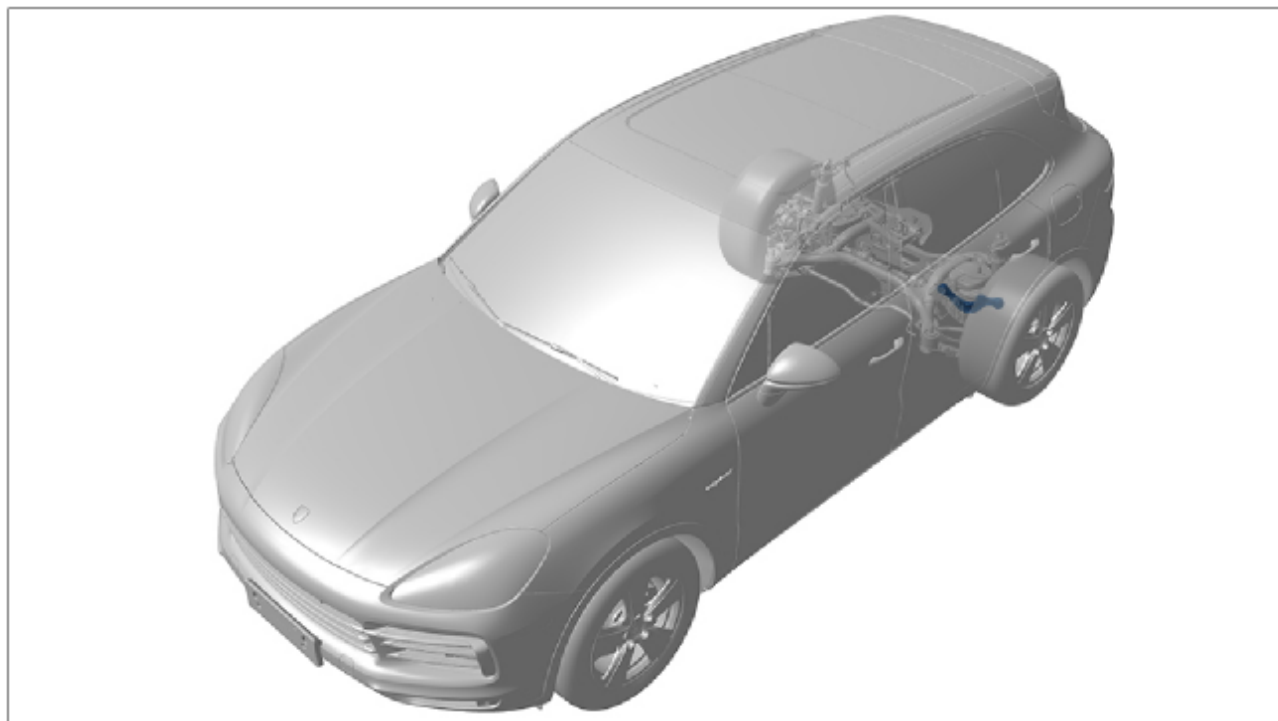
Cause: **Due to a process error in production, it is possible that an incorrect axle control arms have been installed on the upper left rear axle of the affected vehicles.**

Installation position for upper rear left trailing arm

Action: **Check trailing arm on the rear axle (upper left) and replace if necessary**

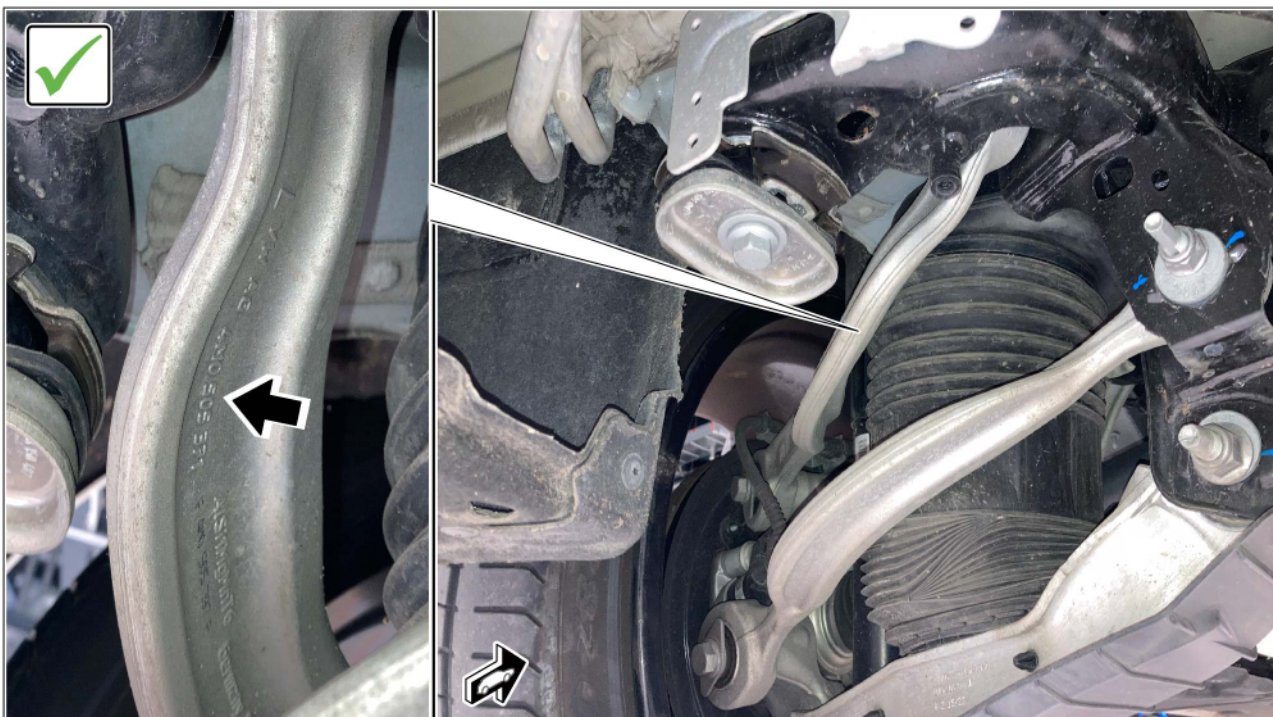
- Work Procedure: 1 Move the vehicle onto a lifting platform and raise it. ⇒ *Workshop Manual '4X00IN Raise the vehicle'*
- 2 Check part number on **rear left trailing arm** in **the installed state**.
To this end, check whether the part number **4M0505397** is present in front. If necessary, clean the trailing arm with a cloth until the part number is visible.

Upper rear left trailing arm

Assessment		Action
(✓)	The part number "4M 0505397" is present .	End of action. ⇒ Continue with Step 3 [Invoicing: Scope 1]
(✗)	The part number "4M 0505397" is not present but "4K 0505397" is present.	Replace rear upper left trailing arm. ¹ ⇒ Continue ⇒ <i>Workshop Manual '423519 Removing and installing upper trailing arm'</i> [Invoicing: Scope 2 – 3]
