Technical Service Bulletin

GROUP	NUMBER
CAMPAIGN	24-01-067G
DATE	MODEL(S)
AUGUST 2024	GV70 (JK1A) GV70 ELECTRIFIED (JK1A EV)

SUBJECT: FLOOR CONSOLE UPPER COVER DELAMINATION INSPECT & REPLACE (SERVICE CAMPAIGN T44G)

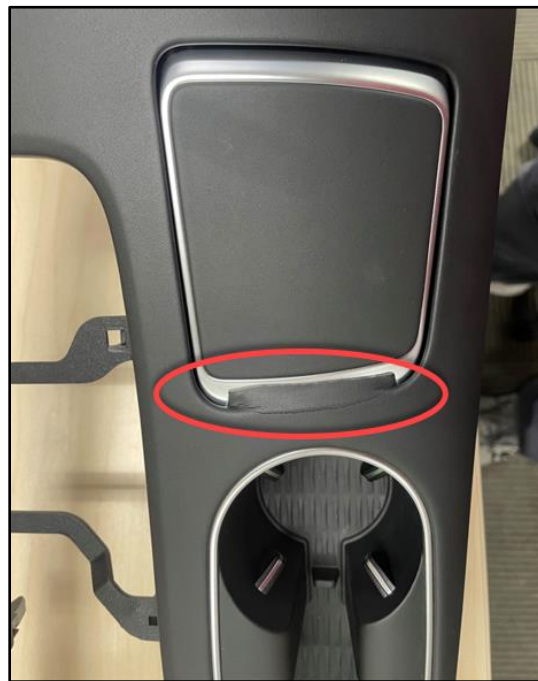
Description: Certain 2024MY GV70 (JK1A) and GV70 Electrified (JK1A EV) vehicles may exhibit delamination of the upper cover on the floor console assembly. Follow the procedure in this bulletin to inspect and, if necessary, replace the floor console assembly.

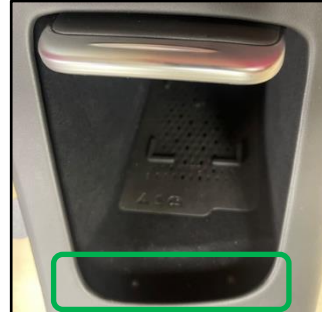
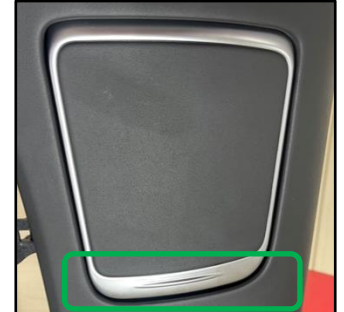
1. Inspect the upper cover of the floor console for signs of delamination.
 - 1a. **GOOD:** The compartment should open freely with no interference.

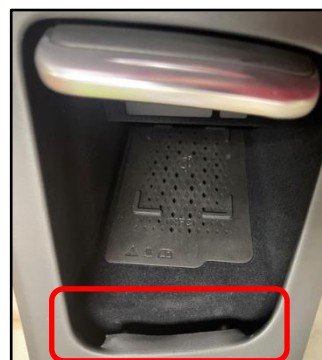
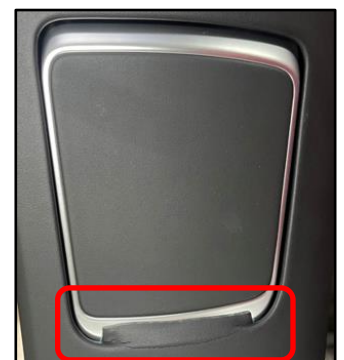
- 1b. **NOT GOOD:** Delamination affects appearance and may hinder compartment opening.

Proceed to “Floor Console Replacement”.

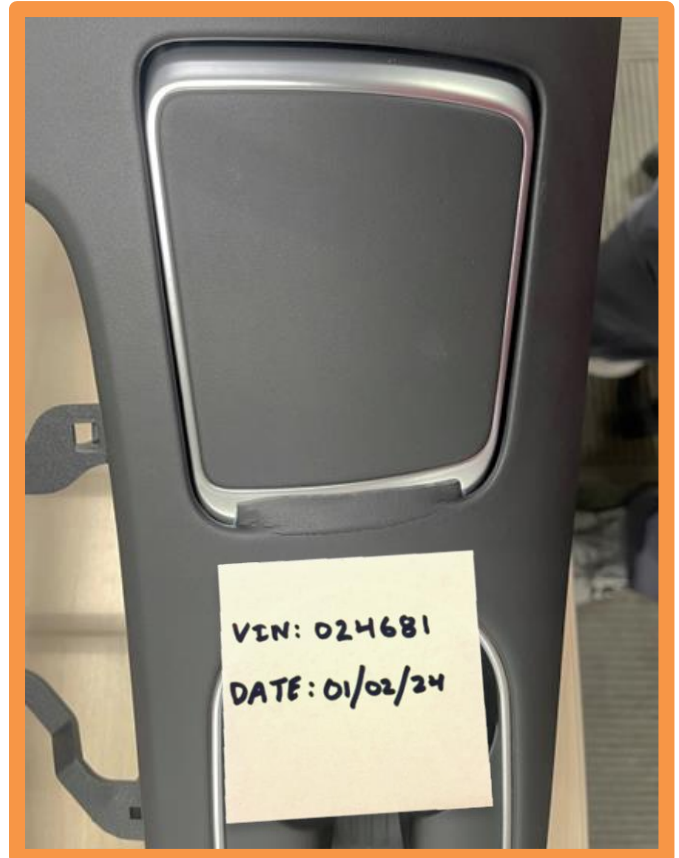
Using STUI, take a photo of the delamination on the floor console assembly with the last 6 digits of the VIN and the date of repair on a piece of paper.
