# Technical Service Bulletin

<b>GROUP</b>	<b>NUMBER</b>
<b>BODY</b>	<b>24-BD-010G</b>
<b>DATE</b>	<b>MODEL(S)</b>
<b>AUGUST 2024</b>	<b>GV60 (JW1 EV)</b>

**SUBJECT:** TAILGATE RATTLE NOISE REPAIR

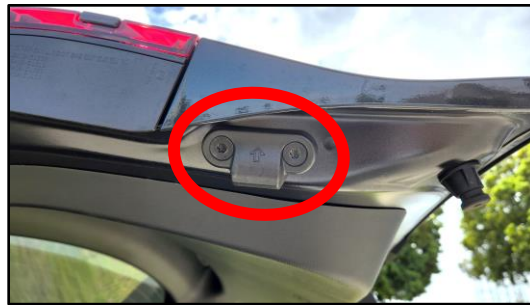
**Description:** This bulletin provides instructions to install washers to the side guide bumpers on the tailgate side panels for GV60 vehicles that experience a rattle noise from the tailgate area while driving.
