Connect Registration and Pairing PDI Tips – Resolve Blinking Red SOS Light

Vehicles Affected

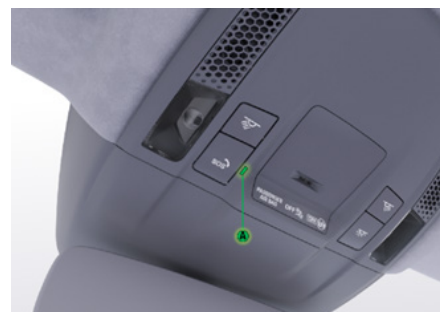
Figure 1

Since the MIB3 system utilizes an eSIM that is not preregistered at the factory, the eSIM must go through a "Registration and Pairing" (R&P) process once Flight Mode is deactivated in the Connect Control Unit (Part ID 9196, also known the ConBox High or Emergency Call Control Unit). The R&P process typically takes 5 to 20 minutes under ideal conditions, but often requires a subsequent sleep cycle. In some cases, this process can take a few hours depending upon signal strength and backend system availability. Once the eSIM completes the R&P process, the SOS light in the overhead console will turn green. (As in Figure 1.)
