Technical Service Bulletin

Subject: WATER ENTRY INSIDE FRONT COMBINATION LIGHT	Bulletin No.: 09-041/24
	Last Issued : 08/30/2024

2016-2022 CX-3 (Japan built) vehicles with VINs lower than JM1 DK*****606638 (produced before July 11, 2022)
2023-2024 CX-3 (Mexico built) vehicles produced before Aug. 2024

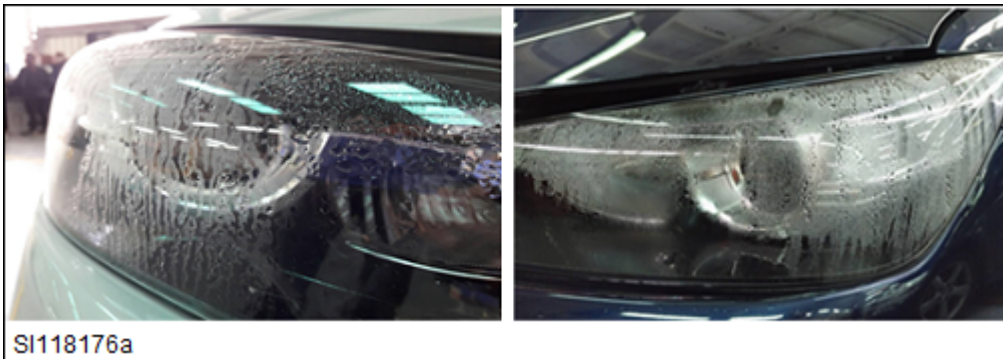
Some customers may notice water entry into the front combination lights (as shown below). This is due to poor sealing where rain or other water can enter inside the light. To eliminate this concern, the shape of the front combination light has been changed to improve sealing ability.

- If water entry is found (as shown in the illustrations above), proceed to the next step.

2. Replace the affected front combination light unit(s) with modified part(s) according to instructions on MGSS online (FRONT COMBINATION LIGHT REMOVAL/INSTALLATION).
3. Verify the repair.
