# Technical Service Bulletin

<b>Subject:</b>  REAR CONSOLE LID DOES NOT SLIDE SMOOTHLY	<b>Bulletin No.:</b> 09-042/24
	<b>Last Issued :</b> 08/30/2024

2019-2023 Mazda3 (Japan built) vehicles with VINs lower than JM1 BP\*\*\*\* \*\* 623994 (Produced before Mar. 27, 2023)  
2019-2023 Mazda3 (Mexico built) vehicles with VINs lower than 3MZ BP\*\*\*\* \*\* 385903 (Produced before Sep. 11, 2023)  
2020-2025 CX-30

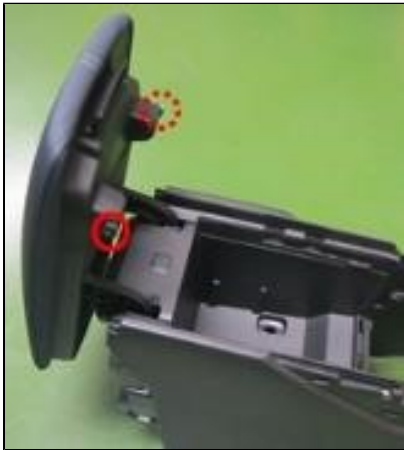
Some customers may complain that the rear console lid does not slide smoothly. This may be caused by improperly positioned felt pads attached to the rear console lid lock, which may have moved out of position after repetitive use. The exposed adhesive residue may stick to the rail and disrupt smooth sliding operation.

To eliminate this concern, the felt pad positions have been changed.
