<b>Subject:</b>  <b>FUEL DOOR STUCK CLOSED OR ALLEGEDLY FELL OFF BY ITSELF (PHEV)</b>	<b>Service Alert No.: SA-042/24</b>
	<b>Last Issued : 08/01/2024</b>

2025 CX-70 (PHEV ONLY)  
2024-2025 CX-90 (PHEV ONLY)

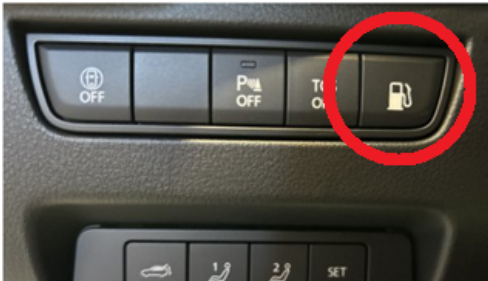
1. Press the fuel filler lid switch on the dash.
