## Service Alert

LOW WASHER FLUID LEVEL WARNING LIGHT COMES ON WITH WASHER FLUID IN THE TANK

Service Alert No.: SA-061/24

2025 CX-70 2024-2025 CX-90

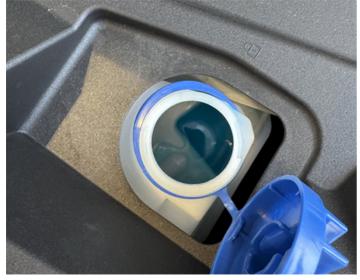
Some customers may complain about a low washer fluid level warning message even though a visual inspection of the washer fluid tank looks like it still has a fair amount of fluid in it. With the CX-90 and CX-70 introduction of the frontengine and rear-wheel-drive layout, the washer tank shape was changed from a vertical to a horizontal type. This makes it look like there is still enough liquid left if viewed from the spout when the warning light comes on.

The warning light is designed to come on early so that the washer fluid does not run out at a short notice during long-distance driving. The light comes on when approximately 0.26 gallons (1.0 liter) of the washer fluid remains in this model, compared to 0.13 gallons (0.5 liters) for other models. The capacity of the washer fluid tank itself is 1.1 gallons (4.2 liters), and approximately 0.8 gallons (3 liters) should be replenished when poured to the FULL position (the edge of the spout).

- 1. Washer fluid (shaded): filled with 1.1 gallons (4.2 liter)
- 2. Washer fluid level sensor
- 3. Full level of washer fluid: Fill washer fluid up to the line.

Before attempting any repairs, first try filling the washer fluid tank to the spout line.
